**Entry:** 001 **Date:** 1/27/2011 **Version:** 1.00 **Title:** Defining requirements

After the overwhelming success of the Class-D audio amplifier, it was decided to pursue an improved, less experimental version. Some ideas for the revised circuit include using entirely surface mount parts (reduced size and potentially increased performance), a higher supply voltage (increased power output), and an output inductor with a lower series resistance.

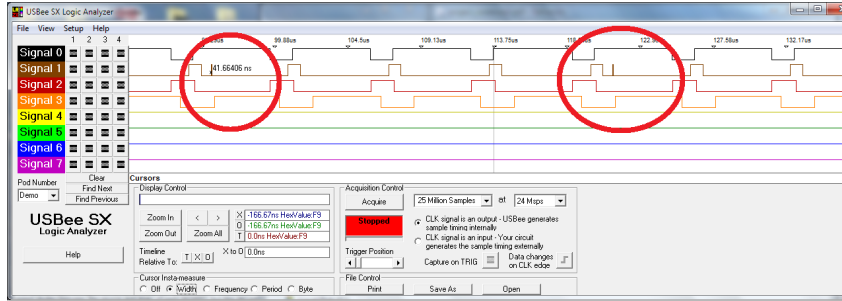
First, I hooked up the logic analyzer to the gating command signals (from the comparator) and to the bottom MOSFET gates. The upper gates were not included due to their need for a floating supply and the 5V maximum input of the logic analyzer. It was discovered that at high input levels, the bottom MOSFET on a given channel would turn itself on while the top MOSFET was conducting, leading to the shoot-through condition. I tried to stop this from happening by placing reverse-biased high-speed diodes between the source and drain of each MOSFET, but this did not solve the problem. It may be necessary to get a "stronger" gate driver that can sink multiple amps of current to keep transistors turned off when they're

supposed to be off.

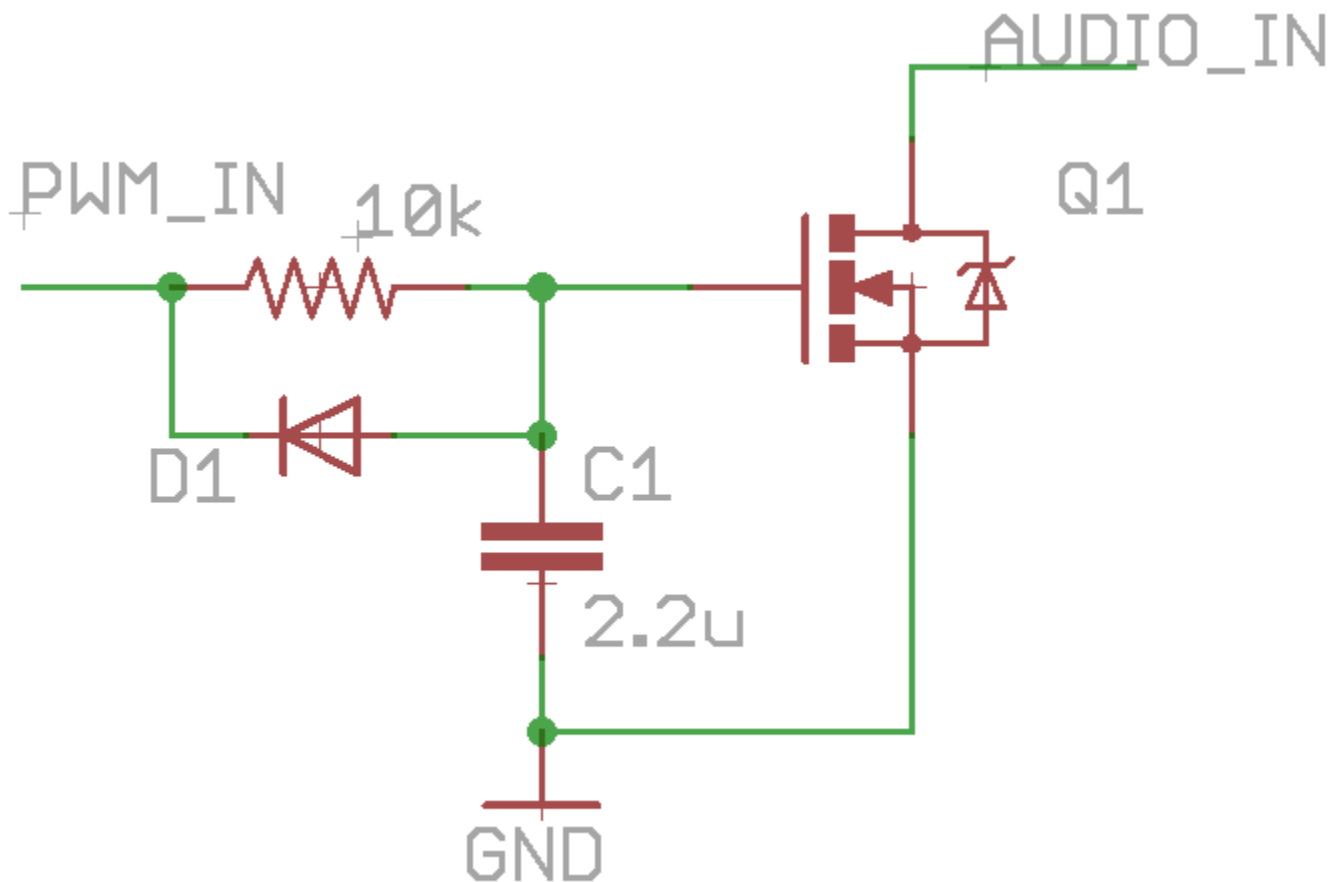
The limiter consists of an RC circuit connected to an N-channel MOSFET. The resistor in the RC circuit is connected in parallel with a diode biased such that it conducts only on the "low" edge of a PWM waveform. The circuit's capacitor is connected across the MOSFET's gate and source terminals such that it delays the turn-on of the MOSFET. When the PWM waveform goes high, the capacitor begins to charge via the resistor. If the PWM signal goes low before the MOSFET turns on, the circuit operation is unchanged. If, however, the PWM signal stays high long enough to charge the capacitor, the MOSFET fires and pulls the amplifier channel's audio input to ground via a resistor (not pictured). When this signal goes

to ground, the amplifier tries to compensate by reducing the output voltage, turning off the PWM signal and the problem transistor. The duty cycle limited capacitor then discharges, and the circuit automatically resumes normal operation.

To fix this, the bootstrap capacitor value was first increased to 1uF, after which a marked increase in available conduction time was noted... but the problem persisted at times. Rather than increase the capacitor arbitrarily, an alternative solution was developed: a duty cycle limiter.

It is believed that this circuit will fix nearly every issue this breadboarded prototype has been having. Before ordering a final PCB, though, I will wait until I've had a chance to validate desired operation of the MCP14628 driver IC, which I hope to use in the new amplifier version due to performance and availability concerns with the old driver.
