HQDFM Design for Manufacture(DFM) Report

File name: esp32_2L

Time: 2025-07-21 Layer count:2 PCB Thickness: 1.60 Quantity: 5 mm

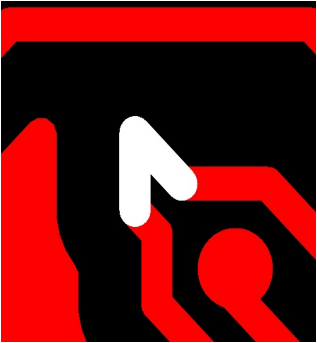
ID	Check	Limits	Value	Issue	Image	Position	Qty	Level
1	Signal Integrity_Acute Angle Traces	-,,-	Error(s) detected	There is an acute angle connection mode in your design,which will affect the signal integrity of the product.it is recommended to adjust the acute angle position to arc or obtuse angle connection mode

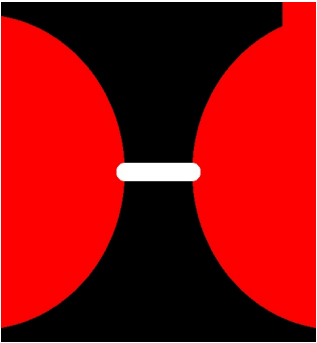
98.79,-94.88	2	Warning
2	Smallest Trace Spacing_SMD Pad Spacing	4,6,10	0.15 mm	Pad-to-pad spacing of 5.91mil were detected in your design. This could result in incomplete solder mask dams between the pads, thereby increasing the risk of incomplete etching of the pads, which decrease manufacturing efficiency and yield, and affect the reliability of the boards. It is recommended to increase the spacing to at least 6 mill. For solder mask covered pads, 4 mil spacing is sufficient.

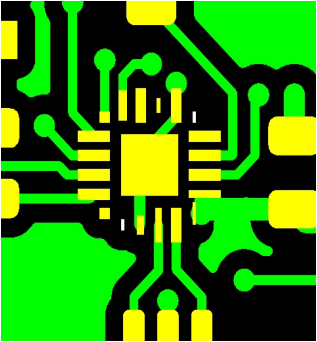
3	Pad Size_Long Pads	6,7,10	0.10 mm	<p>For most factories, the minimum pad width requirement for rectangular pads is 0.2 mm. Failure to meet the factory's requirement could result in overetching, detached pads and increased testing costs, which decrease manufacturing efficiency and yield, and affect the reliability of the boards. Rectangular/Oblong pads with width 0.10mm were detected in your design. The width should be enlarged to at least 0.2 mm.</p>

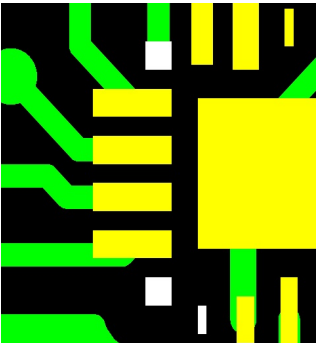
100.00,-86.57	24	Risk
4	Pad Size_Short Pads	8,12,20	0.10 mm	<p>Regular pads of size 0.30mm were detected in your design. This could result in overetching, detached pads and increased testing costs, which decrease manufacturing efficiency and yield, and affect the reliability of the boards. The pads should be enlarged to at least 0.3 mm if possible.</p>

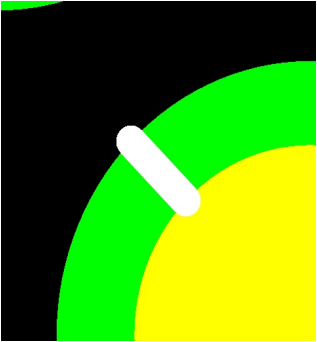
5	Annular Ring Size_PTH Annular Ring	6,7,8	0.05 mm	<p>PTH Pad Rings3.91 mil in size were detected in your design. This could increase the risk of tangency or breakouts, which decrease electrical reliability and yield, and affect the reliability of the boards. It is recommended that PTH Pad Rings have a width of at least 6 mil.</p>

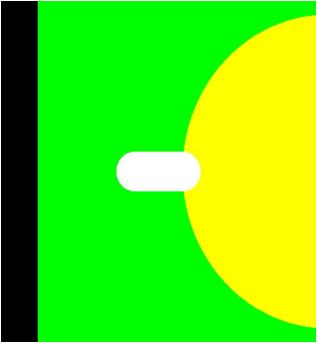
97.56,-99.61	2	Risk
6	Annular Ring Size_Via Annular Ring	4,5,6	0.05 mm	<p>Min via annular rings1.95mil in size were detected in your design.It will affect production efficiency and electrical reliability. It is recommended that the minimum ring size for "via annular rings" be ≥ 5 mils.</p>

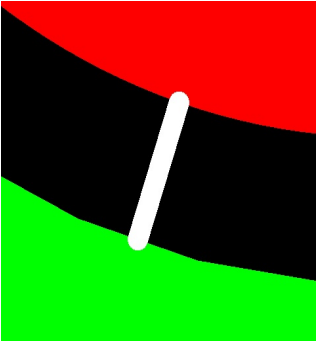
7	Drill to Copper_NPTH-to-Copper	8,10,12	0.25 mm	<p>NPTH to copper spacing of 9.86mil was detected in your design. This could increase the risk of defects such as short circuits, which decrease manufacturing efficiency and yield, and affect the reliability of the boards. It is recommended to increase the spacing to at least 12 mil.</p>

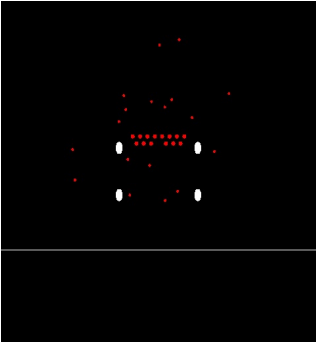
117.38,-53.71	4	Warning
8	Drill Diameter_Slot Aspect Ratio	1.5,2,2	0.30 mm	<p>Slots with aspect ratio of 1.92 were detected in your design. This could increase the risk of incomplete drilling of the slot, which decrease manufacturing efficiency and yield, and affect the reliability of the boards. The ratio should be increased to at least 2:1</p>

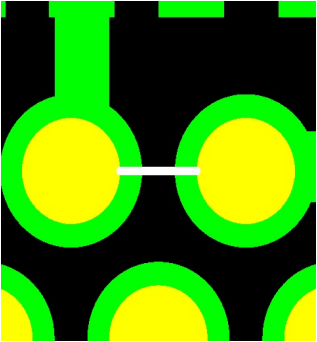
9	Drill Spacing_Di fferent Net PTH Spacing	0. 4,0.45,0.5	0.35 mm	<p>For most factories, the different net PTH spacing requirement is 16-18 mil.</p> <p>Failure to meet the factory's requirements could increase the risk of solder bridges during soldering, which decrease manufacturing efficiency and yield, and affect the reliability of the boards.</p> <p>Different net PTH spacing of 13.74mil were detected in your design. It is recommended to increase the spacing to at least 17 mil.</p>
