HQDFM Design for Manufacture(DFM) Report

File name: esp32_2L

Time: 2025-07-21 Layer count:2

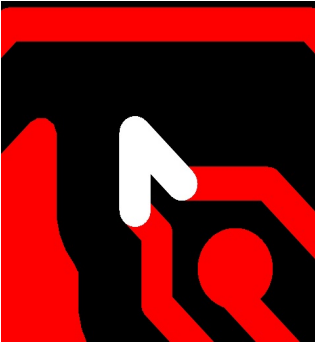
ID	Check	Limits	Value	Issue	Image	Position	Qty	Level
1	Signal Integrity_Acute Angle Traces	-,,-	Error(s) detected	There is an acute angle connection mode in your design,which will affect the signal integrity of the product.it is recommended to adjust the acute angle position to arc or obtuse angle connection mode

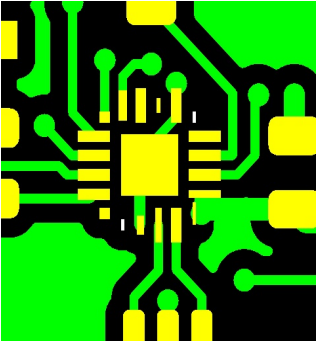
3	Pad Size_Long Pads	6,7,10	0.10 mm	<p>For most factories, the minimum pad width requirement for rectangular pads is 0.2 mm. Failure to meet the factory's requirement could result in overetching, detached pads and increased testing costs, which decrease manufacturing efficiency and yield, and affect the reliability of the boards. Rectangular/Oblong pads with width 0.10mm were detected in your design. The width should be enlarged to at least 0.2 mm.</p>

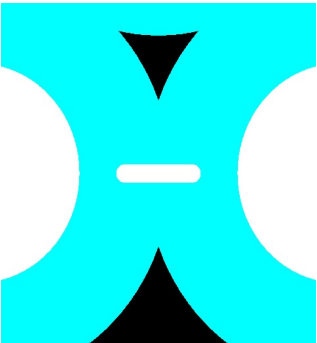
101.76,-99.09	11	Risk
10	Solder Mask Dam_Solde r Mask Dam	5,6,10	5.91 mil	<p>Solder mask dam of width less than 5.91mil were detected in your design.</p> <p>This could result in incomplete solder mask dams between the pads, thereby increasing the risk of solder bridges during assembly, which decrease manufacturing efficiency and yield, and affect the reliability of the boards.</p> <p>The width should be at least 6 mil where possible.</p>
