Quality Assurance Division

Model #
Neptune r1.3 (Sept 2024)

No.
001

SUBJECT:

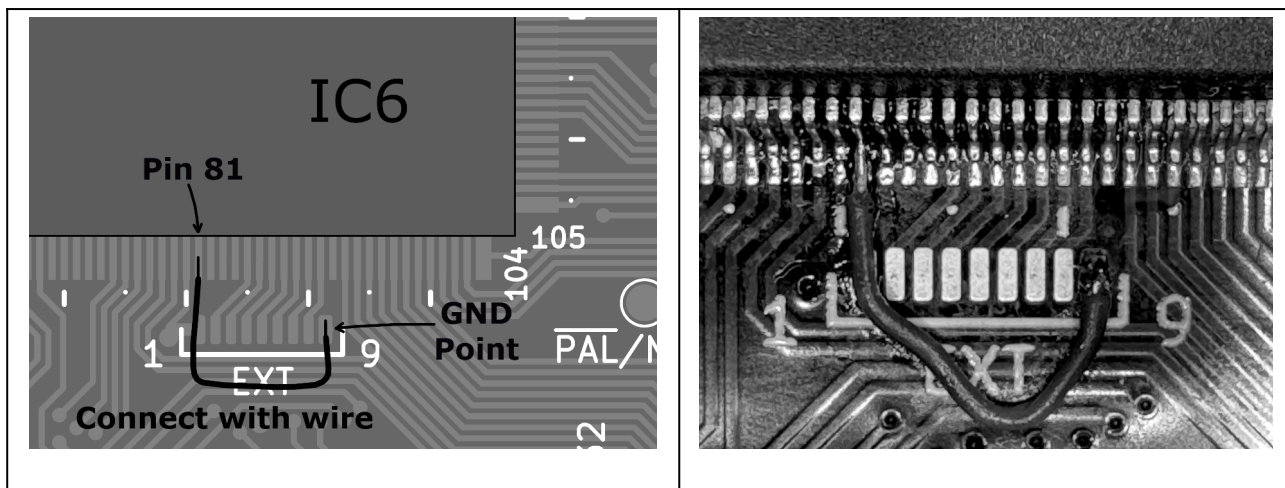
Circuit Change

While using the Neptune r1.3 (Sept 2024) and earlier, games that actively use the region/version of the console may display graphical artifacts in certain mode combinations.

It has been found that the contents of the version register \$A10001 are unstable and occasionally present a corrupted/illegal value.

The TEST0 pin (81) of IC6 must be connected to ground to fix this problem, see CIRCUIT CHANGE below.

1. Locate pin 9 (GND) of the EXT header near IC6. If the EXT header is in use, locate an alternative point that is connected to GND.
2. Solder a small wire from pin 81 of IC6 to the chosen GND point.
3. If wire is long or subject to movement, secure with hot glue.
