## Coatings for Cathodic Protection Systems in Flue Gas Desulphurisation Equipment

H.Y. Chang, G. Hwangbo, T.E. Jin, Y.R. Yoo, J.K. Yoo<sup>1</sup>, Y.S. Kim<sup>2</sup>, M.C. Shin<sup>3</sup>

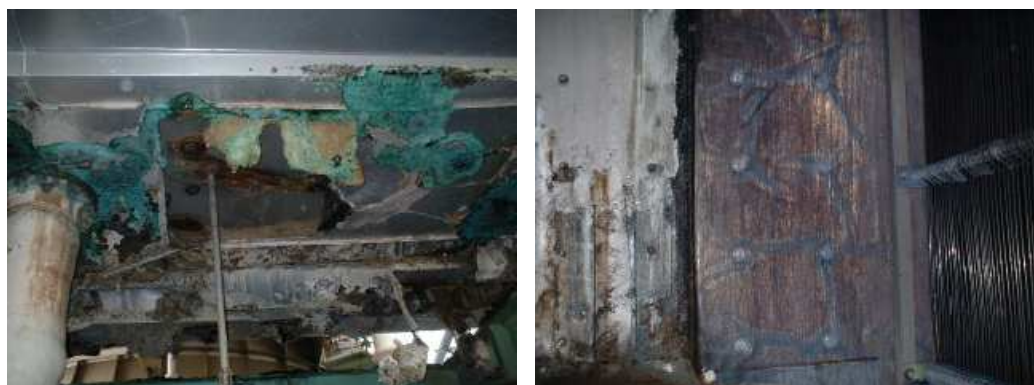
Figure 1: Severe corrosion damages in FGD systems

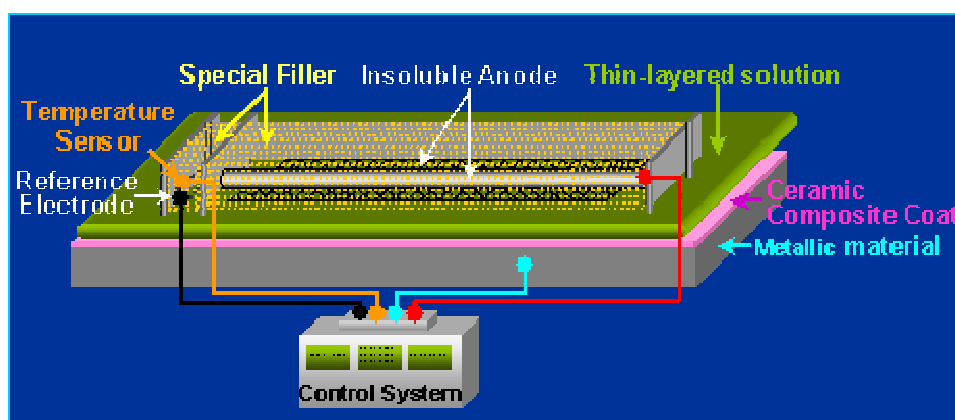
Figure 2: Schematic diagram of electrode system

Fig. 2 and Fig. 3 show the CP system and electrodes used in this study. This system has been under evaluation for its performance since it was initially applied over a 900m<sup>2</sup> area in one unit of a full-scale FGD system. Even though the solution in this environment includes a highly concentrated sulphuric acid (i.e. at the sulphuric acid dewpoint), anodic protection cannot be applied. The main reason is that it is almost impossible to draw the exact condition to produce passive film on the metals over the whole area in this system. Thus a cathodic protection system must be used instead.

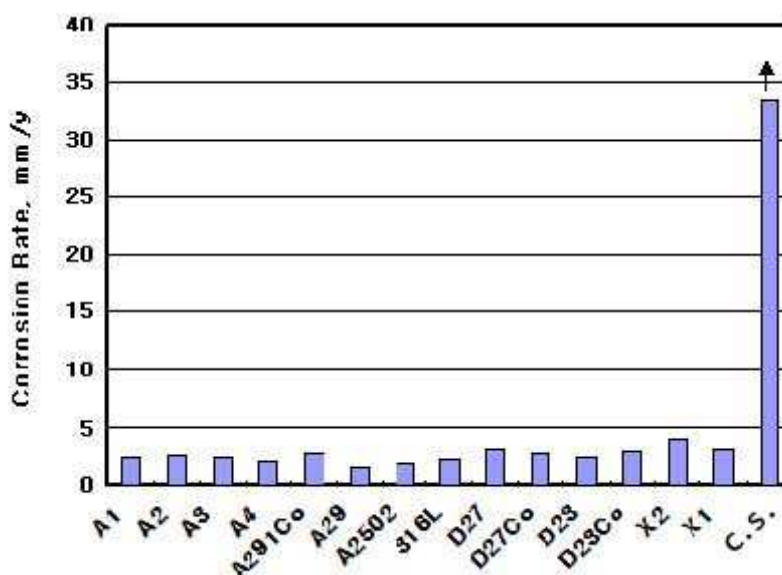
Figure 4: Corrosion rates of several metallic coupons in FGD system

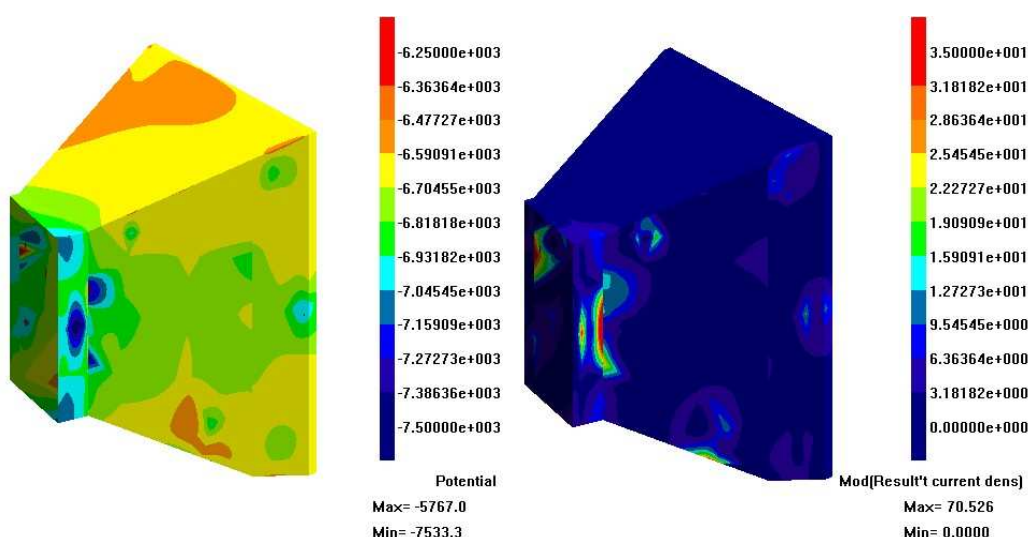
Figure 5: Simulation results of CP system in FGD system

In order to see the performance of the CP system the protection currents and potentials were monitored by the computer when a coating flaw was introduced into the outlet hood

of the GGH (Fig. 5). This zone was originally made of super alloy clad (1 mm) on carbon steel (6 mm). The CP system and coating were applied to carbon steels in this zone, after the corrosion-damaged clad materials were removed. It is obvious, from observing Fig. 6, that the carbon steel exposed at the coating failure (25 cm length, 10 cm width) remained undamaged corrosion after 6 months service.

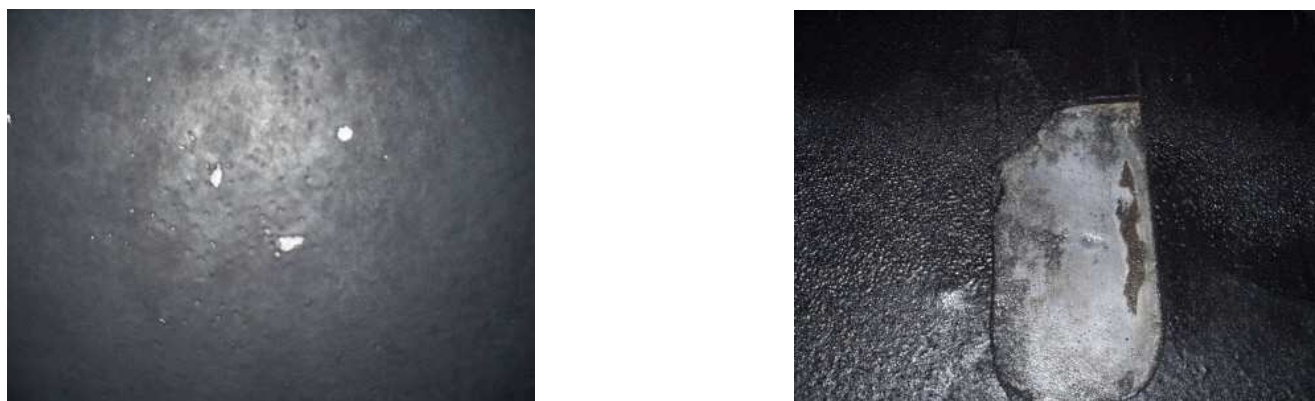
Figure 6: Surface of carbon steel exposed by the coating failure (cathodically protected)

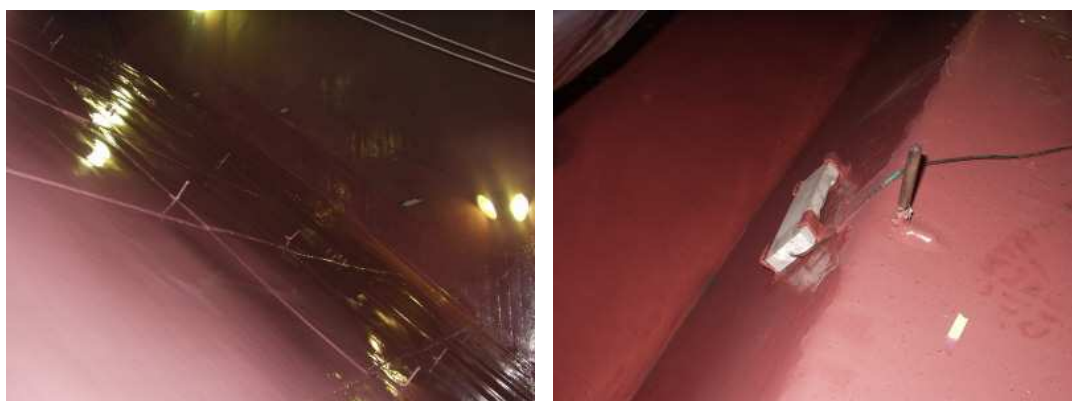
Figure 7: Application of epoxy Novolac coating with CP anodes in FGD system

up to 150°C. These coatings also showed good stability against the CP current and had excellent adhesion to metal substrates. The epoxy Novolac coating was applied in this study for its workability and mechanical properties [6] (Fig. 7). The main components of this coating are Phenol Epoxy Novolac as a resin and Nepheline Seyenite as a reinforcement with minor additives such as  $\text{Na}(\text{AlSi}_3\text{O}_8)$  and  $\text{K}(\text{AlSi}_3\text{O}_8)$ .

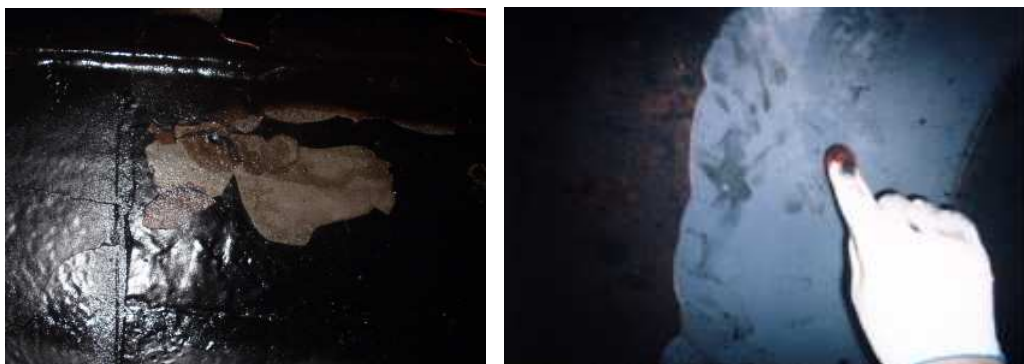
Figure 8: Local disbonding and cracking occurred in high temperature gas

This coating showed a good performance in the condensed sulphuric acid (60–70%) at a gas temperature of 150°C. However, when the local temperature rose to 180°C, some disbonding and cracking occurred (Fig. 9). Therefore, the heat resistance of this coating needed to be improved. Immersion tests were therefore performed [7] as follows:

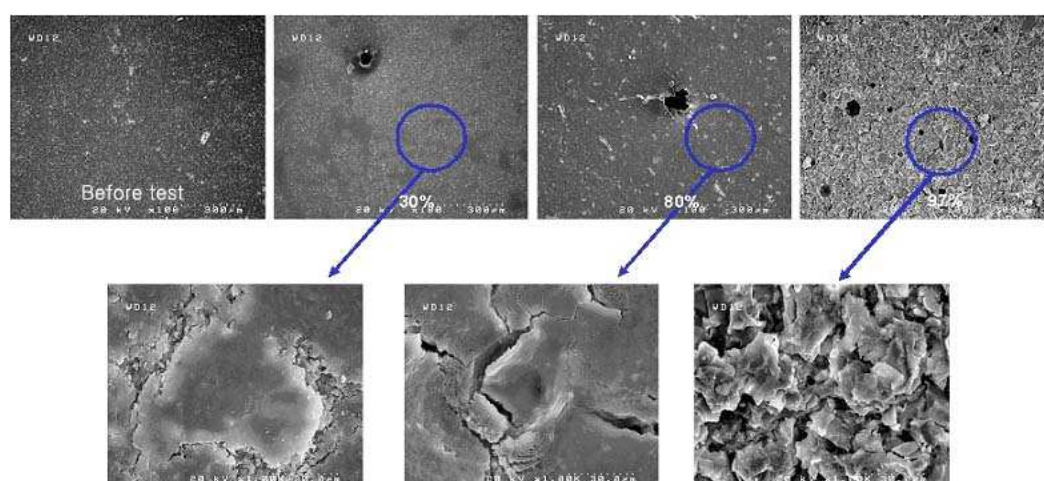
Figure 10: Micro-structure of coatings with variation of concentration of acids

Fig. 10 and Fig. 11 show the microstructures of coatings after immersion in varying concentrations of acids as above [8]. As the concentration of sulphuric acids increased, the thickness of coating decreased and the separation between interfaces became worse. The surface of the coating showed that cracking increased with the acid concentration. In the 97wt% sulphuric acid, acid had penetrated into the coating layer through the numerous cracks and voids.

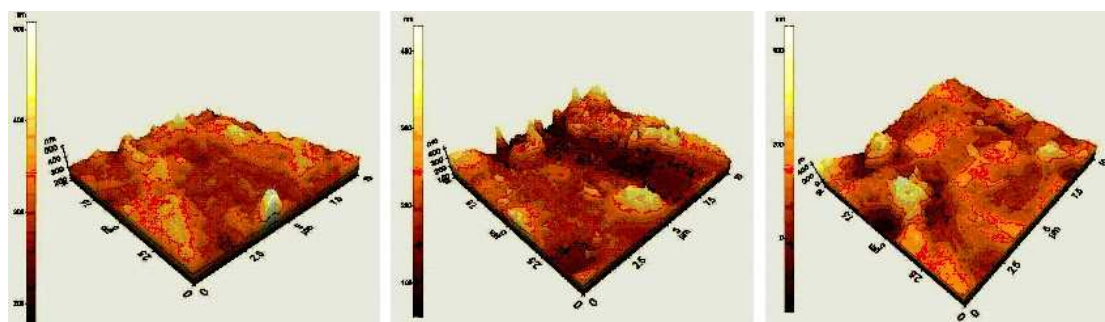
Figure 11: Surface analysis of damaged coatings by sulphuric acid (AFM) – 3D

The results of AFM (Atomic Force Microscopy) are shown in Fig.11 and Fig. 12 [9]. These indicate that as the concentration of acid increased fine indents disappeared and bigger indents were smoothed. It was likely that as the concentration went up, some compositions in coating forming the fine dents might be dissolved out. It was impossible to perform AFM analysis of specimen in 97wt% sulphuric acid because the surface of the specimen in that solution was too rough.

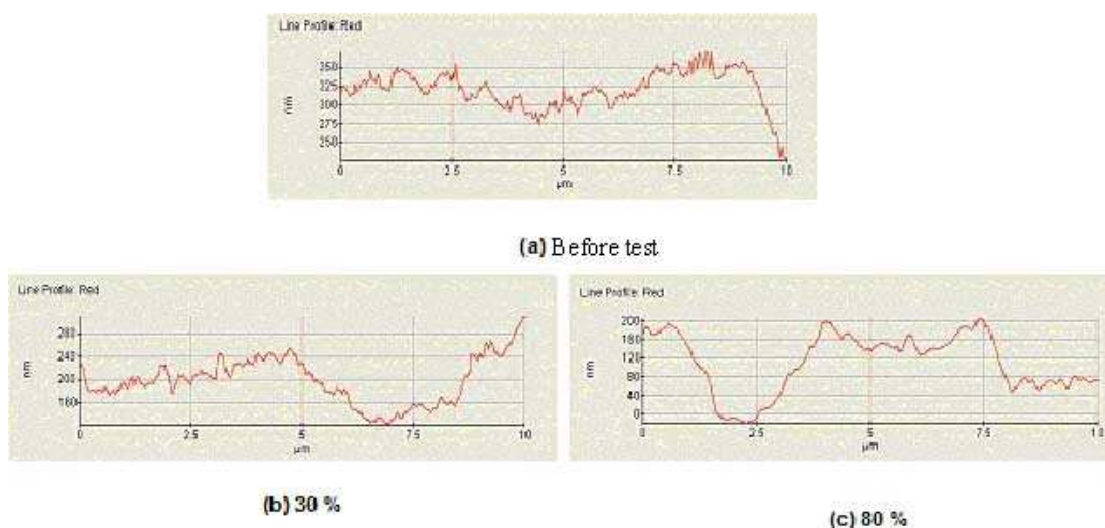
Fig. 12 Surface profile of coatings damaged by sulphuric acid (AFM) – 2D

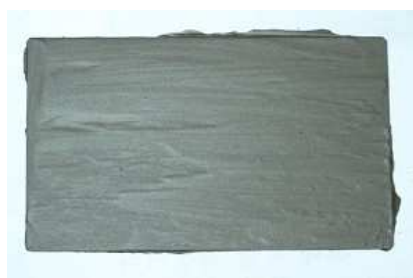
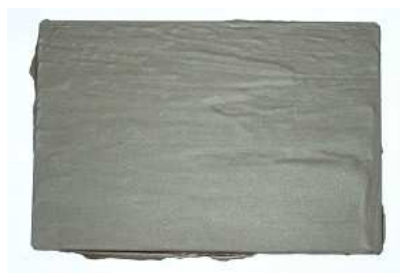
12 hours passed

4 days passed

Figure 14: Heat resistance of modified epoxy Novolac coatings (210°C)

The heat resistance was the best without deterioration of acid resistance when epoxy Novolac coating was mixed with the additive mixtures in a 50:50 ratio. Fig.14 shows that this new formulation was heated up to 210°C for 12 hours and 4 days but it had no cracks and disbonding [18]. Furthermore Fig.15 shows that this modified coating has an equivalent acid resistance to the original epoxy Novolac coating with only small cracks initiated in 80wt% sulphuric acid solution at 100°C after at least 6 days had passed.

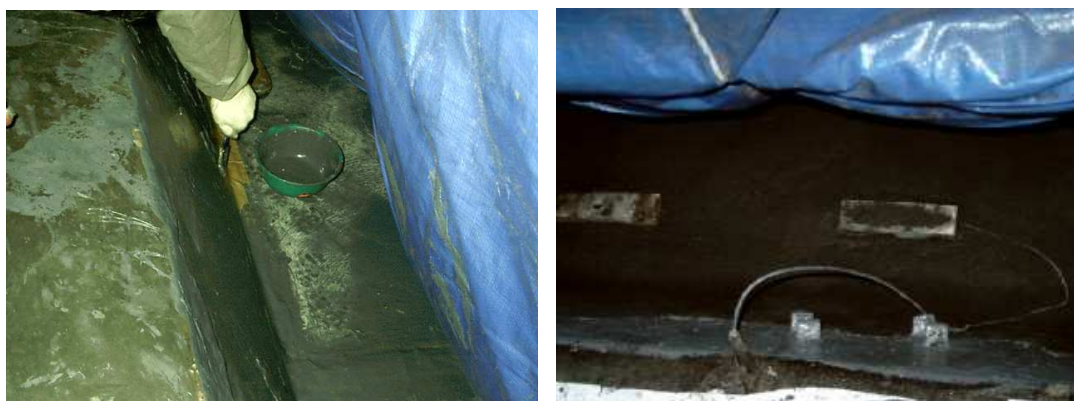
Figure 16: Application of modified phenol epoxy Novolac coatings on damaged region

This modified phenol epoxy Novolac has been showing excellent performance without any cracks and peel-offs since it was applied to the region in which the original one had been damaged (Fig.17).
