Reproducible Pitting Corrosion of Mild Steel in Sodium Chloride/Sodium Nitrite Environments

Abstract

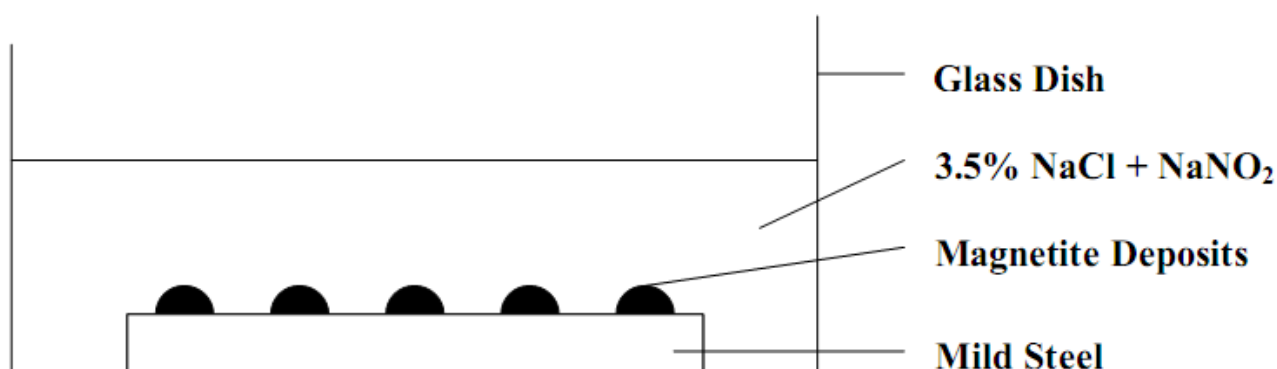
Figure 1: A simplified schematic impression of the initial experimental set-up.

Initial experiments involved the use of deposits of magnetite (Fe_3O_4) powder. Mild steel coupons with deposits of magnetite on the exposed surface of each coupon were totally immersed in 500 ml of this pitting environment (shown schematically in Figure 1) for a given amount of time, usually 168 hours and then visually inspected for signs of localised corrosion. For this particular system, it has been suggested that sodium nitrite passivates the surface of the mild steel coupon and that chloride species (Cl^-) have the ability to permeate through the deposits of magnetite and thereby corrode the surface, whereas nitrite species (NO_2^-) cannot [11].

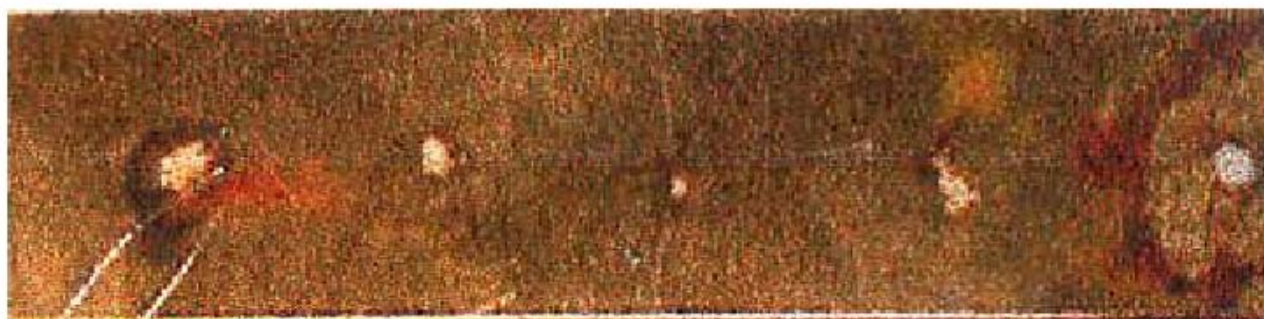
Figure 2: A selectively corroded mild steel coupon upon removal of magnetite deposits and after being exposed to a solution consisting of 3.5% NaCl + NaNO₂ at a ratio of 10:1M for a period of 168 hours (magnification x1.6).

It was therefore thought possible that localised corrosion (pits/crevices) on mild steel surfaces could be created by selectively positioning the deposits of magnetite and by reducing the thickness of the magnetite deposits, thereby allowing greater transport of chloride species to the metal surface. However, this proved unreliable, so a trial and error procedure was adopted by varying the concentration of sodium nitrite. Solution compositions of 3.5% NaCl + NaNO_2 at a molar ratio of 15:1 and at a molar ratio of 20:1 were then used, with the 15:1 molar ratio showing the greatest amount of corrosion beneath the deposits of magnetite. However, this also proved unreliable with respect to the reproducibility of corrosion beneath the deposits of magnetite and as a result an alternative experimental method/technique was sought. Figures 2–4 show three mild steel coupons after being subjected to the above-mentioned test conditions.

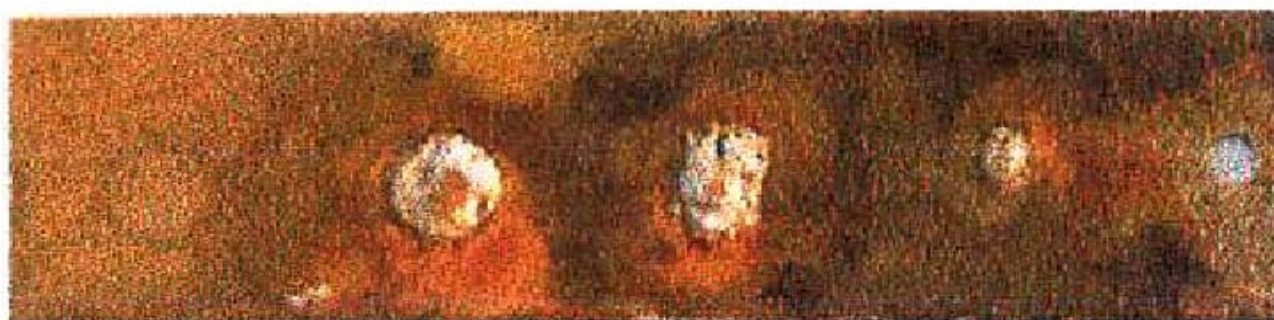
Figure 3: A selectively corroded mild steel coupon upon removal of magnetite deposits and after being exposed to a solution consisting of 3.5% NaCl + NaNO₂ at a ratio of 15:1M for a period of 168 hours (magnification x1.6).

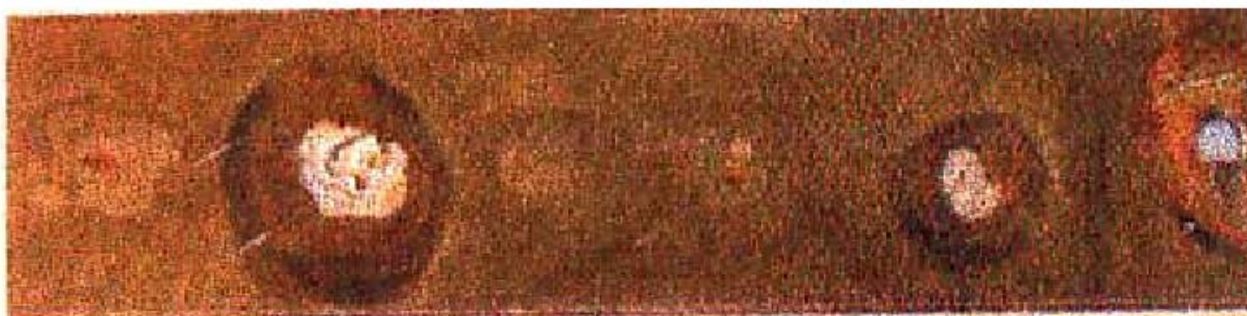
Figure 4: A selectively corroded mild steel coupon upon removal of magnetite deposits and after being exposed to a solution consisting of 3.5% NaCl + NaNO₂ at a ratio of 20:1M for a period of 168 hours (magnification x1.6).

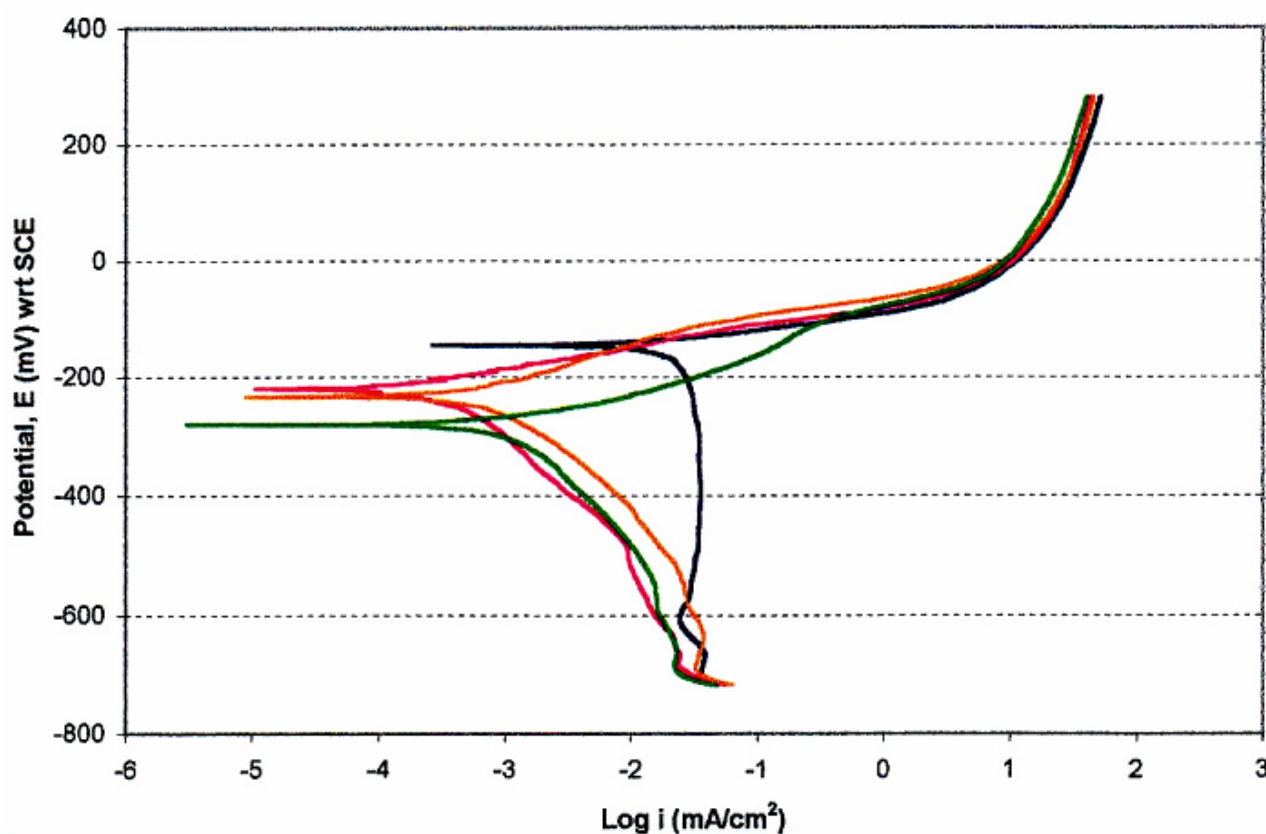
Figure 5: Polarisation curves for mild steel in varying molar ratios of 3.5% NaCl to NaNO₂, where the green transient represents 3.5% NaCl + NaNO₂ at 20:1M, orange transient represents 3.5% NaCl + NaNO₂ at 15:1M and the pink transient represents 3.5% NaCl + NaNO₂ at 10:1M.

A potential polarisation technique was then adopted where samples were polarised above their pitting potential (found to be -175 mV v. saturated calomel electrode (SCE) using 3.5% NaCl + NaNO_2 at 15:1M under natural aeration). Again a trial and error procedure was adopted, where a range of potentials were selected above the pitting potential to

potentiostatically polarise mild steel coupons in this environment. Polarisation curves were obtained using auto Tafel software (ACM Instruments) at a scan rate of 1 mV/s on an electrode area of 1 cm². Figure 5 shows a polarisation curve under natural aeration.

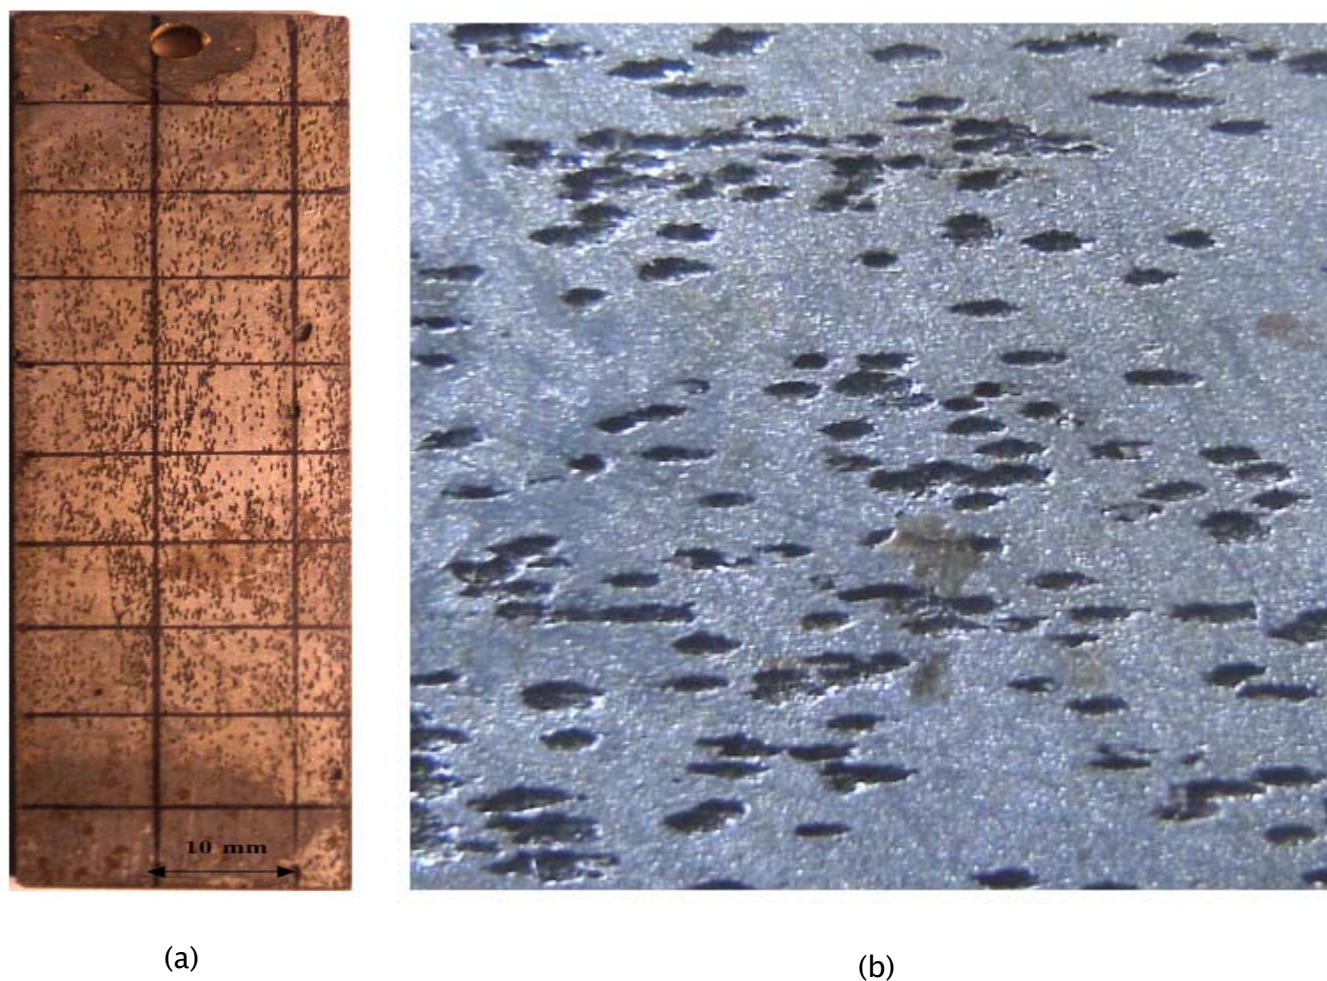
Figure 6: (a) A heavily pitted mild steel coupon (with scribed markings to aid pit counting) after 24 hours of exposure to the test conditions; (b) pitted area after chemical cleaning (magnification x14).

Figure 6(a) shows a typical photograph of the coupon after exposure with scribed markings to aid pit counting while Figure 6(b) shows a close-up of one of the marked areas after chemical cleaning. Pitting was also observed on the reverse sides and edges of the mild steel coupons but to a much lesser extent. This is most likely due to the positioning of the counter electrode and shielding of the glass plate.
