A DEPENDENT RESURVEY for Weyerhaeuser Co. within  
the W.1/2 NW.1/4 of SECTION 7, T4N R4W, W.M.  
as situated within  
COLUMBIA COUNTY, OREGON  
February 25, 2018

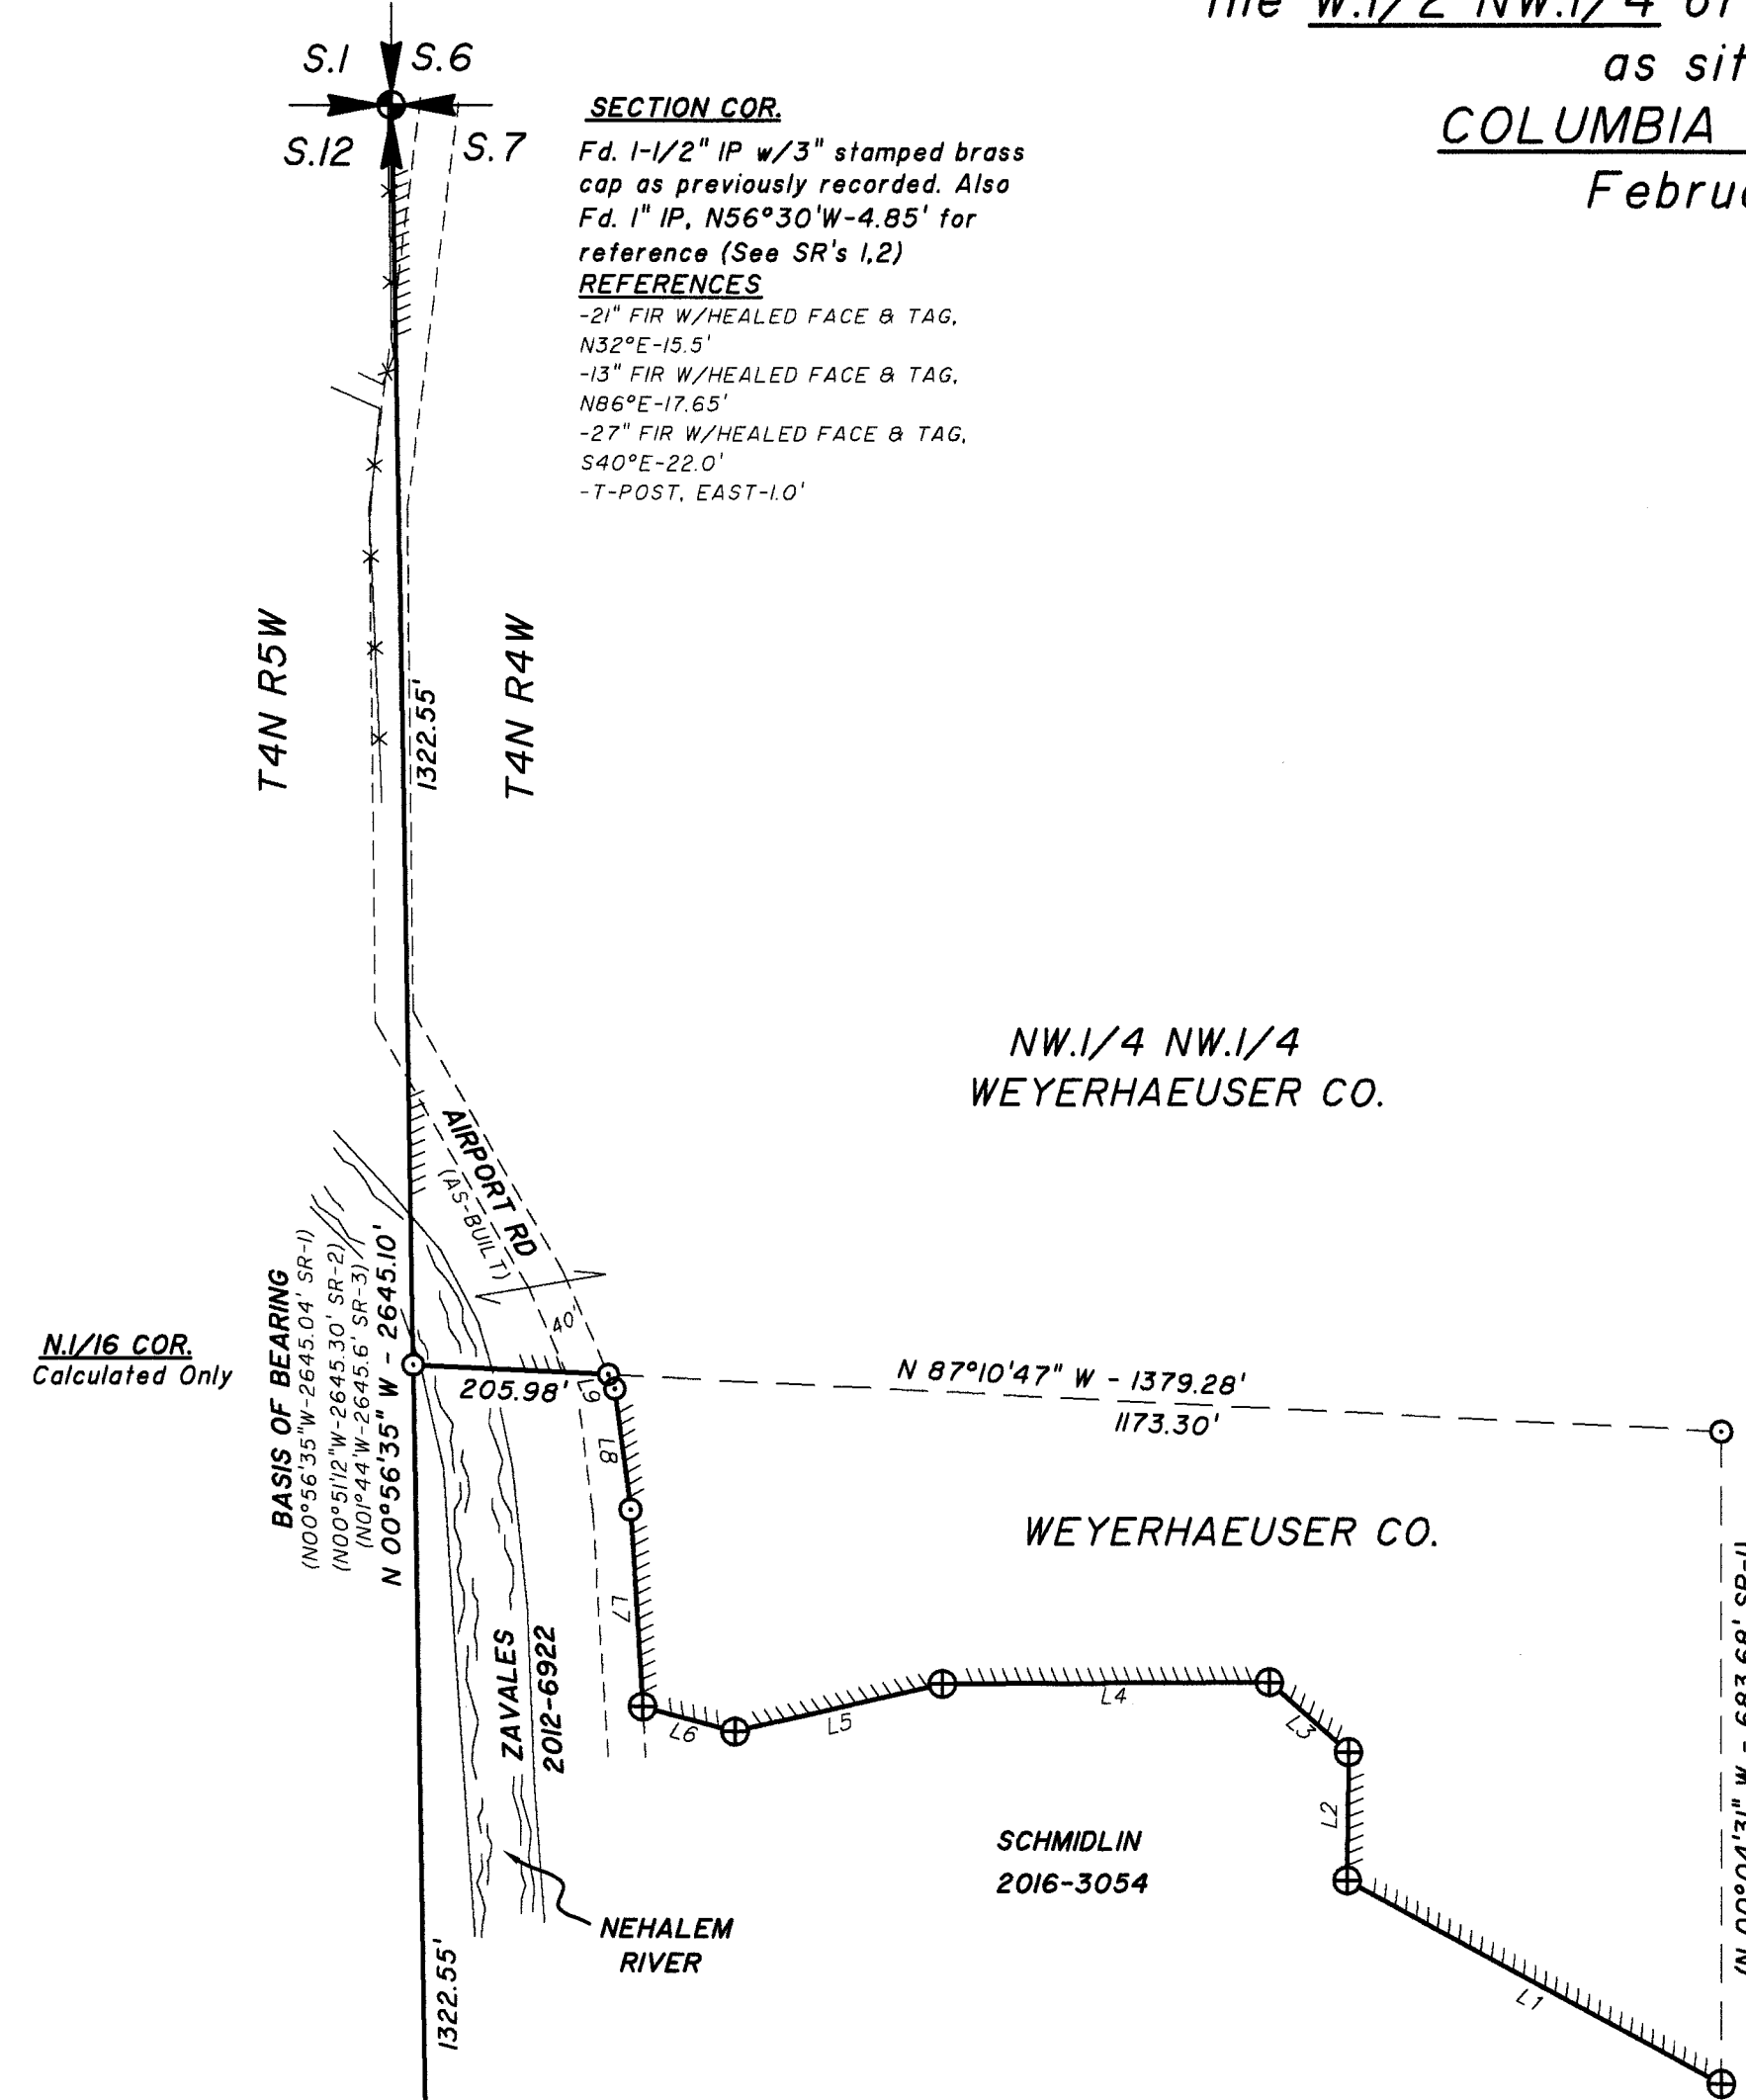
**SECTION COR.**  
Fd. 1-1/2" IP w/3" stamped brass cap as previously recorded. Also  
Fd. 1" IP, N56°30'W-4.85' for reference (See SR's 1,2)  
**REFERENCES**  
-21" FIR W/HEALED FACE & TAG,  
N32°E-15.5'  
-13" FIR W/HEALED FACE & TAG,  
N86°E-17.65'  
-27" FIR W/HEALED FACE & TAG,  
S40°E-22.0'  
-T-POST, EAST-1.0'

The purpose of this survey was to mark portions of Weyerhaeuser Company's ownership within the W.1/2 NW.1/4 of Section 7, T4 R4W, for timber removal. All of the corners shown hereon were either found or established during that certain survey by KLS Surveying, filed as CS #6110. These corners were all found to be very close to that of record and were all accepted for this survey. The Southwest corner of the NW.1/4 NW.1/4 (N.1/16 corner) falls in the Nehalem River. In 1996, KLS Surveying set a reference corner S.87°55'41"E -156.22 feet from said N.1/16 corner, as shown on their survey filed as CS #4206.

Fd. 2" IP w/2-1/2" stamped brass cap as previously recorded.  
(See SR's 1,2)

- 23" FIR W/HEALED FACE & TAG,  
N60°E-56.5'
- 25" CEDAR W/HEALED FACE & TAG,  
S28°E-50.7'
- ALUM. POST W/TAG, NORTH-1.0'
- T-POST, SOUTH-1.0'
