# **LED Equipment Evaluation**

## **PHASE V: 310W HPS Equivalent**

Prepared by:  
Bureau of Street Lighting  
City of Los Angeles

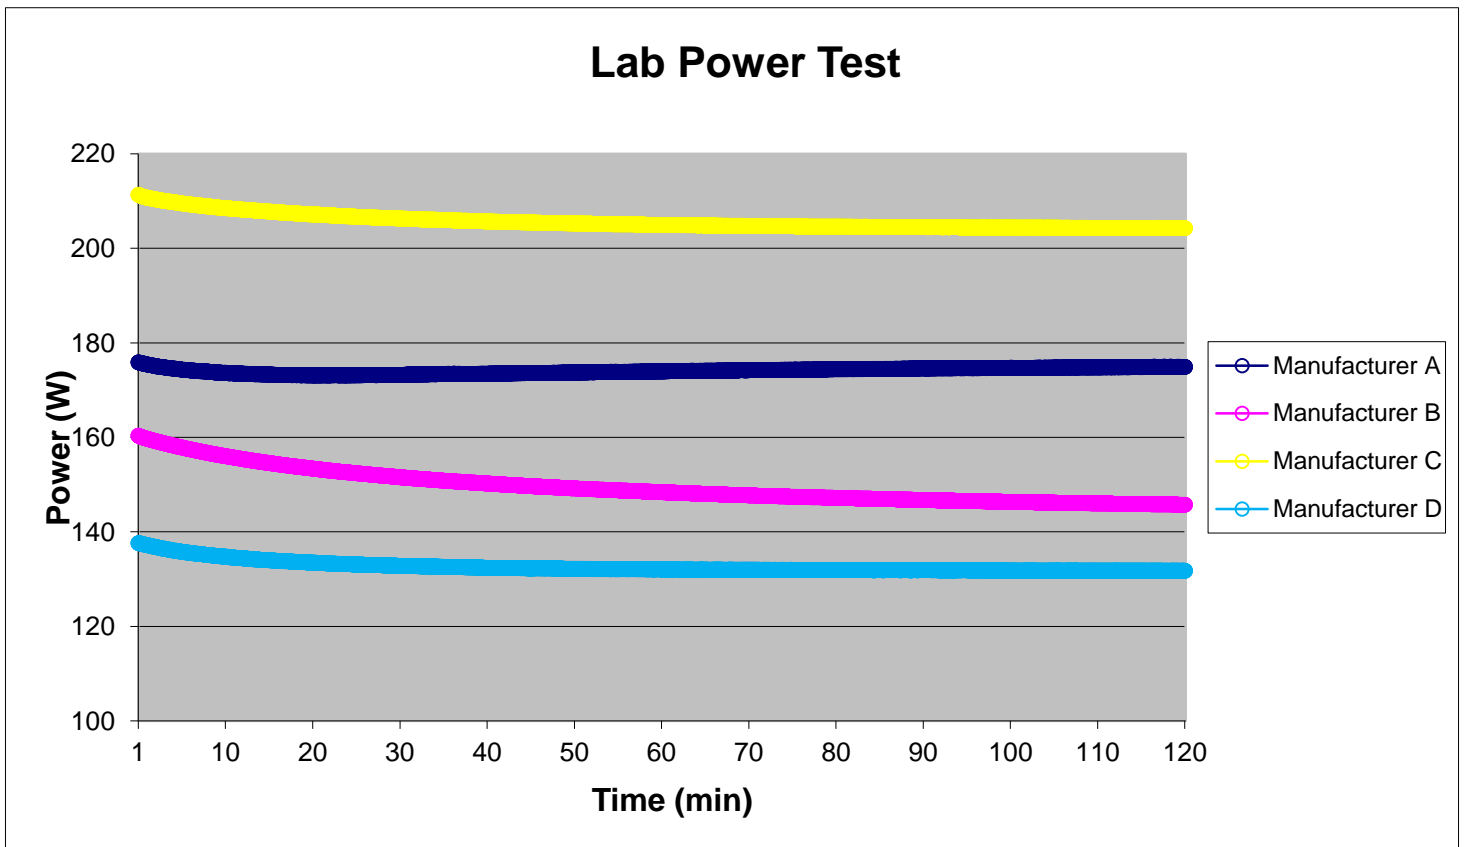
*The power was measured for approximately 2 hours in our lab until it was determined that the test unit's power consumption had steadied (shown below). The fixtures were then moved to standard street lighting pole on a major street. Power readings were taken daily with the use of a Remote Monitoring System (RMS). The RMS readings showed the luminaire continued to function normally for its duration at the test site.*

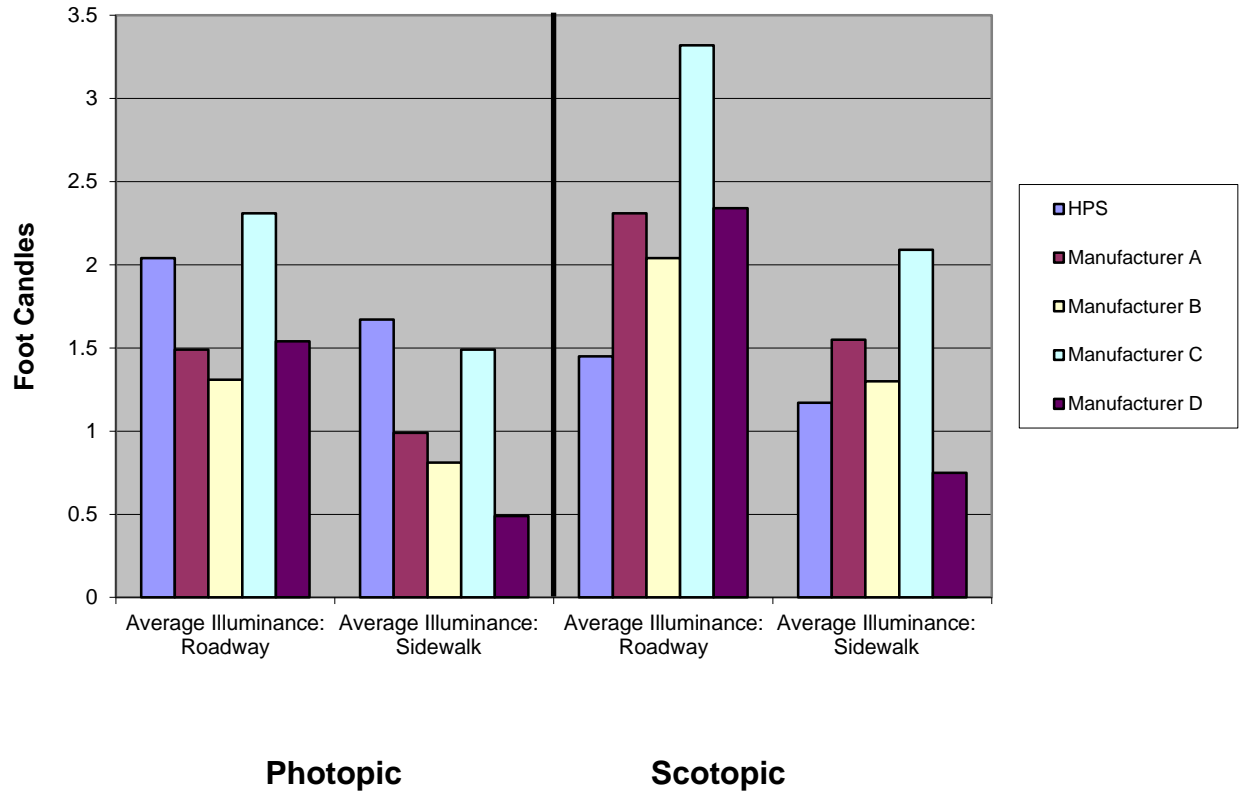
## Photopic/Scotopic Illumination

Illumination readings were recorded using a Solar Light PMA 2100 scotopic/photopic meter. Scotopic readings were taken for possible use in the future to calculate S/P ratios.

The illumination readings were taken between April 1<sup>st</sup> 2011 and July 30<sup>th</sup> 2011. The readings were taken at our test site location (see map and pictures in appendix). Field conditions fairly similar each night. The street was open to traffic, and there was some ambient light pollution from local businesses.

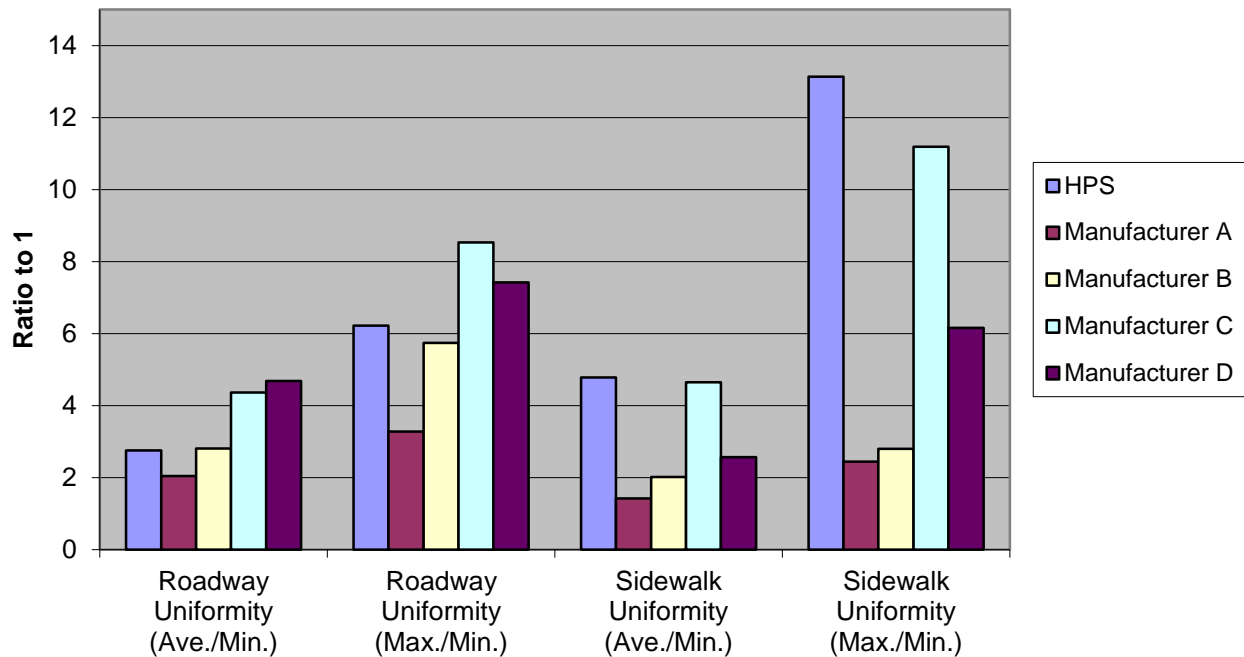
## Photopic Uniformity

An average to minimum uniformity ratio of  $\leq 2:1$  would receive a 10.

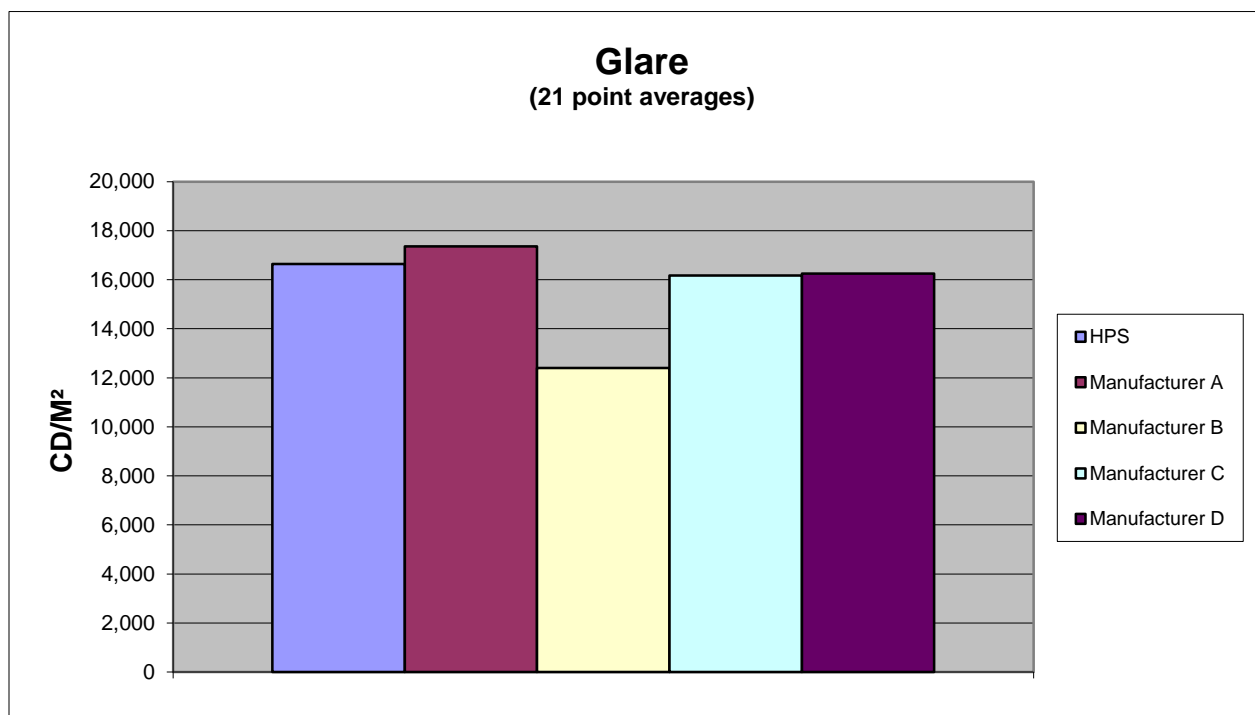
Light readings were taken from twenty one various locations where it was determined that glare sensitivity may exist and create a significant negative impact to drivers and pedestrians. Luminance readings were recorded using a Minolta Luminance Meter LS-100 at an average eye level, aimed at our target luminaire.

than the existing HPS. Our final field test was to see how much glare passing motorists and pedestrians would incur in comparison to the existing HPS fixture. The variations in results were very minimal and three of the four units produced the same amount of glare as the existing HPS lights did. The fourth sample had a little less glare than the existing HPS.

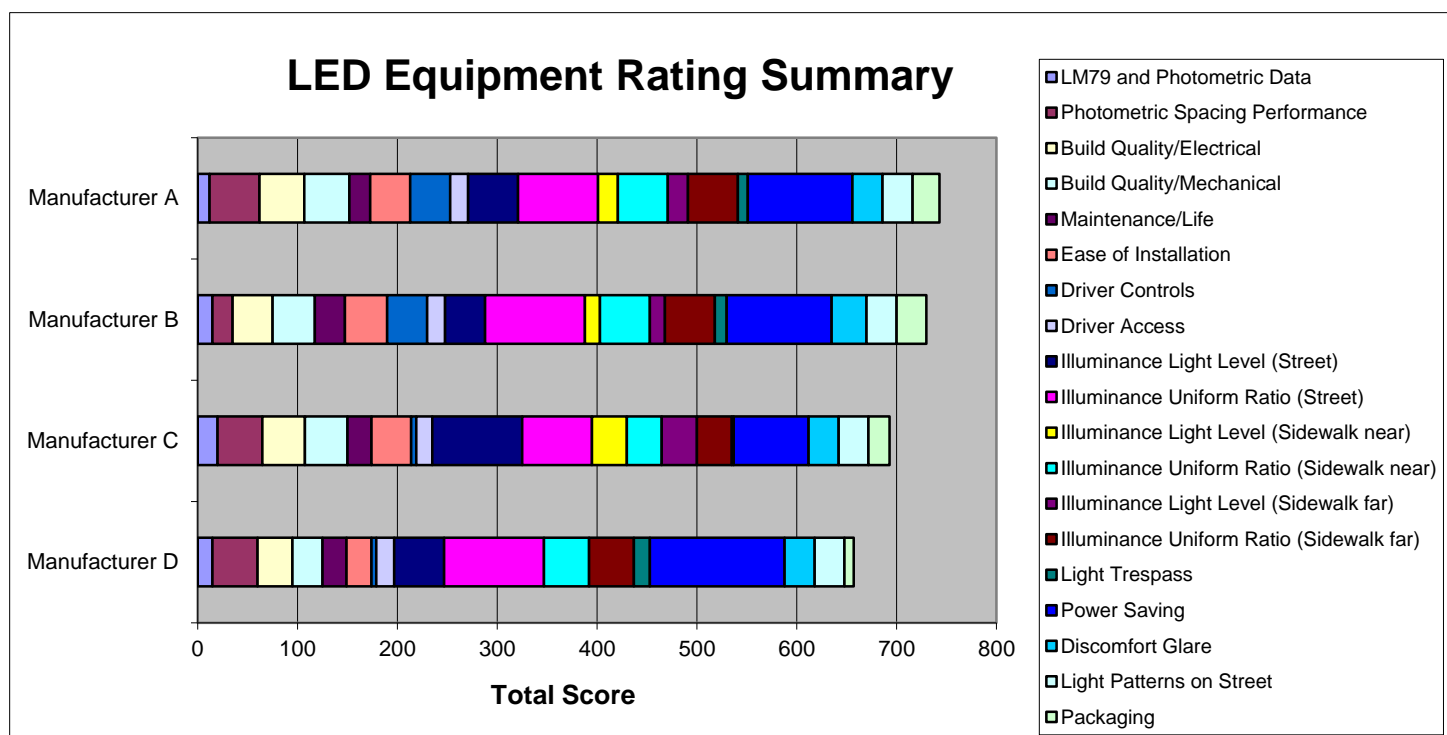
When we compiled all of our test results and observations, it was obvious how much the technology and products have improved over the last two years. Having power savings now up to over 60% while illumination levels still meet IES recommendations highlights this phase. At the conclusion of our last phase of testing larger luminaires, we felt only one unit we tested met our standards. After we completed Phase V, we approved or conditionally approved three of the four units we put through a full evaluation for city wide HPS replacement. Below are the final scores for each of the four products we evaluated in Phase V. Each of the 19 scoring categories were weighted based on what we felt was more relevant in choosing luminaires for city wide replacement. When added all together this was the final result.
