Sheet: /		
File: miniRGBii.sch		
Title:		
Size: A4	Date:	Rev:
KiCad E.D.A. kicad (5.1.5-0-10_14)		Id: 1/1

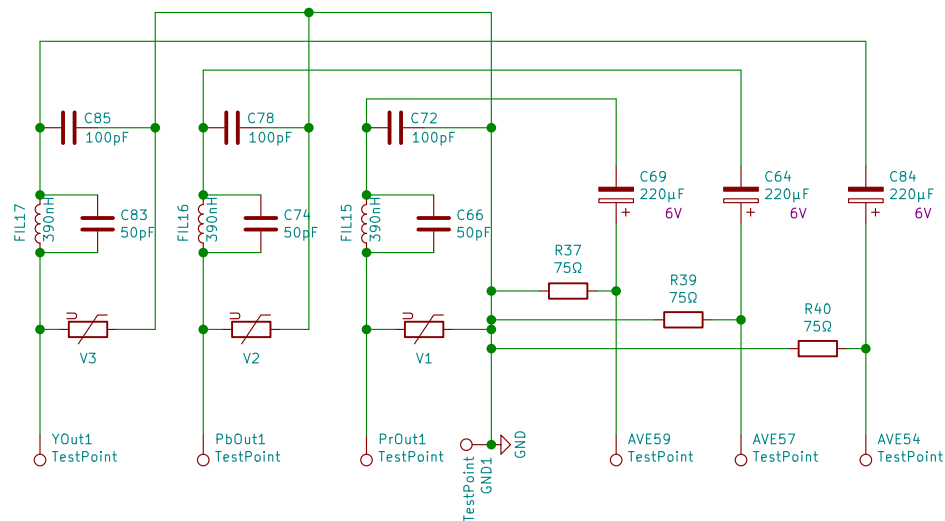
C62
 RVL-CPU-30 and earlier boards utilised capacitors instead of the V1-V3 varistors. Knowing the value of either is trivial for completing a safe replacement of the component video circuitry.
