Diagnostic Rev. 586220 – Extended Keyboard Dongle

Project number: 143

Revision: 1

Diagnostic 586220 Harness - Keyboard Dongle Extended Rev. 1

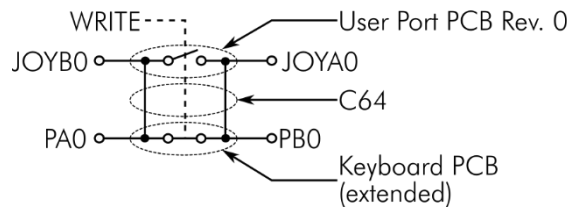
Figure 3: Test situation with the extended Keyboard Dongle

The extended Keyboard Dongle provides switched feedbacks for the signals, that are shared with the joysticks.

These are $PB0 \leftrightarrow PA0$, $PB1 \leftrightarrow PA1$, $PB2 \leftrightarrow PA2$, $PB3 \leftrightarrow PA3$ and $PB4 \leftrightarrow PA4$. The switches are opened by a (cassette port) WRITE signal going high, which also closes the connection on the user port dongle at the same time. The reason is, that

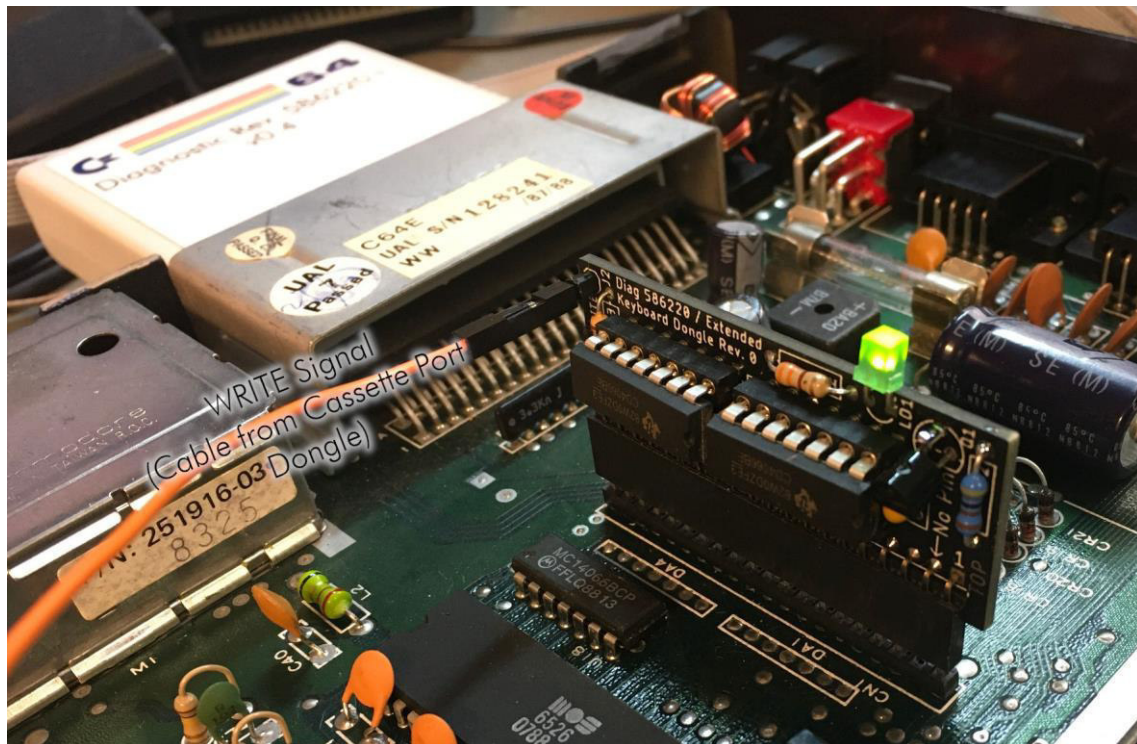
Figure 5: The Extended Keyboard Dongle on an ASSY 250469

The extended Keyboard Dongle works with all versions of the standard Diagnostic 586220 software. A modification of the software is not required.
