DTC	B2798	Communication malfunction No.2
-----	-------	--------------------------------

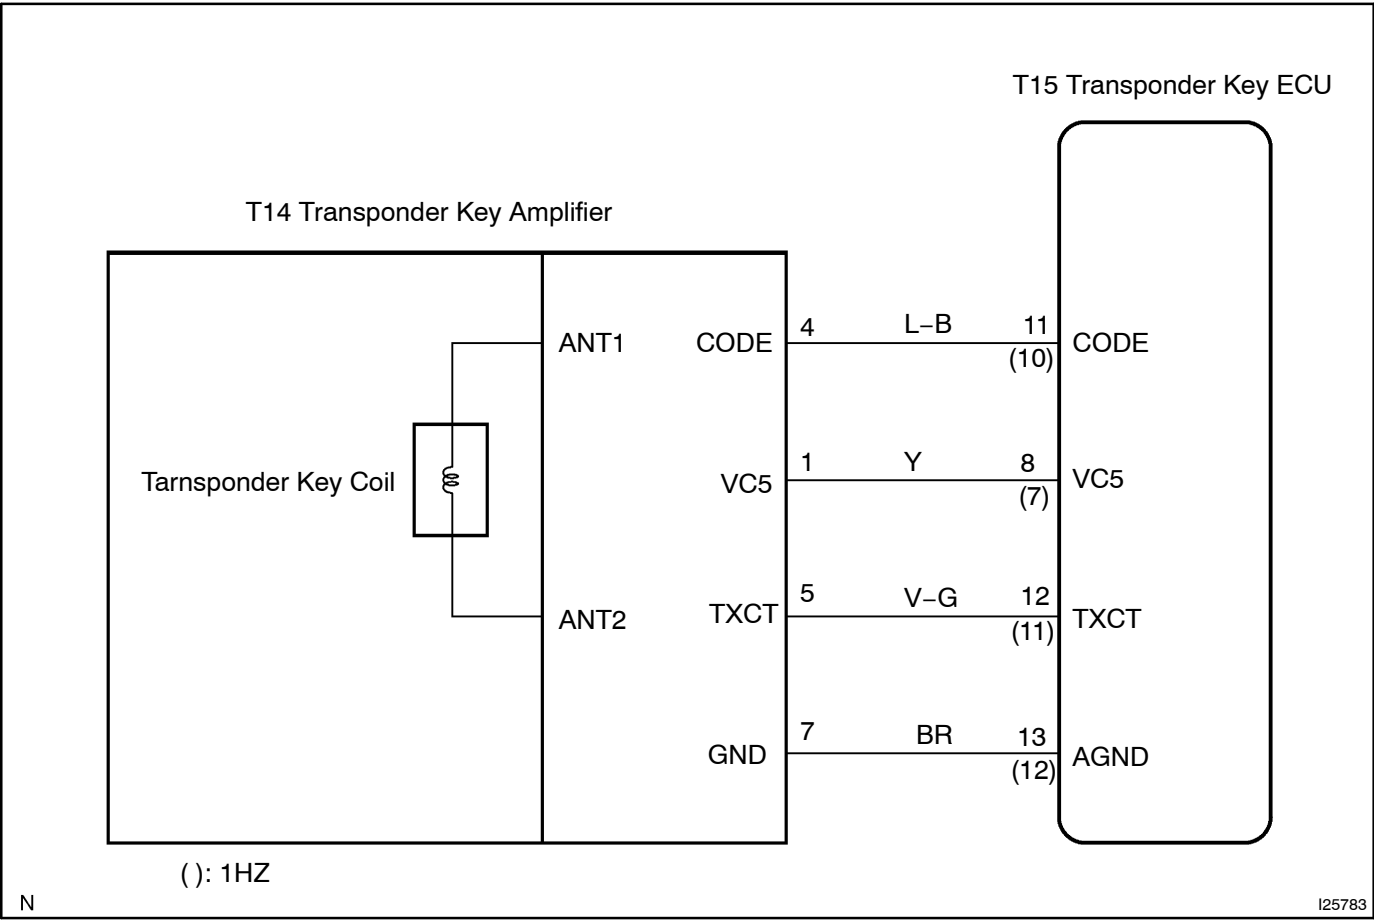
WIRING DIAGRAM

CIRCUIT DESCRIPTION

This code is detected when an error occurs, although the communication has been performed normally.  
(Example. Some noise is included in communication line.)

DTC No.	DTC Detecting Condition	Trouble Area
B2798	Communication error	<ul style="list-style-type: none"><li>•Key</li><li>•Transponder Key Amplifier with coil</li><li>•Wire harness</li><li>•Transponder key ECU</li></ul>
