DTC	17	Rear Evaporator Temperature Sensor Circuit
------------	-----------	---

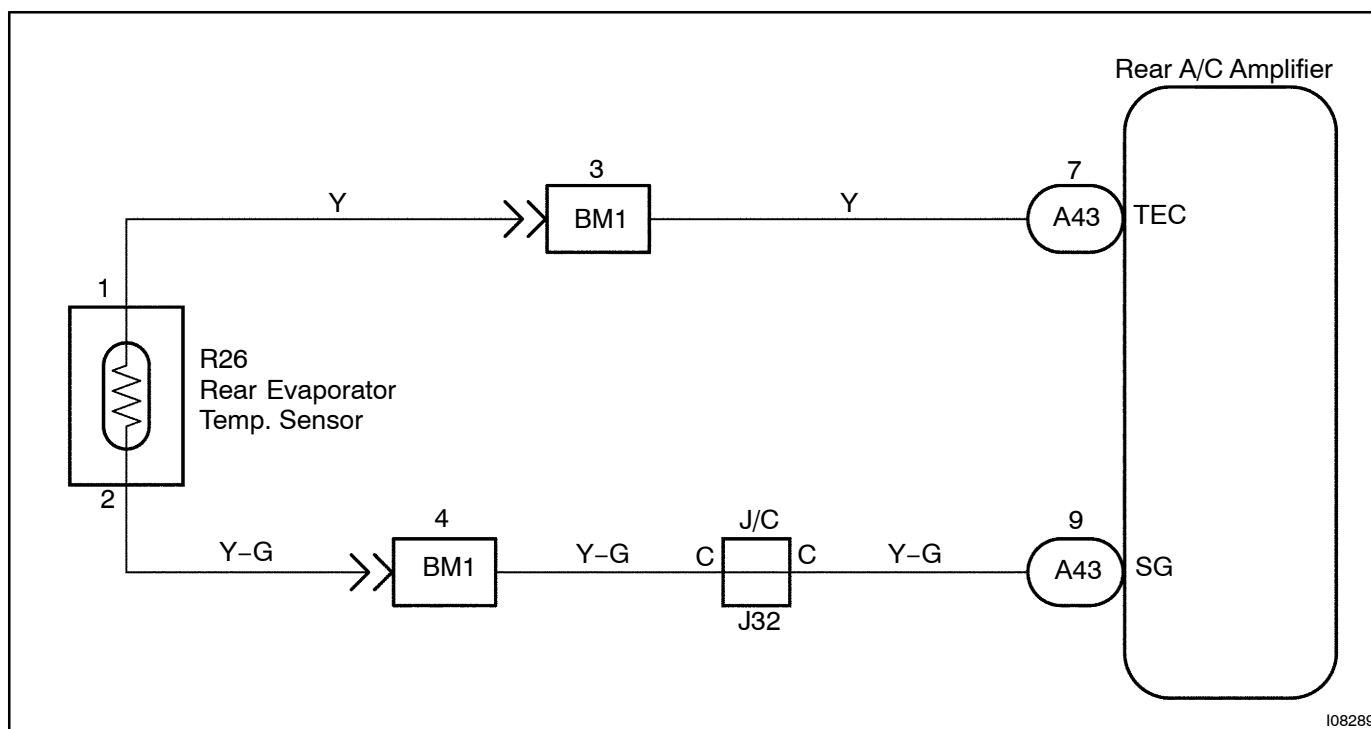
WIRING DIAGRAM

This sensor detects the rear evaporator temperature and sends the appropriate signals to the A/C amplifier.

DTC No.	Detection Item	Trouble Area
17	Open or short in rear evaporator temperature sensor circuit	<ul style="list-style-type: none"> •Rear evaporator temp. sensor •Harness or connector between rear evaporator temp. sensor and rear A/C amplifier •Rear A/C amplifier

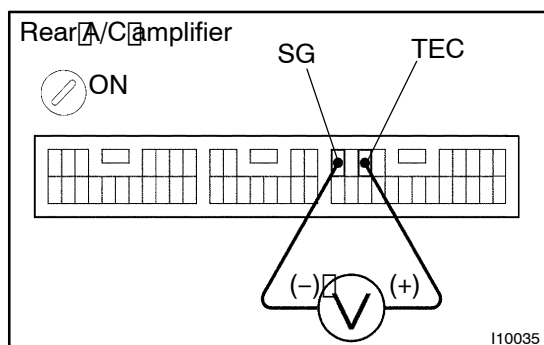
1 Check voltage between terminals TEC and SG of rear A/C amplifier.

Remove rear A/C amplifier with connectors still connected.

- Turn ignition switch to ON.
- Measure voltage between terminals TEC and SG of rear A/C amplifier connector at each temperature.

OK:**Voltage**

at 0°C (32°F) 2.0 – 2.4 V

at 15°C (59°F) 1.4 – 1.8 V

As the temperature increases, the voltage decreases.

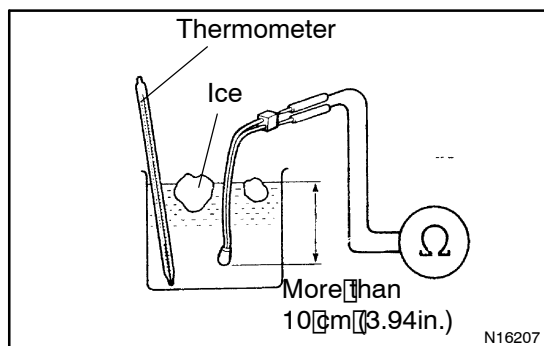
2 Check rear evaporator temperature sensor.

Remove rear evaporator temperature sensor.

Measure resistance between terminals 1 and 2 of evaporator temperature sensor connector at each temperature.

OK:**Resistance :**

at 0°C (32°F) : 4.5 – 5.2 kΩ

at 15°C (59°F) : 2.0 – 2.7 kΩ

As the temperature increases, the resistance decreases.
