OSM Damage Assessment Review

Interim Report

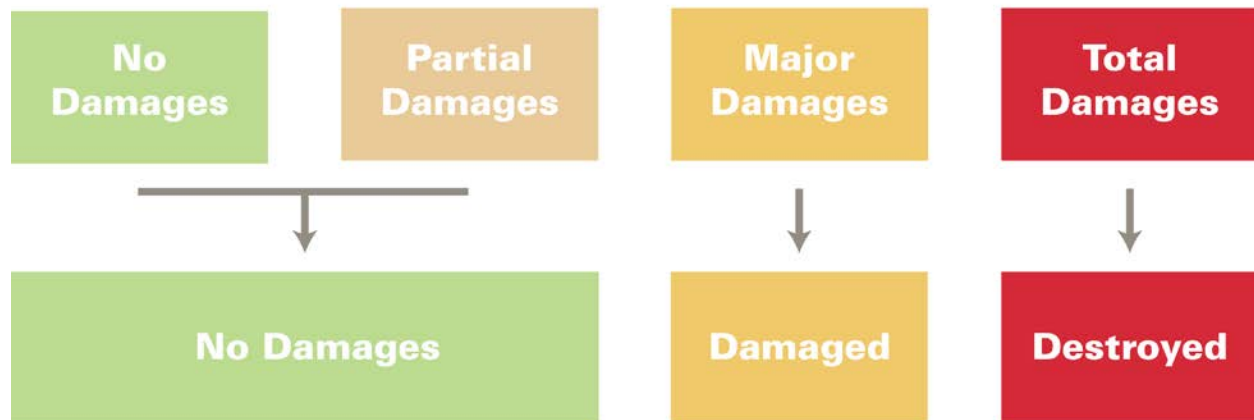
Observed Damages Classification Scheme

The enumerators' categories compared with a three-category damage classification system used for OSM:

1. Undamaged
Tags: "building=yes"

2. Damaged (equivalent to major damage above)
Tags: "building=yes" and "damage=major" OR "building=damaged"
3. Destroyed or collapsed (equivalent to totally damaged or destroyed above)
Tags: "building=yes" and "damage=destroyed" OR "building=destroyed" OR "building=collapsed"

OSM Damage Classifications

The OSM community adopted this three category classification scheme because minor damages and levels of damage as a whole could not be perceived using existing satellite imagery.
