Technical Service Information

TSI-03-13-06

Subject: Eaton AutoShift 18 Speed Transmission Splitter Clutch Identification Effective October 1, 2003

Topic: Automated Splitter Clutch Identification

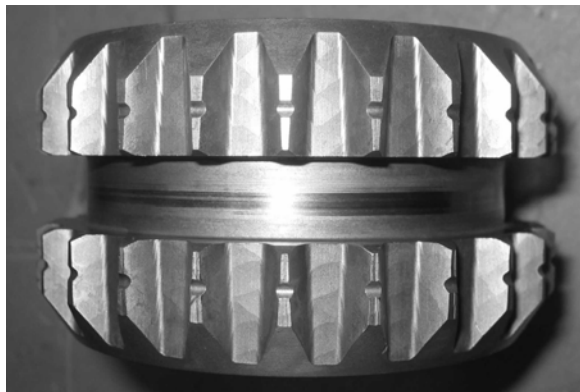
Figure 1

Splitter clutches used in Autoshift applications are manufactured with a tooth spacing different than that of a standard mechanical transmission. This is to assist in smooth shift performance of the Autoshift transmission.

To help identify the sliding clutch used for Autoshift P/N 691934, a groove will now be machined on the top of the clutching teeth. (See figure 1) There is no change in form, fit and function of the new sliding clutch.
