VEHICLE RECALL

G-00513
October, 2000

SUBJECT: SAFETY RECALL (U.S., EXPORT)
TRW Drag Links On Certain 1000, 2000, 3000, FE bus, RE bus, 4000 and 8000 model series built from 7/5/1999 through 10/31/1999.

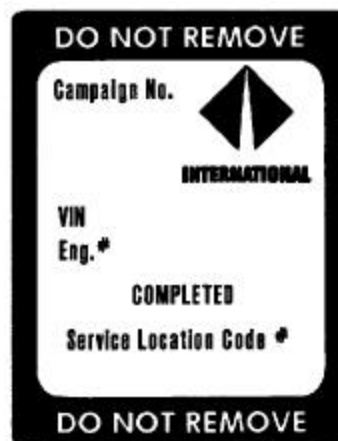
CAMPAIGN IDENTIFICATION LABEL

Each vehicle corrected in accordance with Campaign letter **G-00513** will require a CTS-1075 Campaign Identification Label.

Attach the CTS-1075 label on a clean surface next to the vehicle identification number (VIN) plate.
