# VEHICLE RECALL

**IC CORPORATION RECALL # 03301**  
**NHTSA RECALL # 03V-118**

**SUBJECT: VEHICLE RECALL**  
**Missing Seat Mounting Reinforcement**

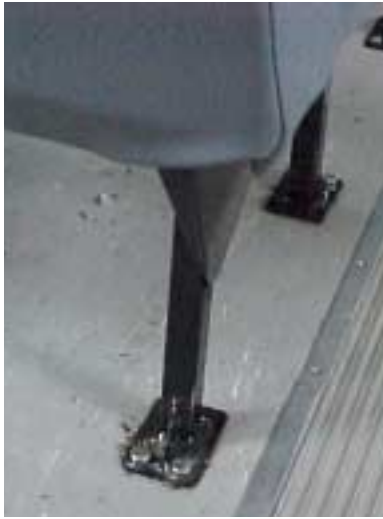
**Figure # 1 Aisle side view of 4-leg rear mounting bolts.**

1. Remove the nuts and washers from the mounting bolt.
2. Clean excess undercoating from the area where the reinforcement will seat.
3. Install the reinforcement using the bolts as a guide. For proper placement of the reinforcement use figures #3 and #4 as a guide.
4. Reinstall the washers and nuts.
5. Torque to 13 - 16 ft. lbs.

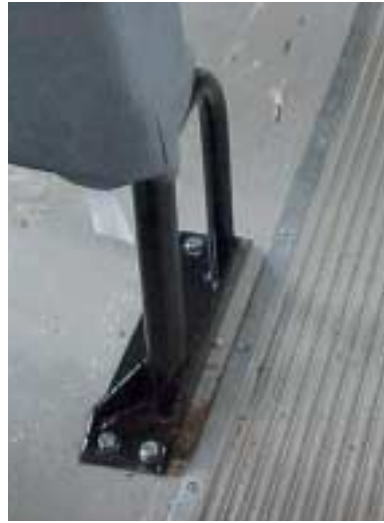
**Figure # 2 Aisle side view of flip seat rear mounting bolts.**

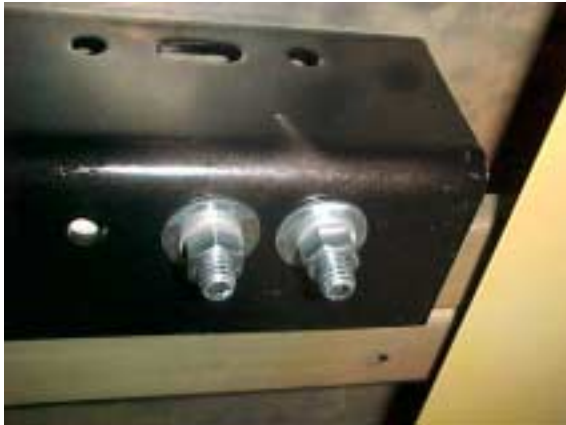
**Figure # 3 Reinforcement position when bolts are positioned through the floor joints or cross sill.**

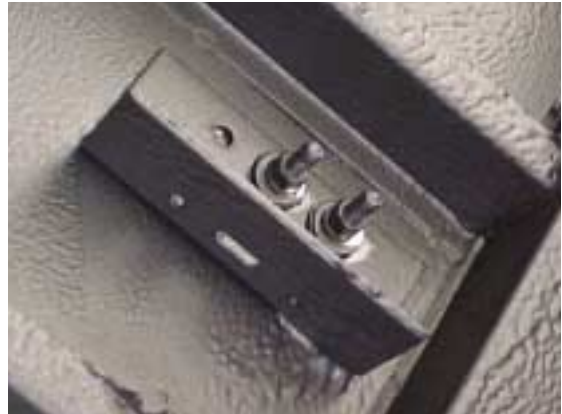
**Figure # 4 Reinforcement position when bolts are positioned through the floor only.**
