G-01501
February, 2001

SUBJECT: SAFETY RECALL (U.S., EXPORT)

Changing the brake pedals on all 1652 stripped chassis built from 6/12/00 through 11/17/00 and all IC buses built from 3/2/00 through 12/4/00. All of these vehicles have hydraulic brakes and automatic transmissions.

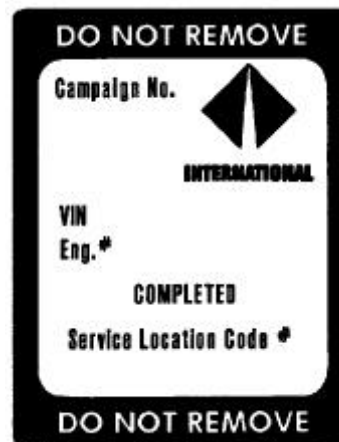
Attach the CTS-1075 label on a clean surface next to the vehicle identification number (VIN) plate.
