# VEHICLE RECALL

**G-04514**  
**October 2004**

**SUBJECT: SAFETY RECALL (U.S., EXPORT)**  
**PARK BRAKE ASSEMBLY on certain 3200, 4200, 4300, 4400 and CE School Bus models built 7/20/2004 thru 8/5/2004 with Hydraulic Brakes.**

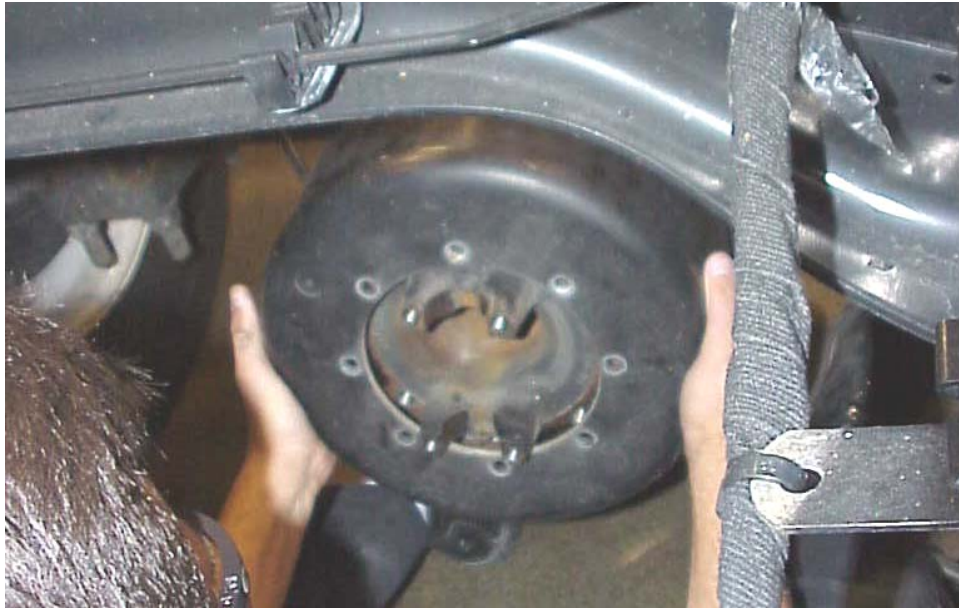
**Figure 1**

1. Disconnect driveshaft at rear axle.
2. Remove park brake drum bolts and park brake drum.

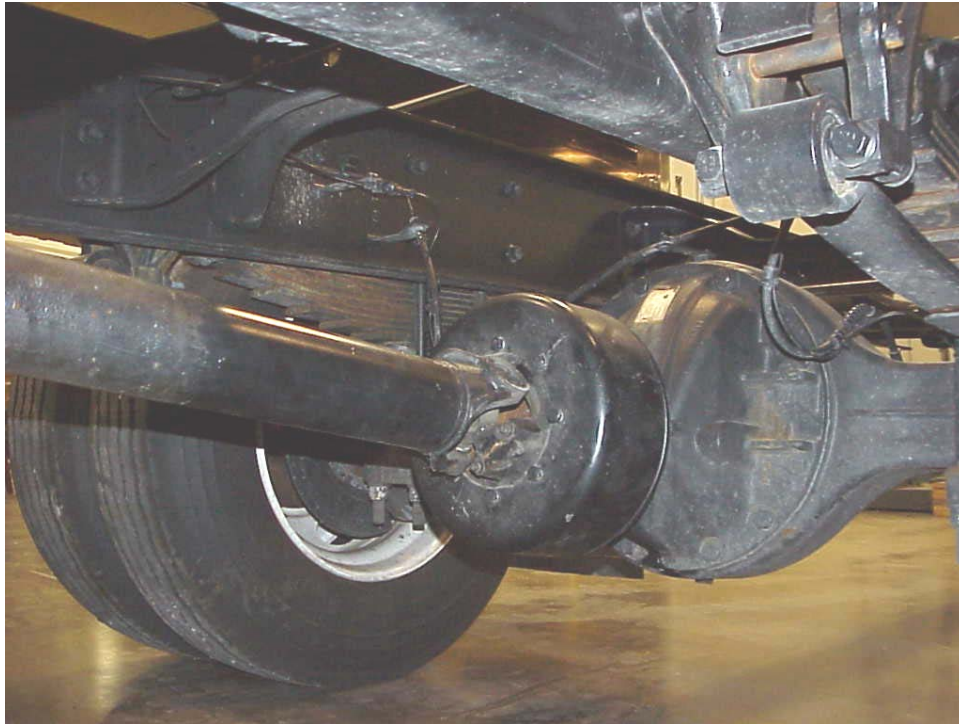
**Figure 8**

15. Re-attach drive shaft with new straps and bolts. Torque strap bolts to drive shaft manufacturer's specifications. Refer to Lineset Ticket and Master Service Manual for Torque Charts.
