DRIVE BELT INSPECTION [SKYACTIV-G 2.0, SKYACTIV-G 2.5]

Generator Drive Belt

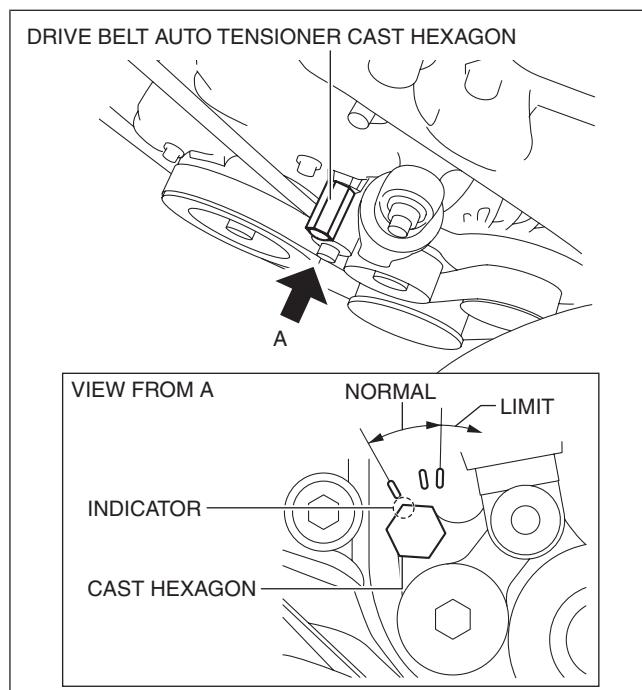
am3uuw00008886

- Verify that the indicator part of the cast hexagon on the drive belt auto tensioner is within the normal range.
 - If it exceeds the limit, replace the drive belt. (See DRIVE BELT REMOVAL/INSTALLATION [SKYACTIV-G 2.0, SKYACTIV-G 2.5].)

- The generator drive belt deflection/tension inspection is not necessary with the adoption of the drive belt auto tensioner.
