FORWARD SENSING CAMERA (FSC) SHORT-CORD INSPECTION

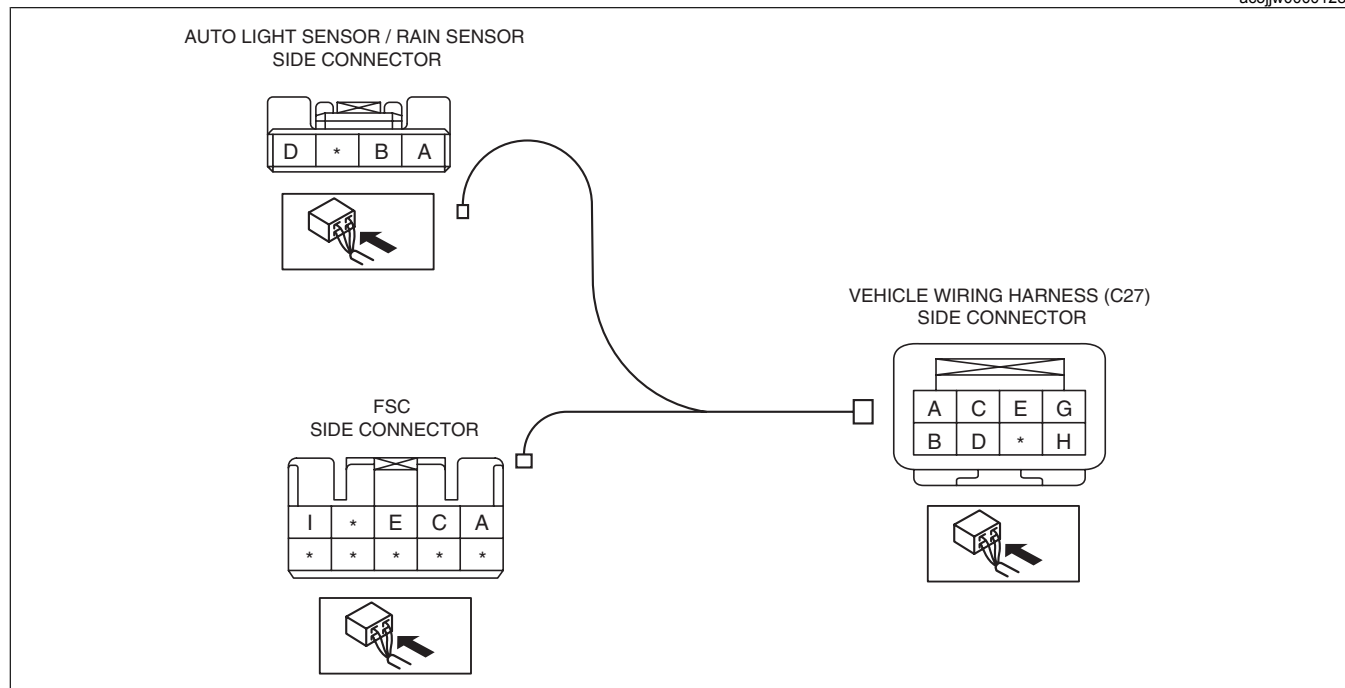
ac5jjw00001285

1. Disconnect the negative battery cable. (See NEGATIVE BATTERY CABLE DISCONNECTION/CONNECTION [SKYACTIV-G 2.0, SKYACTIV-G 2.5].)(See NEGATIVE BATTERY CABLE DISCONNECTION/CONNECTION [SKYACTIV-G 2.0, SKYACTIV-G 2.5 (WITHOUT i-stop)].)(See NEGATIVE BATTERY CABLE DISCONNECTION/CONNECTION [SKYACTIV-D 2.2].)
2. Remove the following parts:
 - (1) Cover (See FORWARD SENSING CAMERA (FSC) REMOVAL/INSTALLATION.)
 - (2) Auto-dimming mirror (See AUTO-DIMMING MIRROR REMOVAL/INSTALLATION.)
 - (3) FSC short-cord (See FORWARD SENSING CAMERA (FSC) SHORT-CORD REMOVAL/INSTALLATION.)
3. Verify that the continuity between the FSC short-cord terminals is as indicated in the table.

Test condition	Terminal													
	Vehicle wiring harness (C27) side connector							Auto light sensor / rain sensor side connector			FSC side connector			
	A	B	C	D	E	G	H	A	B	D	A	C	E	I
Under any condition	○													○
		○								○				
			○									○		
				○				○						
					○								○	
						○					○			
							○		○

- If not as indicated in the table, replace the FSC short-cord.
