## CLUTCH PEDAL POSITION (CPP) SWITCH INSPECTION [SKYACTIV-D 2.2]

### Continuity Inspection

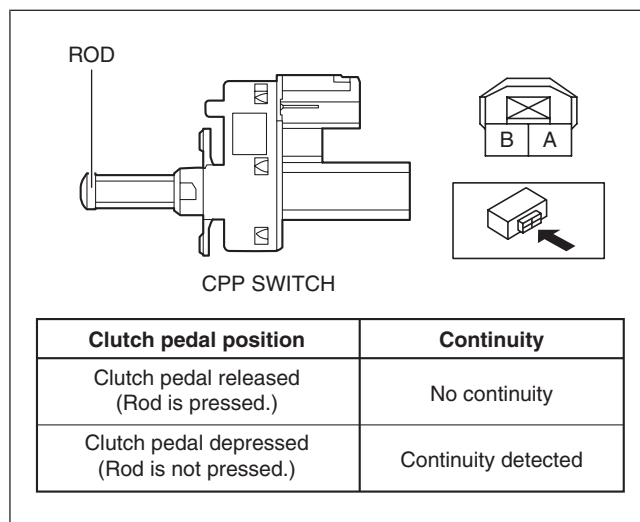
ac5wzw00006415

1. Verify that the CPP switch is installed properly. (See CLUTCH PEDAL POSITION SWITCH REMOVAL/INSTALLATION [D66M-R, D66MX-R].)
2. Disconnect the negative battery cable. (See NEGATIVE BATTERY CABLE DISCONNECTION/CONNECTION [SKYACTIV-D 2.2].)
3. Disconnect the CPP switch connector.
4. Verify that the continuity between CPP switch terminals A and B when the clutch pedal is depressed and when it is released is according to the following table:
  - If not as verified, replace the CPP switch. (See CLUTCH PEDAL POSITION SWITCH REMOVAL/INSTALLATION [D66M-R, D66MX-R].)
