FUEL PUMP UNIT INSPECTION [SKYACTIV-G 2.0]

Continuity Inspection

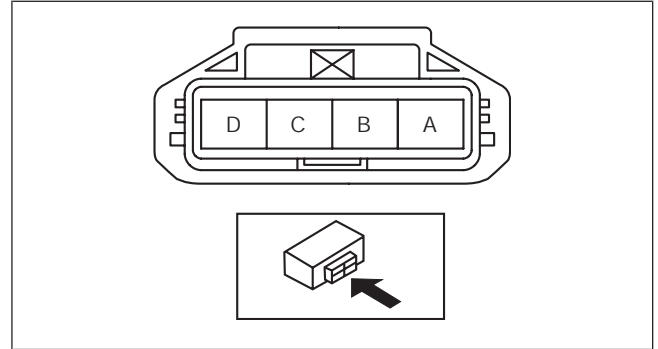
ac5wzw00002708

1. Disconnect the negative battery cable. (See NEGATIVE BATTERY CABLE DISCONNECTION/CONNECTION [SKYACTIV-G 2.0].) (See NEGATIVE BATTERY CABLE DISCONNECTION/CONNECTION [SKYACTIV-G 2.0 (WITHOUT i-stop)].)
2. Disconnect the fuel pump unit connector.
3. Inspect for continuity between fuel pump unit terminals B—D.
 - If there is no continuity, replace the fuel pump unit. (See FUEL PUMP UNIT REMOVAL/INSTALLATION [SKYACTIV-G 2.0].)
