OUTER MIRROR GLASS INSPECTION

Heated Outer Mirror

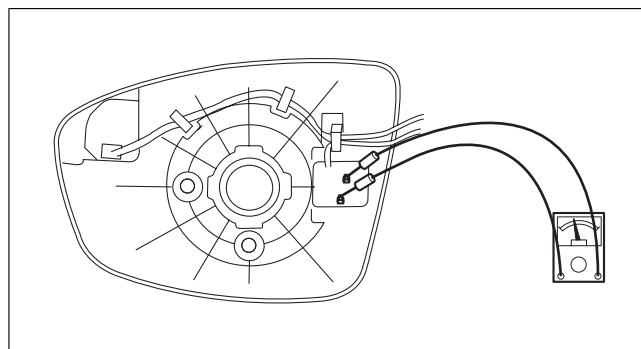
ac5wzw00002988

1. Disconnect the negative battery cable. (See NEGATIVE BATTERY CABLE DISCONNECTION/CONNECTION [SKYACTIV-G 2.0, SKYACTIV-G 2.5].) (See NEGATIVE BATTERY CABLE DISCONNECTION/CONNECTION [SKYACTIV-G 2.0, SKYACTIV-G 2.5 (WITHOUT i-stop)].) (See NEGATIVE BATTERY CABLE DISCONNECTION/CONNECTION [SKYACTIV-D 2.2].)
2. Remove the outer mirror glass. (See OUTER MIRROR GLASS REMOVAL.)(See OUTER MIRROR GLASS INSTALLATION.)
3. Verify that the resistance and continuity between the heated outer mirror terminals is as indicated in the table.

: Resistance
MIRROR OPERATION	TERMINAL	
	A	G
HEATER

Resistance : 9—13.5 ohms

- If not as indicated in the table, or if the resistance is not within the specification, replace the outer mirror glass.

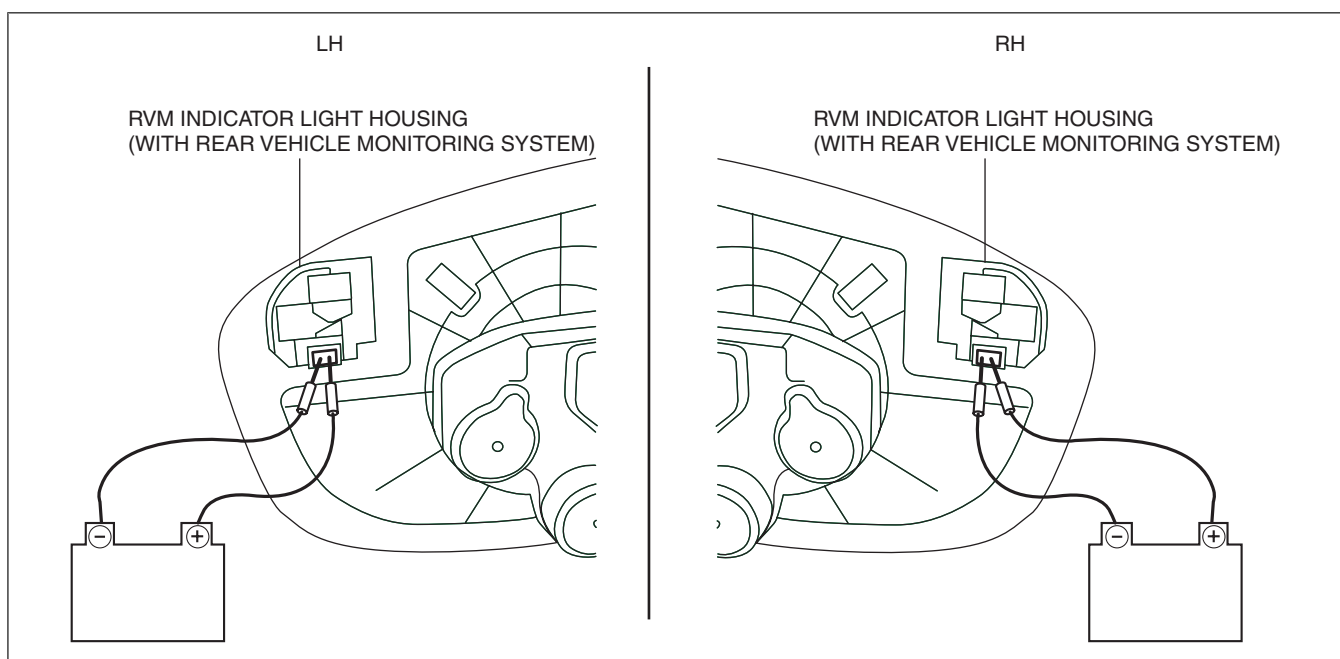
ac5wzw00002989

1. Disconnect the negative battery cable. (See NEGATIVE BATTERY CABLE DISCONNECTION/CONNECTION [SKYACTIV-G 2.0, SKYACTIV-G 2.5].) (See NEGATIVE BATTERY CABLE DISCONNECTION/CONNECTION [SKYACTIV-G 2.0, SKYACTIV-G 2.5 (WITHOUT i-stop)].) (See NEGATIVE BATTERY CABLE DISCONNECTION/CONNECTION [SKYACTIV-D 2.2].)
2. Remove the outer mirror glass. (See OUTER MIRROR GLASS REMOVAL.)(See OUTER MIRROR GLASS INSTALLATION.)
3. Connect the battery voltage as shown in the figure.

- If the RVM indicator light does not illuminate, replace the outer mirror glass.

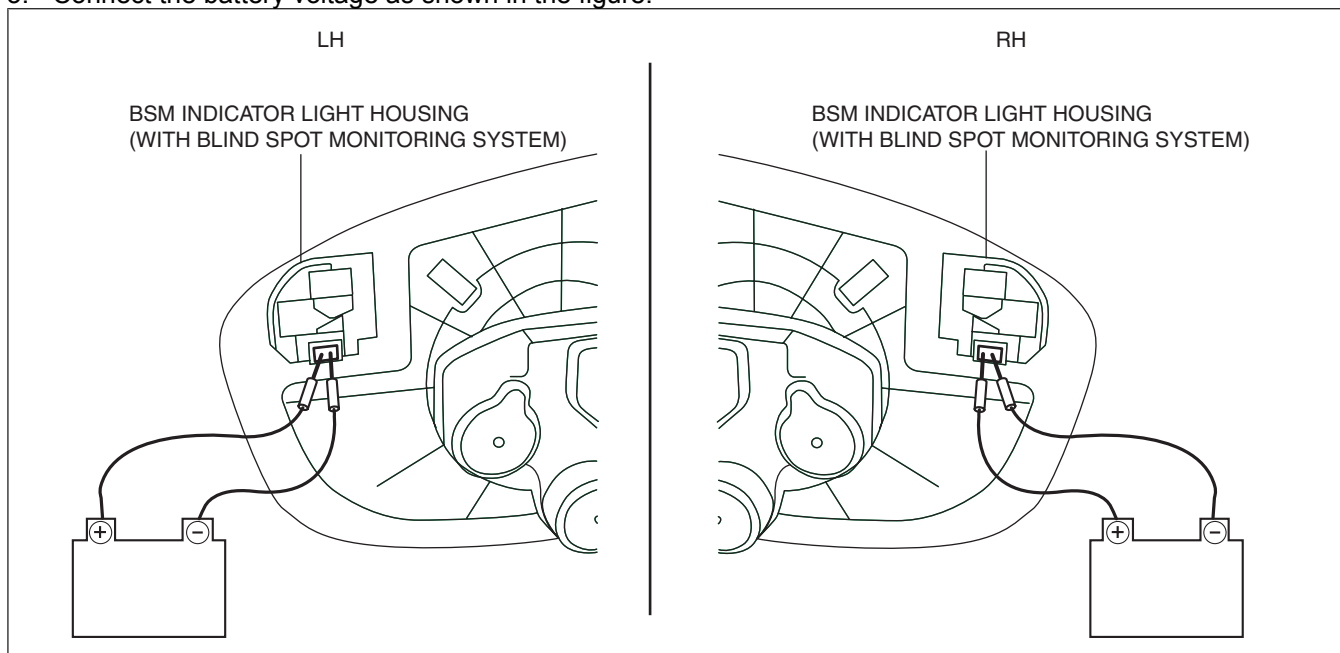
ac5wzw00002990

1. Disconnect the negative battery cable. (See NEGATIVE BATTERY CABLE DISCONNECTION/CONNECTION [SKYACTIV-G 2.0, SKYACTIV-G 2.5].) (See NEGATIVE BATTERY CABLE DISCONNECTION/CONNECTION [SKYACTIV-G 2.0, SKYACTIV-G 2.5 (WITHOUT i-stop)].) (See NEGATIVE BATTERY CABLE DISCONNECTION/CONNECTION [SKYACTIV-D 2.2].)
2. Remove the outer mirror glass. (See OUTER MIRROR GLASS REMOVAL.) (See OUTER MIRROR GLASS INSTALLATION.)
3. Connect the battery as shown in the figure.

- If the BSM indicator light does not illuminate, replace the outer mirror glass.
