EGR COOLER INSPECTION [SKYACTIV-D 2.2]

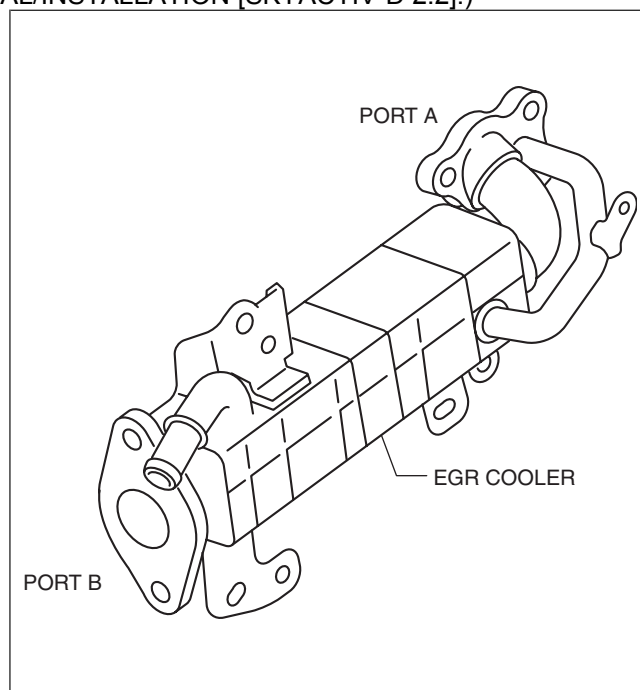
ac5wzw00004754

1. Disconnect the negative battery cable. (See NEGATIVE BATTERY CABLE DISCONNECTION/CONNECTION [SKYACTIV-D 2.2].)
2. Remove the EGR cooler. (See EGR COOLER REMOVAL/INSTALLATION [SKYACTIV-D 2.2].)
3. Verify that there is airflow from port B when pressure is applied from port A.
 - If there is no airflow, replace the EGR cooler. (See EGR COOLER REMOVAL/INSTALLATION [SKYACTIV-D 2.2].)
