MECHANICAL SYSTEM TEST [FW6A-EL, FW6AX-EL]

Mechanical system test preparation

Line pressure test

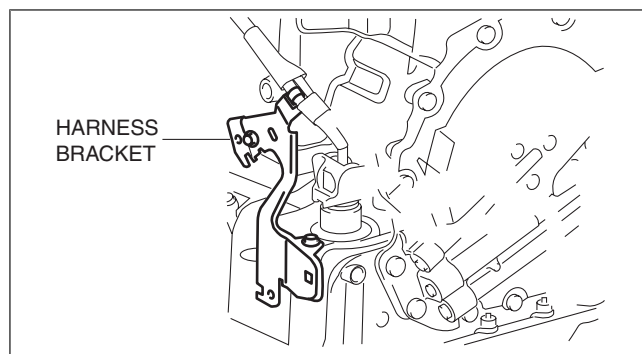
ac5uuw00000211

1. Perform the mechanical system test preparation. (See Mechanical system test preparation.)
2. Remove the air cleaner component. (See INTAKE-AIR SYSTEM REMOVAL/INSTALLATION [SKYACTIV-G 2.0, SKYACTIV-G 2.5].)
3. Remove the harness bracket.

21. Install the harness bracket.

8—10 N·m {82—101 kgf·cm, 71—88 in·lbf}

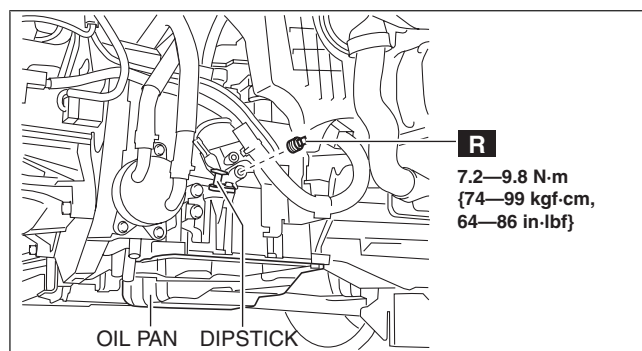
ac5wzw00004593

4. Remove the pressure detection square head plug.

- Do not remove the square head plug when the ATF temperature is high. Otherwise, ATF could overflow and cause severe burns or serious injury. Remove the square head plug when the transaxle and ATF temperatures are low.

20. Install a new square head plug.

- Do not reuse the square head plug because a sealant coating has been applied.

7.2—9.8 N·m {74—99 kgf·cm, 64—86 in·lbf}

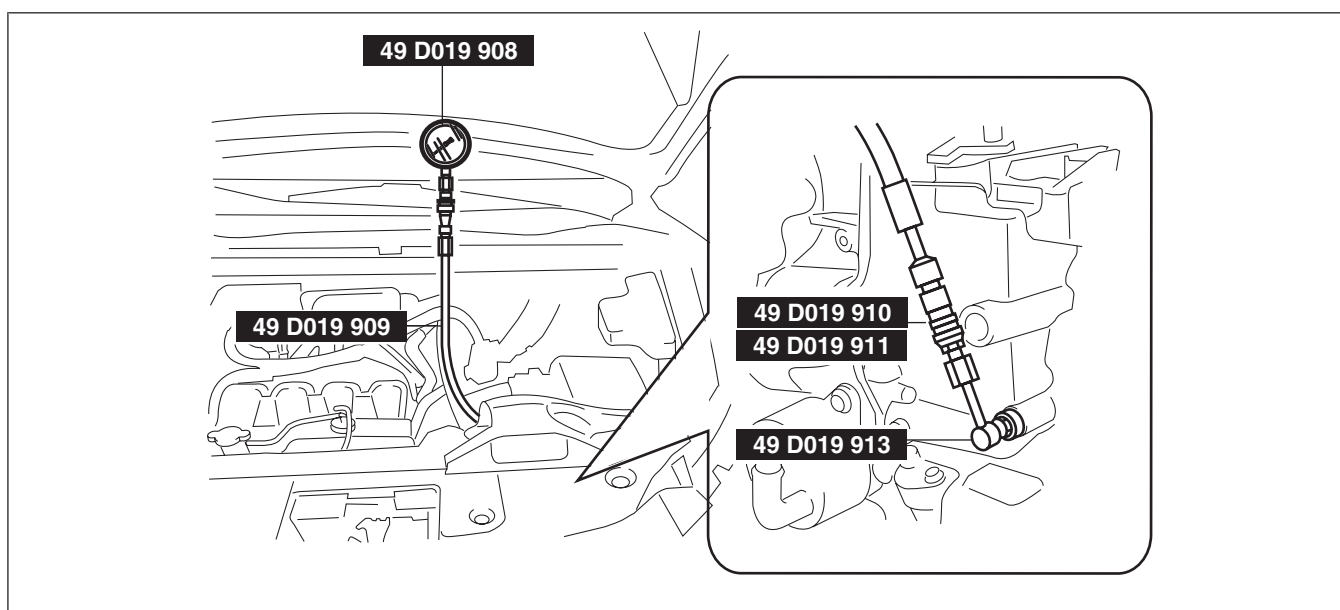
ac5wzw00002429

5. Install SSTs (49 D019 908, 49 D019 909, 49 D019 910, 49 D019 911, 49 D019 913) to the line pressure detection port as shown in the figure.

6. Install the air cleaner component. (See INTAKE-AIR SYSTEM REMOVAL/INSTALLATION [SKYACTIV-G 2.0, SKYACTIV-G 2.5].)
7. Start the engine.
8. Warm up the engine until the ATF temperature is **60—70 °C {140—158 °F}**.
9. Shift the selector lever to the D position.
10. Measure the line pressure while idling in D position.
11. Measure the line pressures while idling in the M (1st gear) and R positions using the same procedure.
12. Stop the engine.
13. Change the low-pressure gauge (49 D019 908) to the high-pressure gauge (49 D019 907).
14. Start the engine.
15. Measure the line pressure while stalling in D position.
 - (1) Strongly depress the brake pedal with the left foot.
 - (2) Shift the selector lever to the D position.

Measurement conditions		Specification (kPa {kgf/cm ² , psi})
Idling	R position	500—700 {5.10—7.13, 72.6—101.0}
	D and M (1GR) position	330—470 {3.37—4.79, 47.9—68.1}
Stalling	R position	1,790—2,100 {18.26—21.41, 259.7—304.5}
	D and M (1GR) position	970—1,170 {9.90—11.93, 141.0—169.6}
