LIFT MOTOR INSPECTION

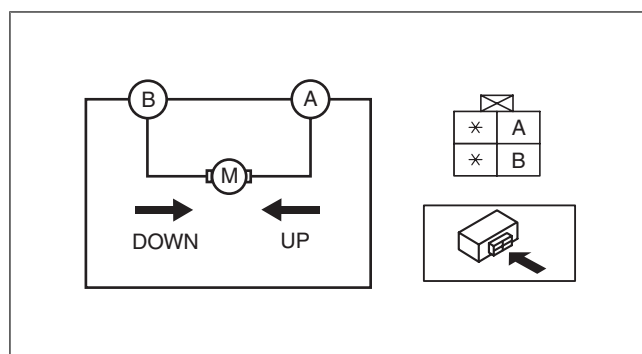
ac5uuw00002043

1. Disconnect the negative battery cable and wait for **1 min or more**. (See NEGATIVE BATTERY CABLE DISCONNECTION/CONNECTION [SKYACTIV-G 2.0, SKYACTIV-G 2.5].) (See NEGATIVE BATTERY CABLE DISCONNECTION/CONNECTION [SKYACTIV-G 2.0, SKYACTIV-G 2.5 (WITHOUT i-stop)].) (See NEGATIVE BATTERY CABLE DISCONNECTION/CONNECTION [SKYACTIV-D 2.2].)
2. Remove the front seat side cover. (See FRONT SEAT SIDE COVER REMOVAL/INSTALLATION.)
3. Disconnect the lift motor connector.
4. Apply battery positive voltage to the lift motor terminals and inspect the front seat operation.
 - If not as specified, replace the lift motor. (See LIFT MOTOR REMOVAL/INSTALLATION.)

Front seat operation	Connection	
	A	B
Up	B+	GND
Down	GND	B+

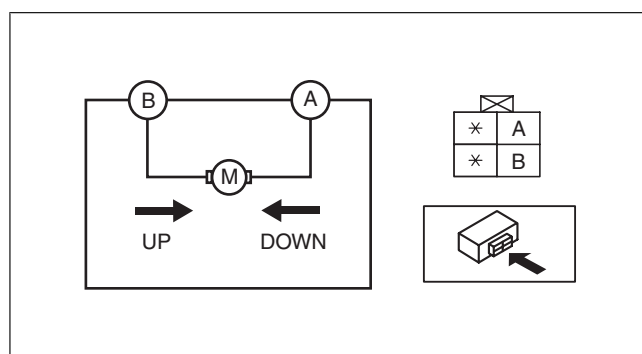
ac5wzw00003794

1. Disconnect the negative battery cable and wait for **1 min or more**. (See NEGATIVE BATTERY CABLE DISCONNECTION/CONNECTION [SKYACTIV-G 2.0, SKYACTIV-G 2.5].) (See NEGATIVE BATTERY CABLE DISCONNECTION/CONNECTION [SKYACTIV-G 2.0, SKYACTIV-G 2.5 (WITHOUT i-stop)].) (See NEGATIVE BATTERY CABLE DISCONNECTION/CONNECTION [SKYACTIV-D 2.2].)
2. Remove the front seat side cover. (See FRONT SEAT SIDE COVER REMOVAL/INSTALLATION.)
3. Disconnect the lift motor connector.
4. Apply battery positive voltage to the lift motor terminals and inspect the front seat operation.
 - If not as specified, replace the lift motor. (See LIFT MOTOR REMOVAL/INSTALLATION.)

Front seat operation	Connection	
	A	B
Up	GND	B+
Down	B+	GND
