## COOLING FAN MOTOR INSPECTION [SKYACTIV-G 2.0, SKYACTIV-G 2.5]

### Part Inspection

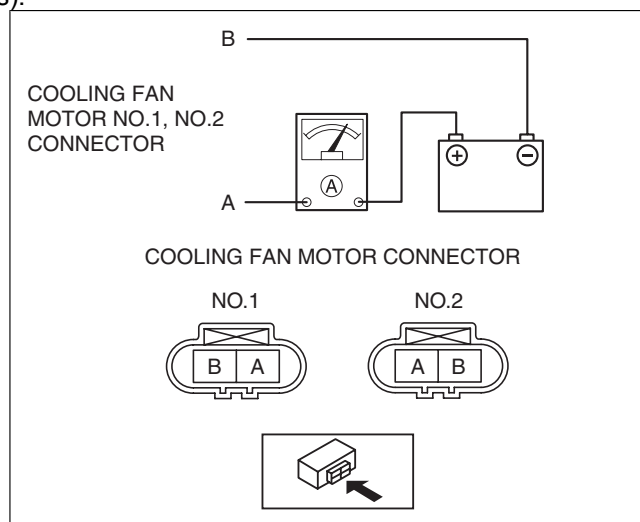
1. Verify that the battery is fully charged. (See BATTERY INSPECTION [SKYACTIV-G 2.0, SKYACTIV-G 2.5].)  
(See BATTERY INSPECTION [SKYACTIV-G 2.0, SKYACTIV-G 2.5 (WITHOUT i-stop)].)
2. Disconnect the cooling fan motor connector (2 terminals).
3. Install a tester and battery to the cooling fan motor connector (2 terminals) as shown in the figure.
4. Verify that each cooling fan motor operates smoothly at the standard current.
  - If there is any malfunction, replace the applicable part.

**Cooling fan motor No.1, No.2 standard current**  
**4.5—8.5 A [12 V]**
