FRONT PARKING SENSOR BUZZER INSPECTION

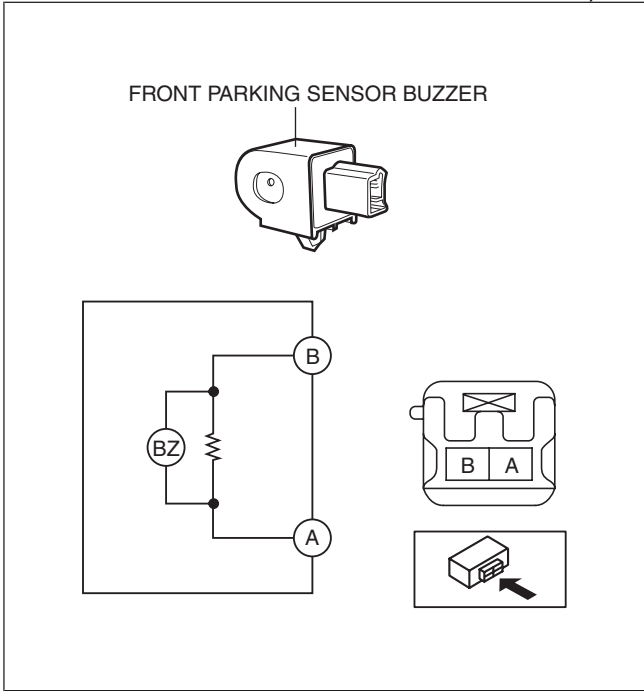
ac5wzw00003790

1. Disconnect the negative battery cable. (See NEGATIVE BATTERY CABLE DISCONNECTION/CONNECTION [SKYACTIV-G 2.0, SKYACTIV-G 2.5].)(See NEGATIVE BATTERY CABLE DISCONNECTION/CONNECTION [SKYACTIV-G 2.0, SKYACTIV-G 2.5 (WITHOUT i-stop)].)(See NEGATIVE BATTERY CABLE DISCONNECTION/CONNECTION [SKYACTIV-D 2.2].)
2. Remove the following parts:
 - (1) Upper column cover (See COLUMN COVER REMOVAL/INSTALLATION.)
 - (2) Meter hood (See METER HOOD REMOVAL/INSTALLATION.)
 - (3) Instrument cluster (See INSTRUMENT CLUSTER REMOVAL/INSTALLATION.)
 - (4) Front parking sensor buzzer (See FRONT PARKING SENSOR BUZZER REMOVAL/INSTALLATION.)
3. Verify the continuity between front parking sensor buzzer terminals A and B.

Test condition	Terminal	
	A	B
Under any condition	○—○	○—○

- If not as indicated in the table, replace the front parking sensor buzzer.
