REAR BRAKE (DISC) INSPECTION

Brake Judder Repair Hints

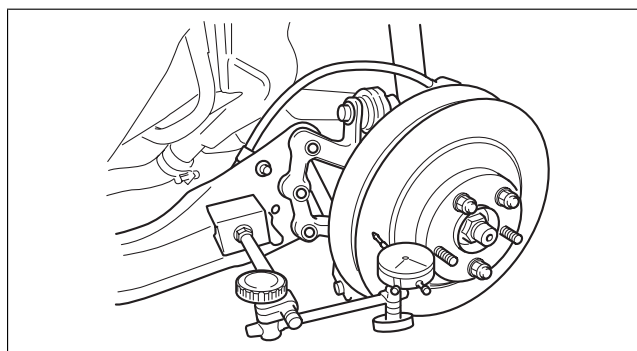
ac5wzw000002184

Lateral runout inspection

1. To secure the disc plate and the hub, insert the washer (thickness **10 mm {0.39 in}**, inner diameter **more than 12 mm {0.47 in}**) between each hub bolt and the hub nut, then tighten all the hub nuts.

2. After tightening all the hub nuts to the same torque, put the dial gauge on the friction surface of the disc plate **10 mm {0.39 in}** from the disc plate edge.
3. Rotate the disc plate one time and measure the runout.

Rear disc plate runout limit

0.1 mm {0.004 in}

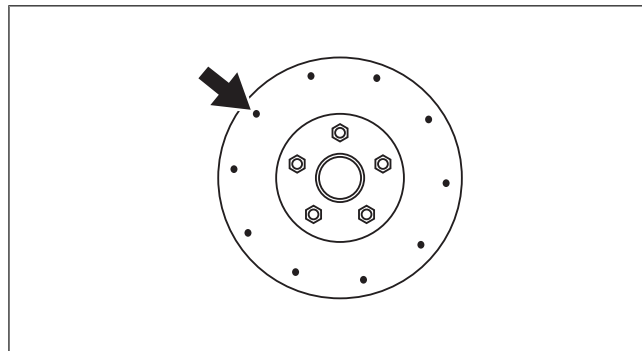
am5ezw00004296

Thickness variation inspection

1. Clean the disc plate-to-pad friction surface using a brake cleaner.

2. Measure the points indicated in the illustration using a caliper (micrometer).
3. Subtract the minimum value from the maximum, and if the result is not within the specification, machine the disc plate using a lathe.

Thickness variation limit
0.015 mm {0.00059 in}

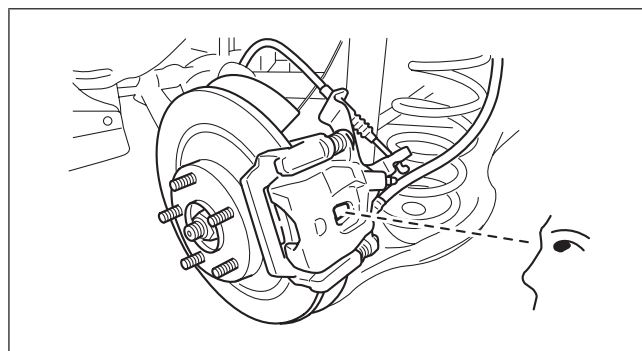
ac5wzw00000188

Disc Pad Thickness Inspection

1. Jack up the front of the vehicle and support it with safety stands.
2. Remove the wheels and tires.
3. Verify the remaining thickness of the pads.

Minimum rear disc pad thickness
2.0 mm {0.079 in} min.

4. Replace the pads as a set (right and left wheels) if either one is at or less than the minimum thickness.
