## REAR FENDER PANEL REMOVAL [PANEL REPLACEMENT]

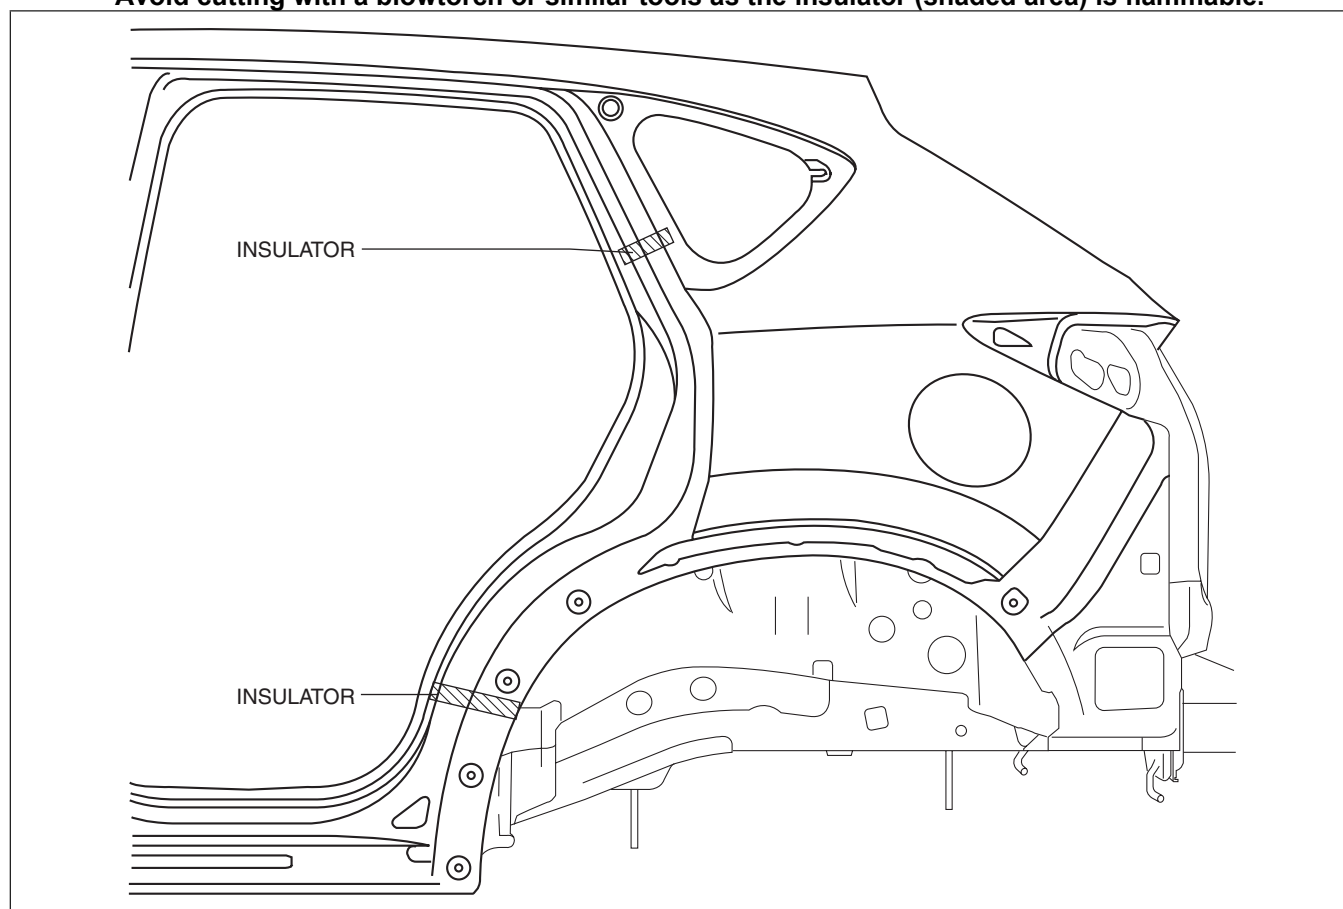
ac5wzb000000234

- Avoid cutting with a blowtorch or similar tools as the insulator (shaded area) is flammable.

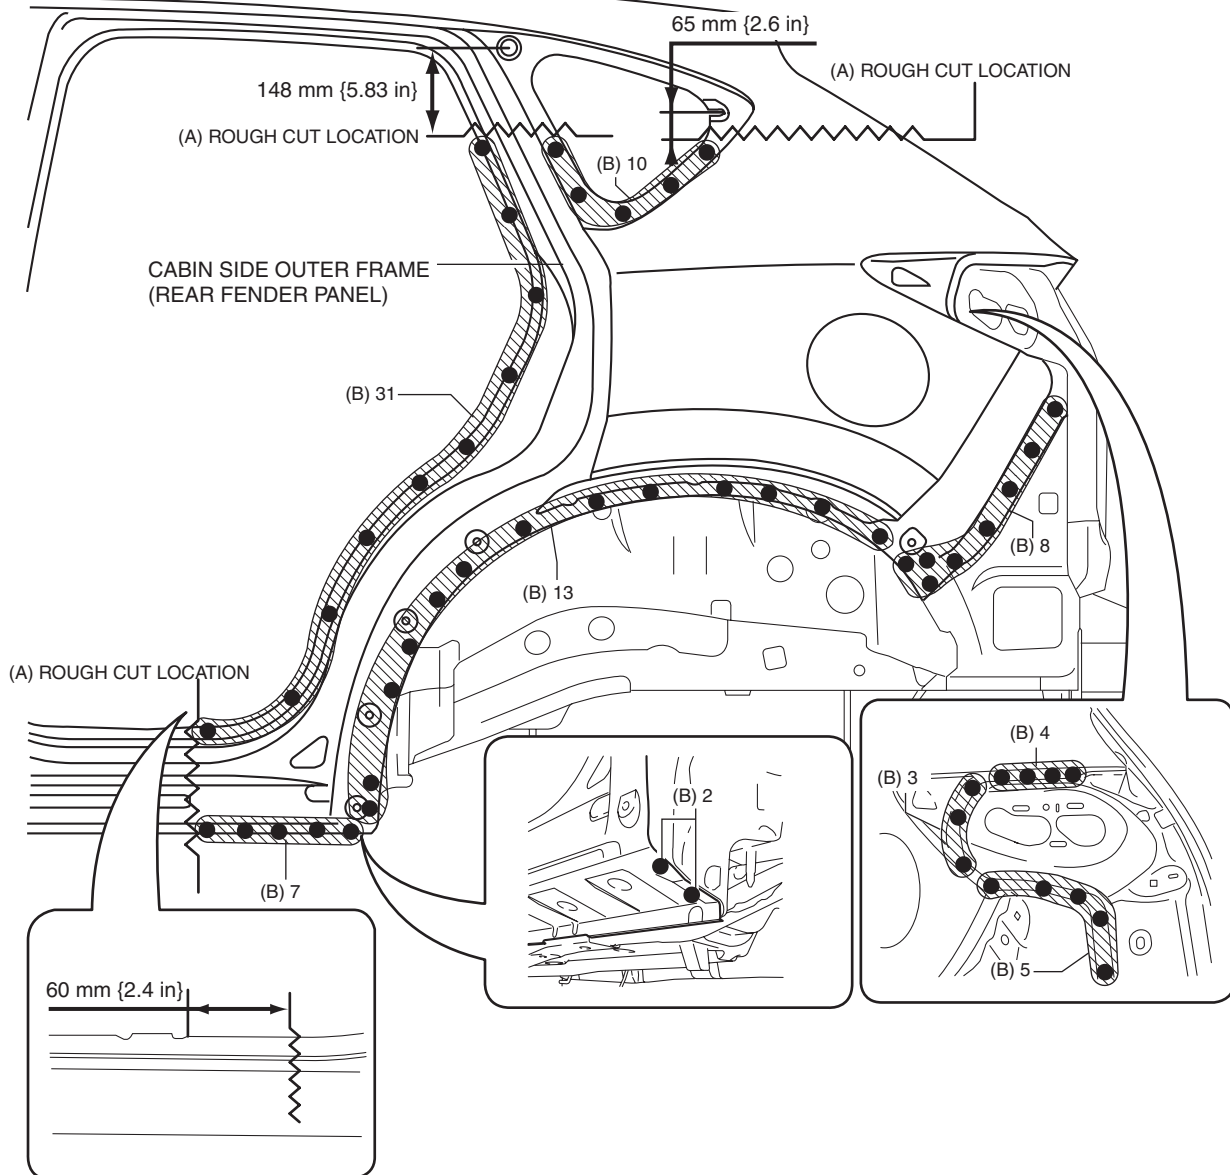
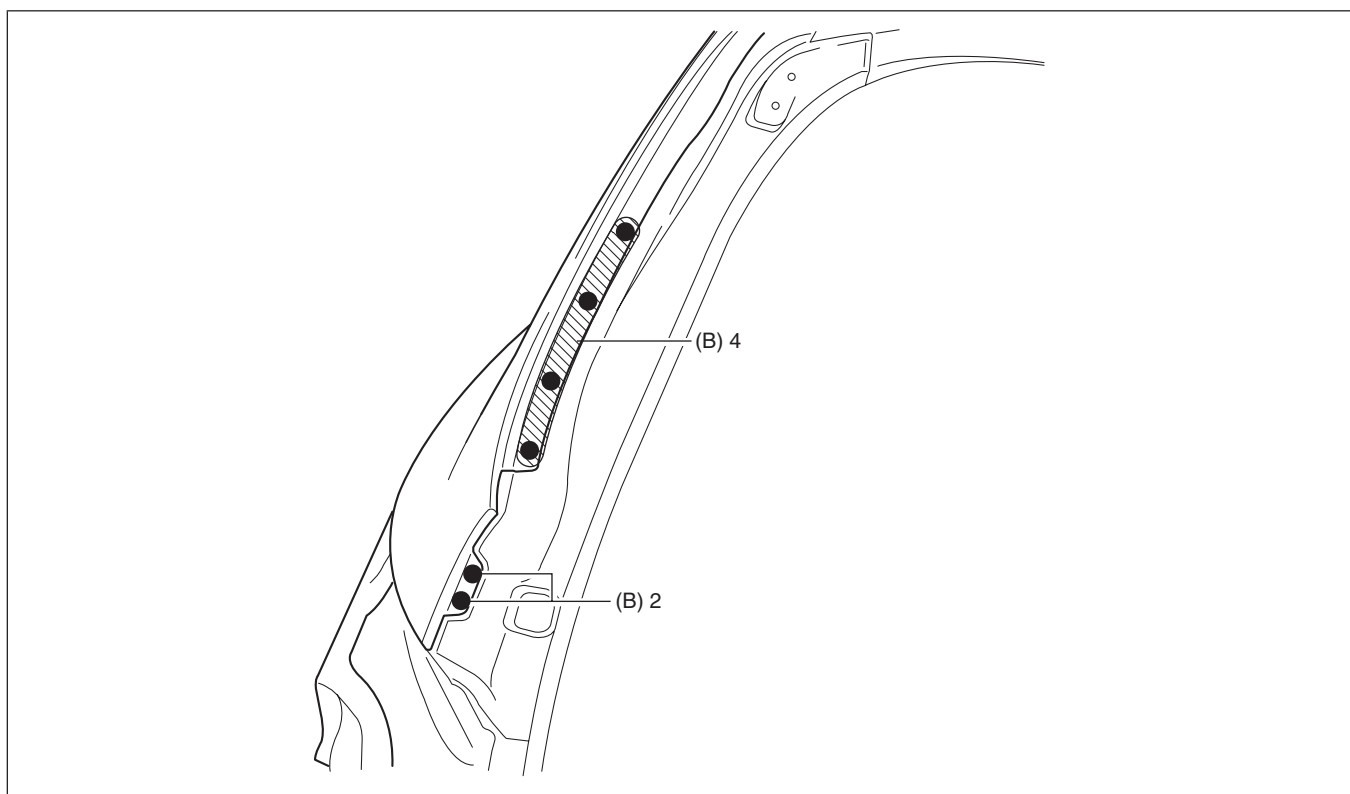
ac5wzb00000123

1. Rough cut the 3 locations indicated by (A) shown in the figure.
2. Drill the 90 locations indicated by (B) shown in the figure.

3. Remove the cabin side outer frame (rear fender panel).
