## HORN INSPECTION

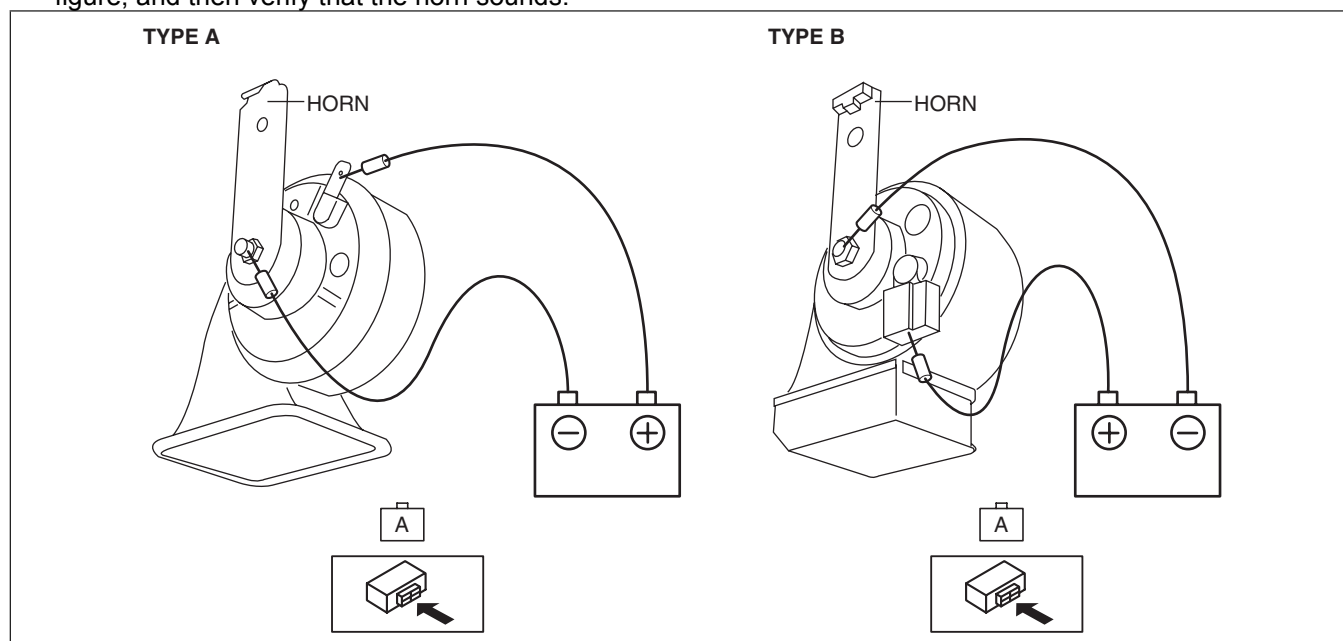
ac5jjw00000655

1. Disconnect the negative battery cable. (See NEGATIVE BATTERY CABLE DISCONNECTION/CONNECTION [SKYACTIV-G 2.0, SKYACTIV-G 2.5].)(See NEGATIVE BATTERY CABLE DISCONNECTION/CONNECTION [SKYACTIV-G 2.0, SKYACTIV-G 2.5 (WITHOUT i-stop)].)(See NEGATIVE BATTERY CABLE DISCONNECTION/CONNECTION [SKYACTIV-D 2.2].)
2. Remove the front bumper. (See FRONT BUMPER REMOVAL/INSTALLATION.)
3. Remove the horn. (See HORN INSPECTION.)
4. Apply battery positive voltage to horn terminal A, and connect the horn retaining bolt to ground as shown in the figure, and then verify that the horn sounds.

- If the horn does not sound, replace the horn.
