## THROTTLE BODY INSPECTION [SKYACTIV-G 2.0, SKYACTIV-G 2.5]

### Resistance Inspection

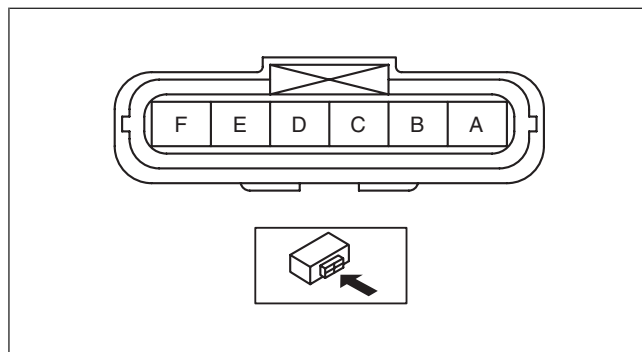
am3uuw00008477

1. Disconnect the negative battery cable. (See NEGATIVE BATTERY CABLE DISCONNECTION/CONNECTION [SKYACTIV-G 2.0, SKYACTIV-G 2.5].) (See NEGATIVE BATTERY CABLE DISCONNECTION/CONNECTION [SKYACTIV-G 2.0, SKYACTIV-G 2.5 (WITHOUT i-stop)].)
2. Disconnect the throttle body connector.
3. Measure the resistance between throttle body terminals E and F.

### Throttle body resistance

**1.38 ohms [20°C {68 °F}]**

- If not as specified, replace the throttle body.  
(See INTAKE-AIR SYSTEM REMOVAL/INSTALLATION [SKYACTIV-G 2.0, SKYACTIV-G 2.5].)
