## FILAMENT INSPECTION

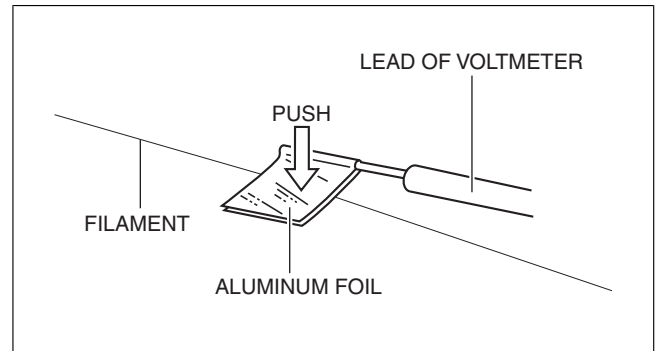
ac5wzw00001347

3. Connect the positive lead of the tester to the positive side of each filament and the negative lead to ground.
4. Gradually slide the positive lead from the positive side to the negative side and verify that the voltage decreases accordingly.
  - If the voltage changes rapidly, the filament has a malfunction. Repair the filament.

- **Directly touching the rear window defroster filament with the lead of the tester could damage it. Wrap aluminum foil around the end of the lead and inspect the filament by touching it with the aluminum foil.**

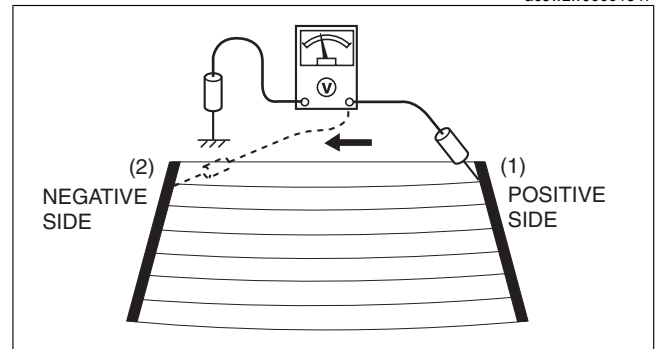
ac5wzw00001348

Measured part	Voltage (Reference)
(1) to (2)	Approx. 11 V to 0 V
