END COVER INSPECTION

Radial Needle Bearing Inspection

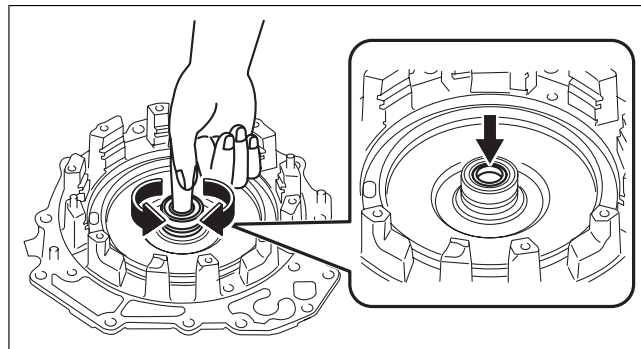
1. Rotate the radial needle bearing shown in the figure by hand and verify that there is no malfunction in the radial needle bearing (rotation sticking).
 - If there is a malfunction, replace the end cover with a new one.
