CATALOGUE

NEW, MODERN, DURABLE, STYLISH ROOF

ASA SYNTHETIC ROOF TILES

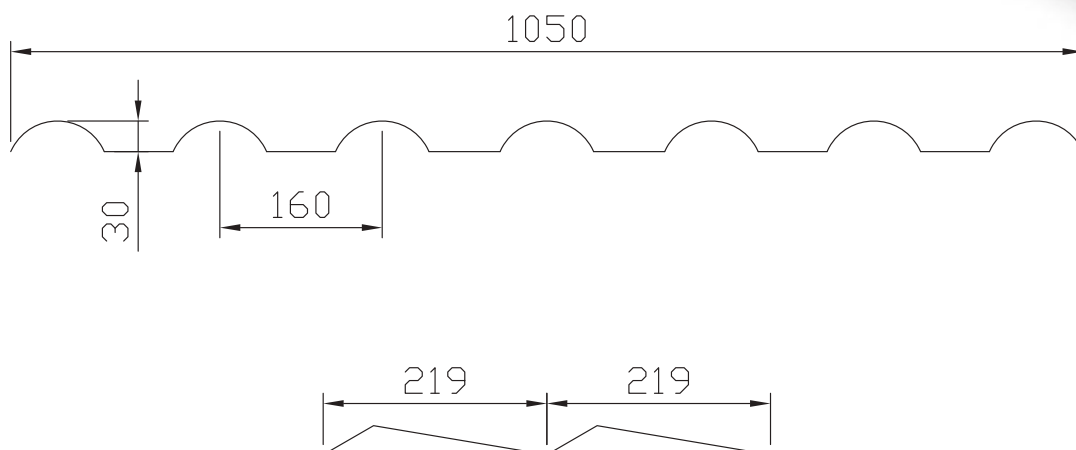
GLAZED TILE (L1050-220)

RM **250.00** /PC
3ft(W) x 19ft(L)

Main Tiles Specification

- Thickness : 2.5 mm
- Length : 19 ft
- Width : 1050 mm
- Color : Red Grey

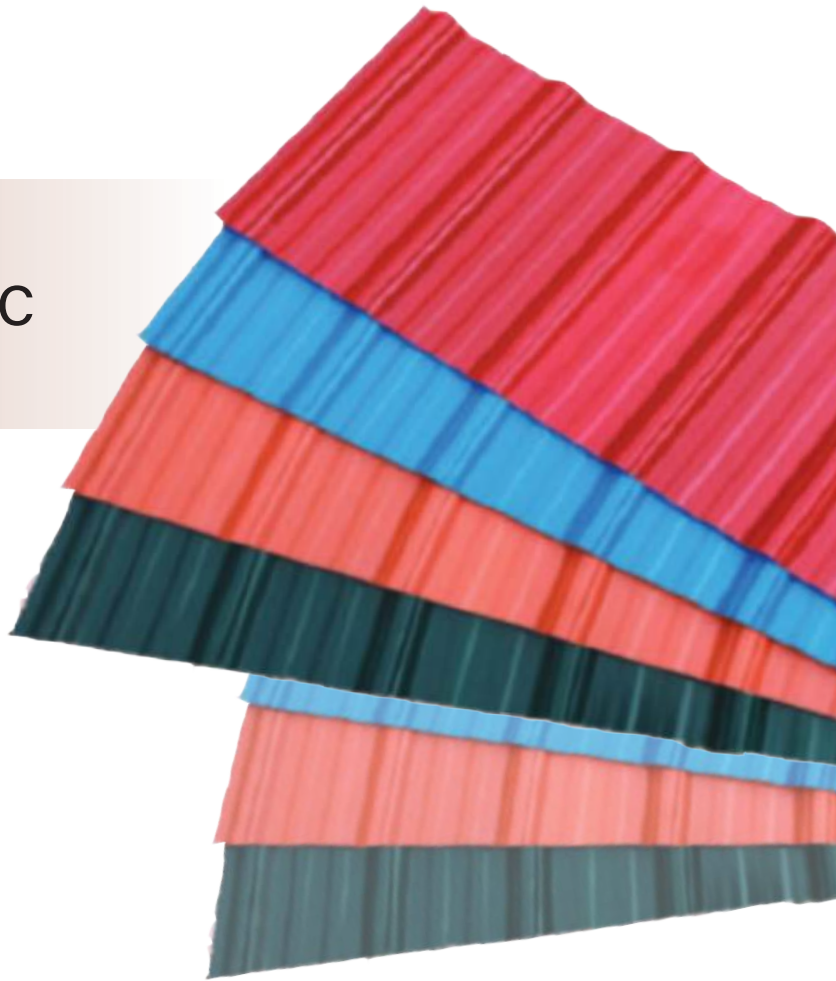
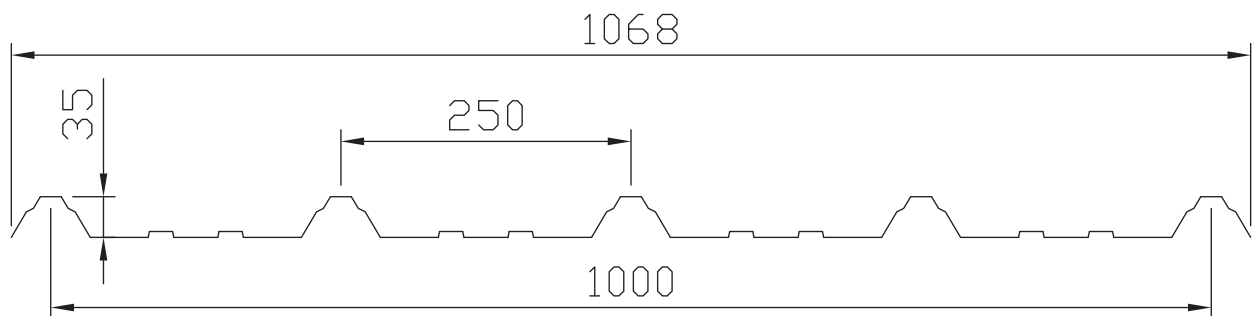
(T1068-35)

TRAPEZOIDAL

RM **270.00** /PC
3ft(W) x 19ft(L)

Main Tiles Specification

- Thickness : 2.5 mm
- Length : 19 ft
- Width : 1068 mm
- Color : Grey, Blue, Transparent

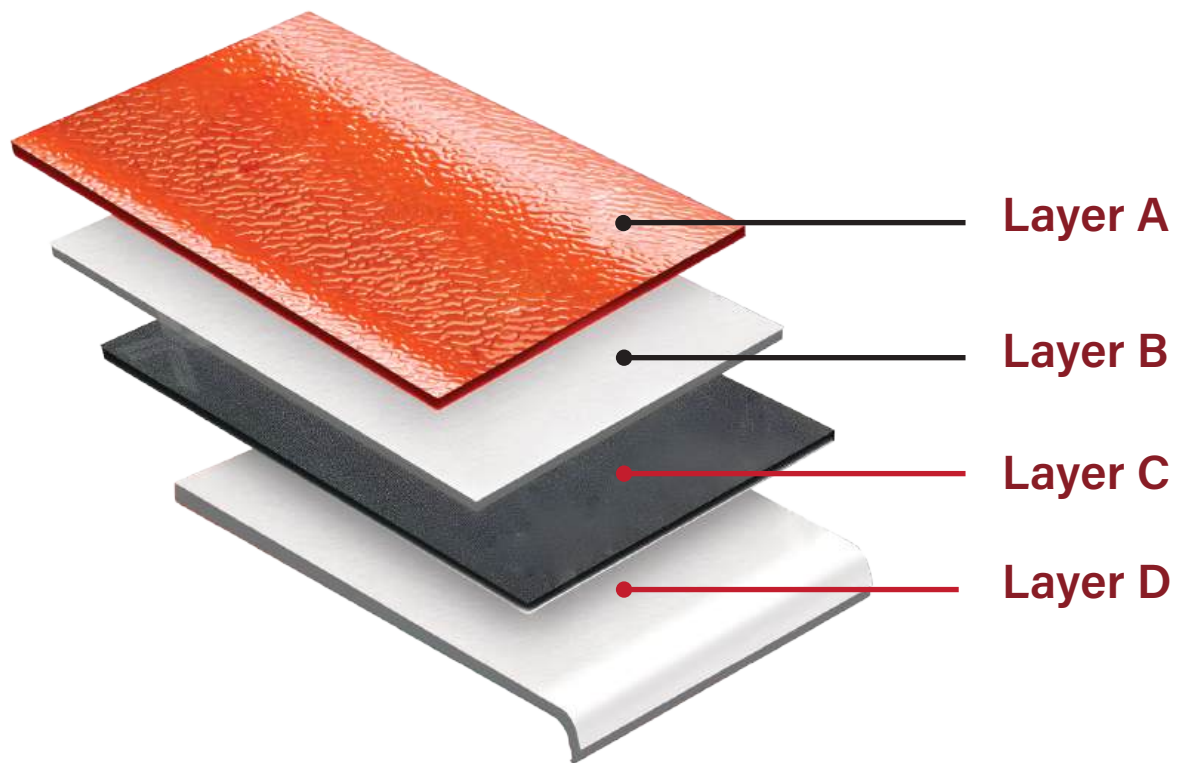
PRODUCT FEATURES

Layer A : Anti Aging Layer

Layer B : Thermal Insulation Layer

Layer C : Sun-Light Shading Protection Layer

Layer D : Wearing Layer

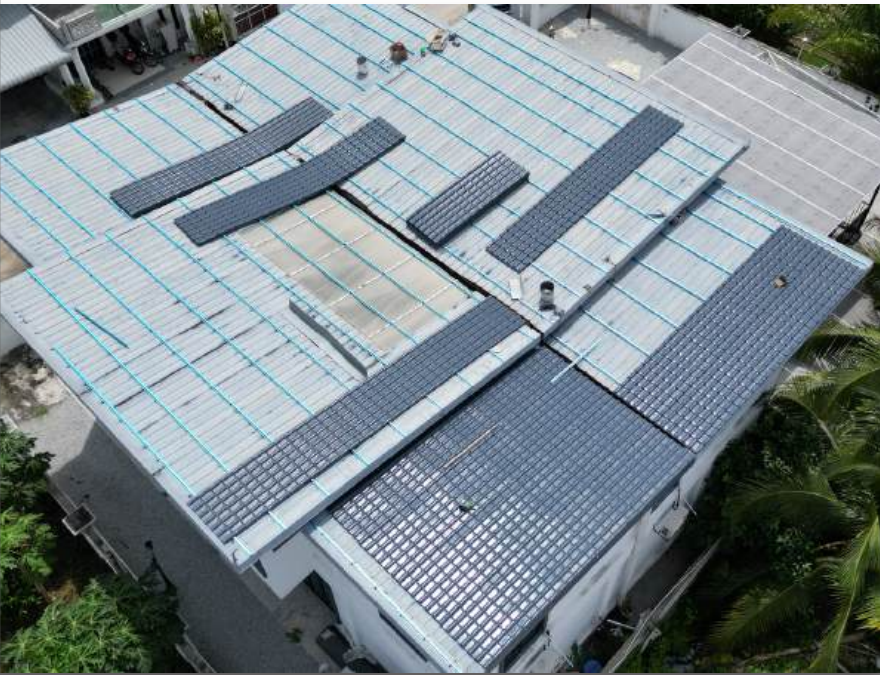
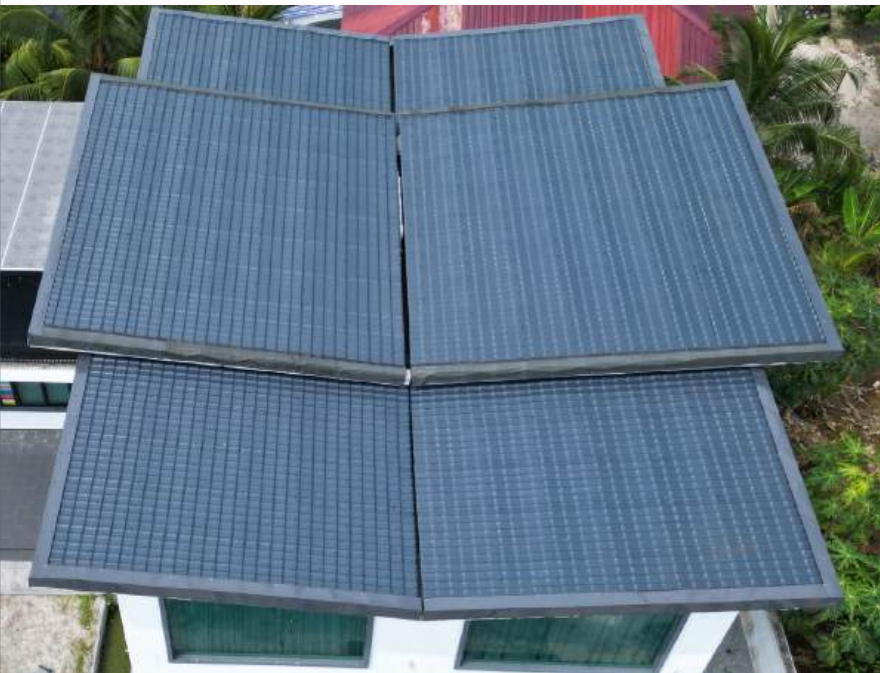
Roof Repairing Double Layer Roof for Metal Deck

Before

After

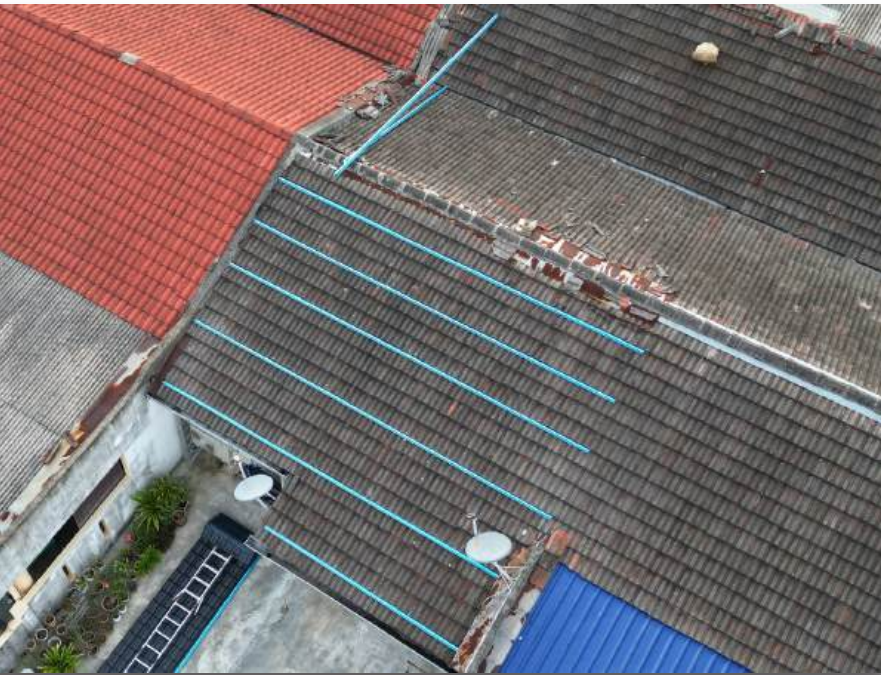
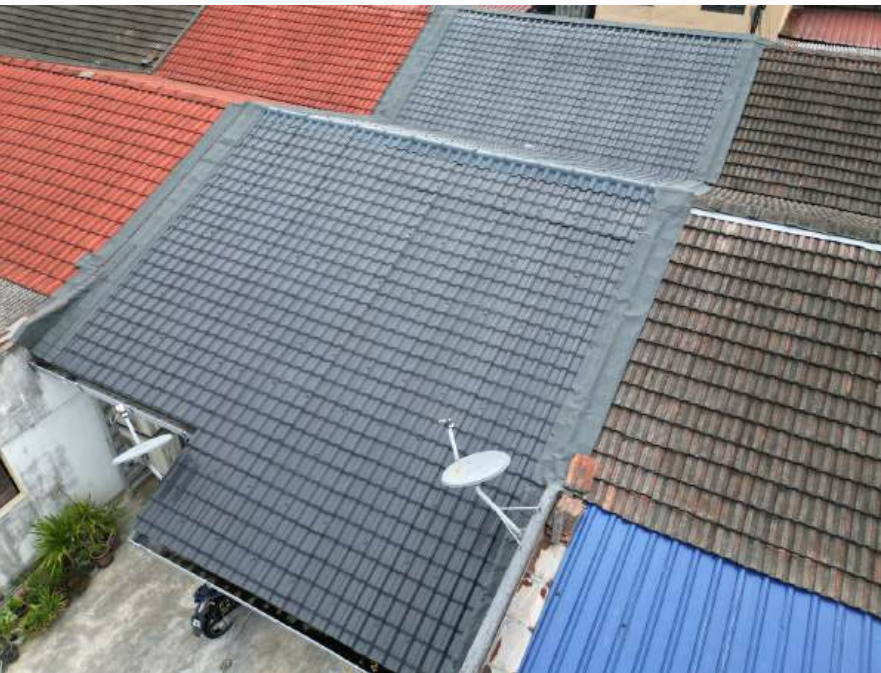
Roof Repairing Double Layer Roof for Roof Tile

Before

After
