Technical Service Information

THM 4L30-E VALVE BODY SCREENS

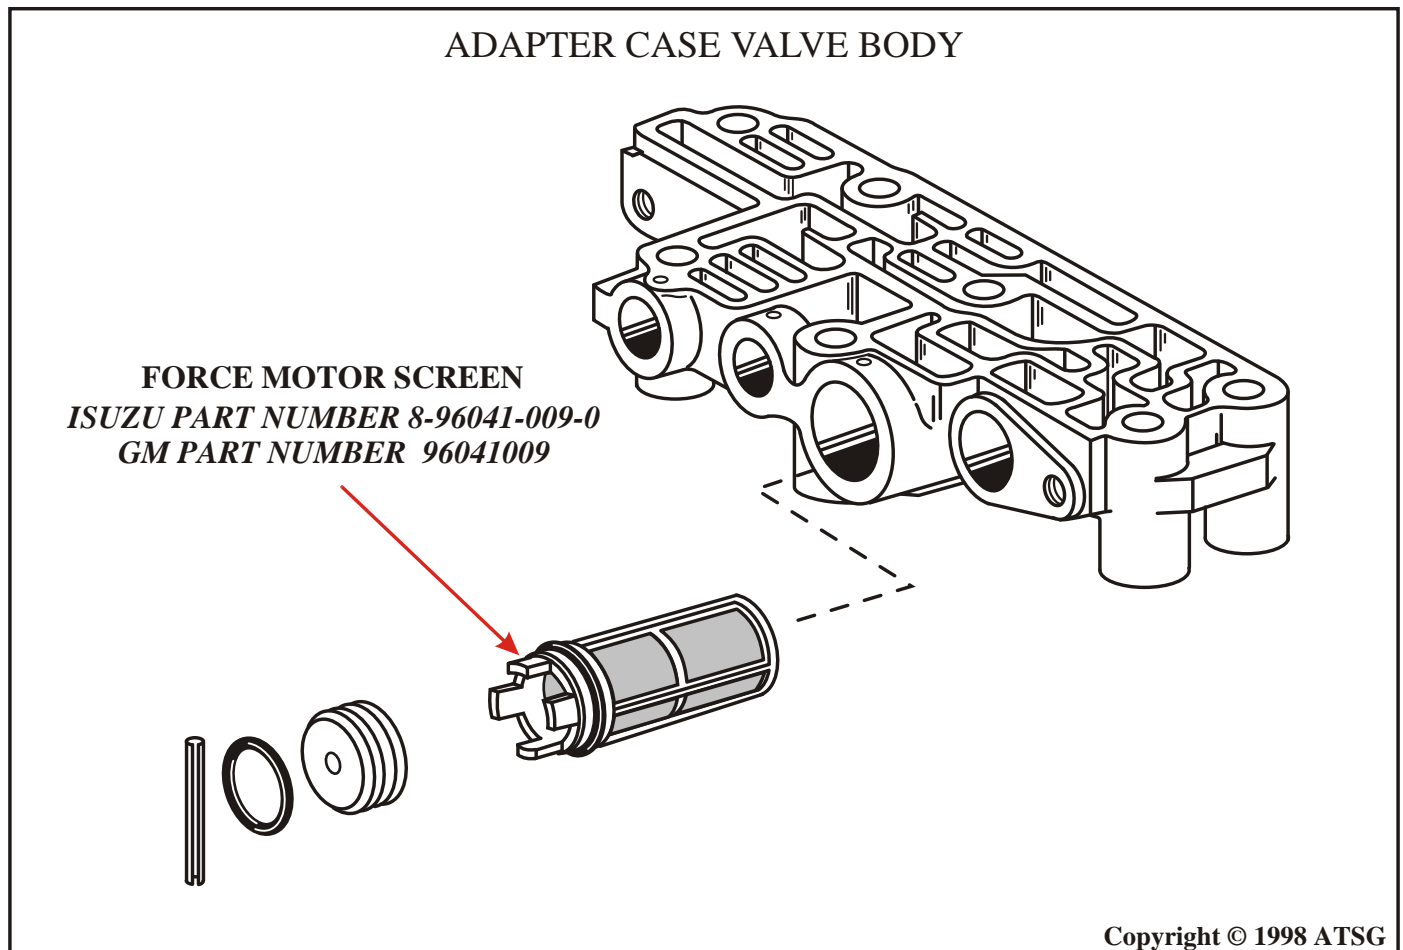
MAIN CASE VALVE BODY

CORRECTION: There are now part numbers available from Isuzu to service the valve body screens individually. Refer to Figure 1 for the location of the Force Motor Screen and Figure 2 for the

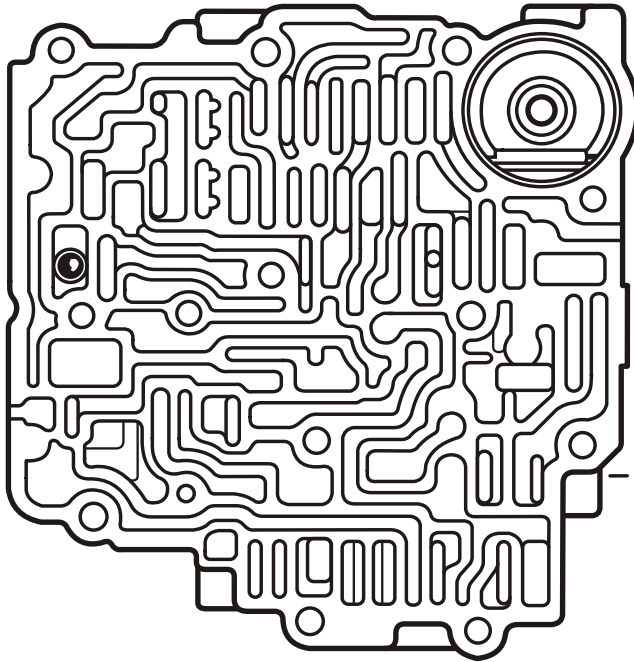
Figure 2

**PWM BAND CONTROL
SOLENOID SCREEN**
ISUZU PART NUMBER 8-96041-012-0
GM PART NUMBER 96041012
