Technical Service Information

FORD AXODE (AX4S)

HARSH 1-2 UPSHIFT, OR FLARE ON 1-2 UPSHIFT

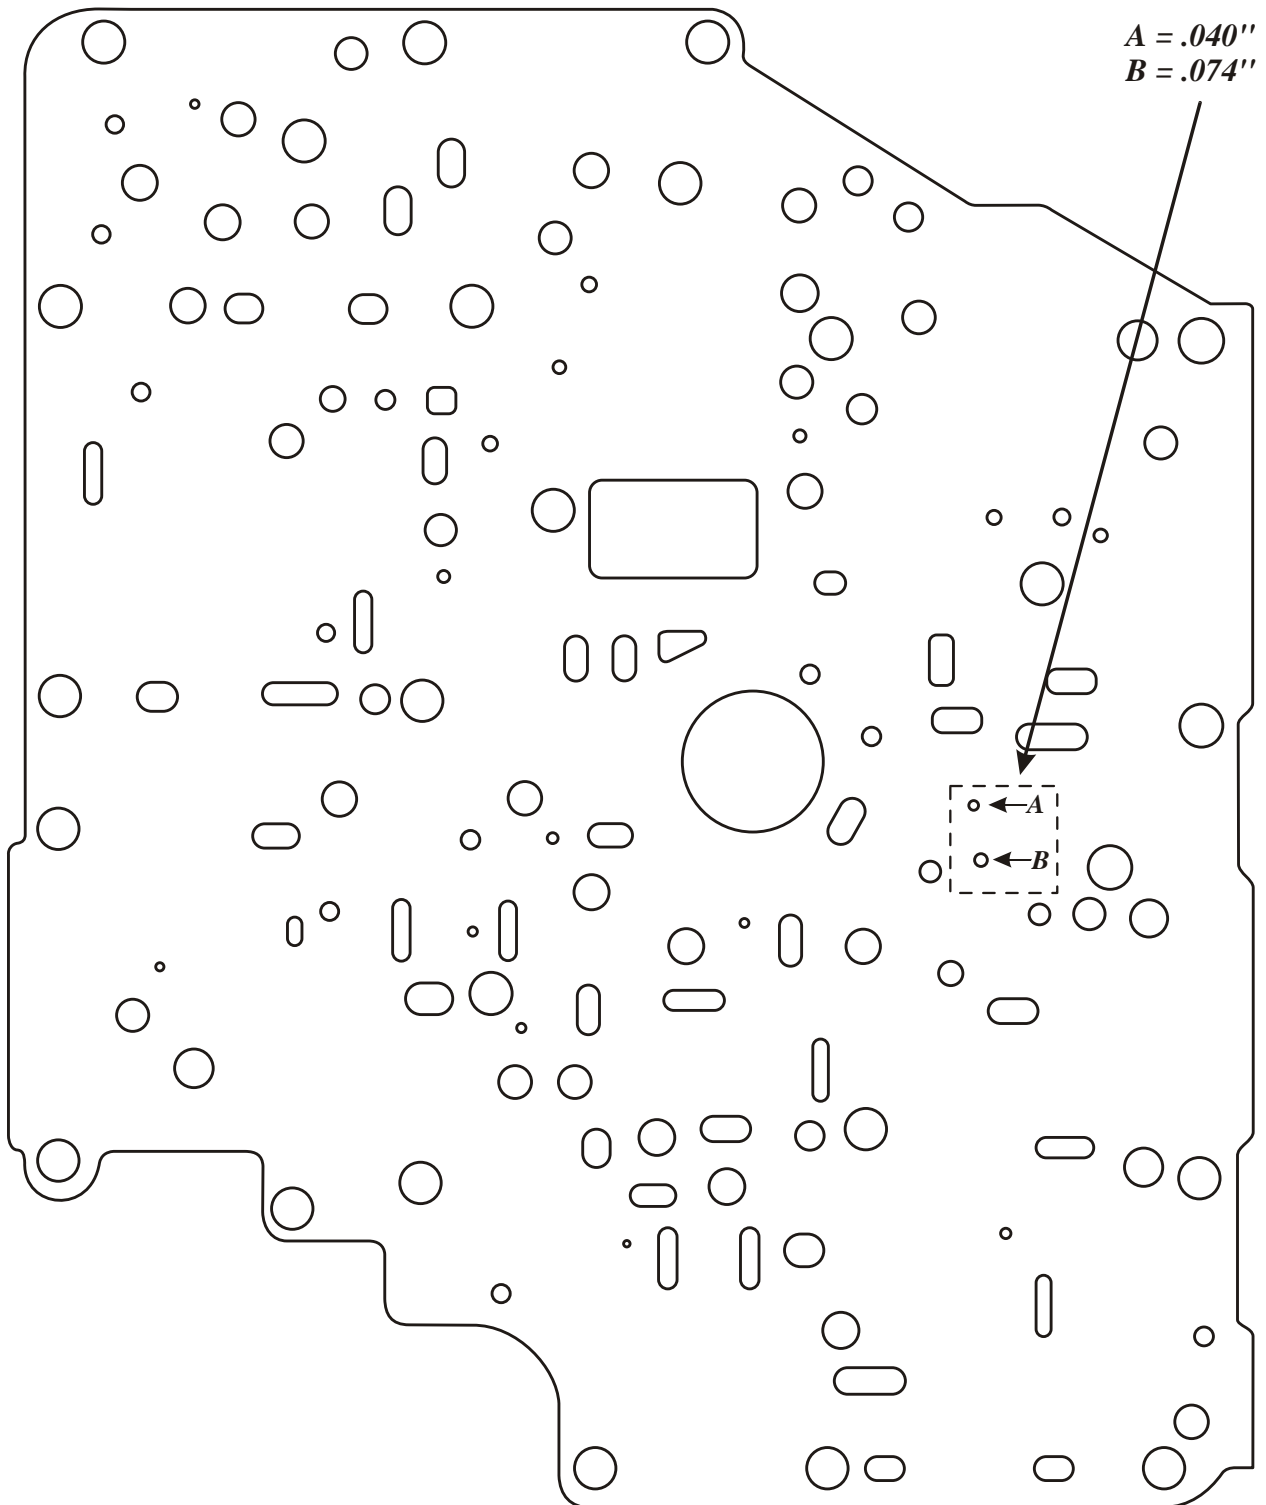
CAUSE: The cause may be, a valve body spacer plate designed for the Taurus, Sable, Continental passenger car family, has been installed on a Windstar Van, creating a harsh 1-2 upshift. If the Windstar Van valve body spacer plate, is installed on the Taurus, Sable, Continental family of vehicles, the result will be a soft or flared 1-2 upshift. ***Obviously these two spacer plates are different.*** Refer to Figures 1 and 2, using the two holes over the 1-2 capacity modulator valve area, for identification.

"WINDSTAR" SPACER PLATE IDENTIFICATION

CORRECTION: Install the proper valve body spacer plate for the Ford family that you happen to be servicing at this time. Refer to the illustration in Figure 1 to identify the valve body spacer plate for the Windstar Van. Refer to the illustration in Figure 2 to identify the valve body spacer plate for the Taurus, Sable and Continental family.

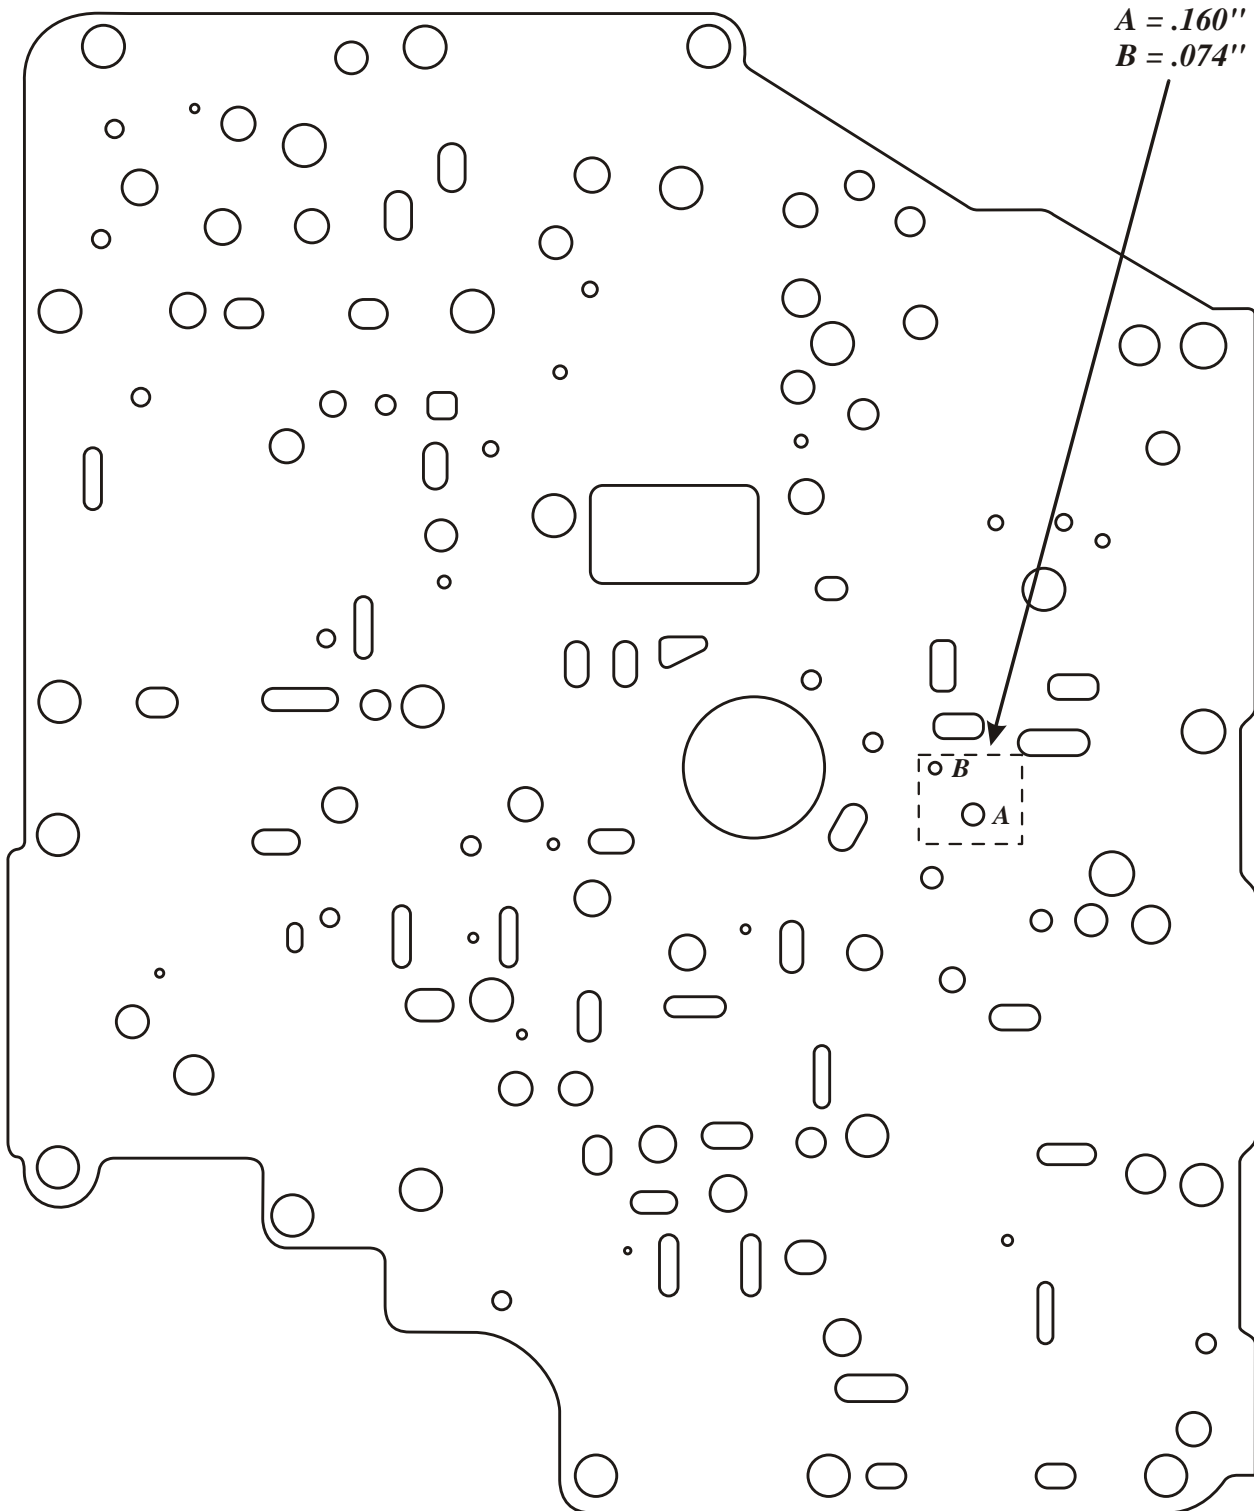
Figure 2

"TAURUS FAMILY" SPACER PLATE IDENTIFICATION
