## THM 4L30-E SLIPPING OR NO 2ND GEAR

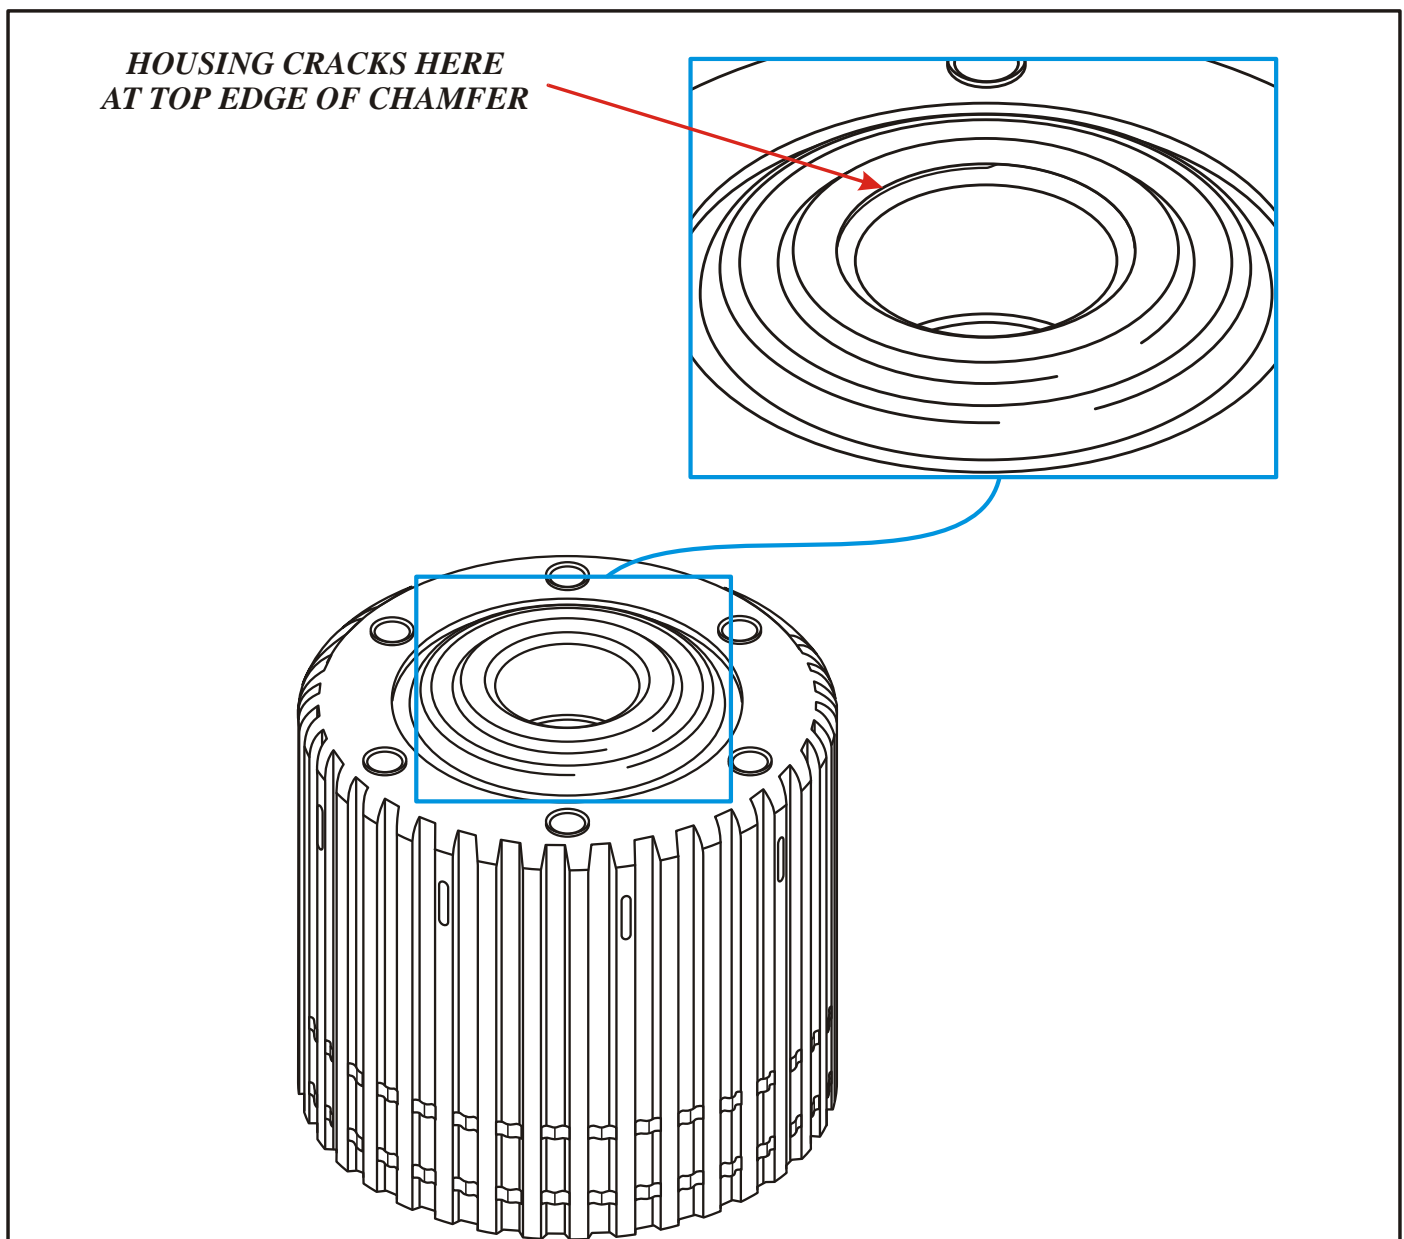
Figure 1

**COMPLAINT:** Before and/or after overhaul, the vehicle exhibits a slipping condition when going into second gear, or possibly no second gear at all.

**CAUSE:** The cause may be, a cracked 2nd clutch housing that is barely perceptible, as shown in Figure 1.

**CORRECTION:** Replace the 2nd clutch housing as necessary. Refer to Figure 1.
