Technical Service Information

THM 440-T4 REVISED THICKNESS "KOLINE" STEELS

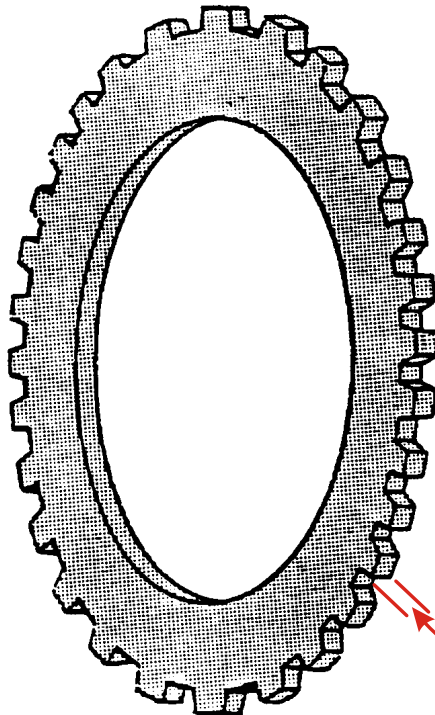
Figure 1

The 2nd clutch steel plates in the 440-T4 are unique, in that they are black in color. They have a black coating on them called "Koline" plating, for shift pleasibility (See Figure 1).

The thickness of the "Koline" plates were revised for the 1987 models, with the addition of the 6 plate clutch pack (See Figure 1).

84-86 - 5 Plate "Kolines" .090"
1987 - 6 Plate "Kolines" .077"

**REVISED PLATE
THICKNESS**

The 2nd clutch steel plates CANNOT be tumbled as it will remove the "Koline" plating. If the "Koline" plating is worn from the steel plates, they must be replaced.

Following are the proper OEM part numbers;

| 84-86 - 5 Plate "Koline" Steels..... | 8662309 |
| 1987 - 6 Plate "Koline" Steels..... | 8662006 |
