# Technical Service Information

## NISSAN RL3F01A STANZA 3-2 DOWN SHIFT CLUNK

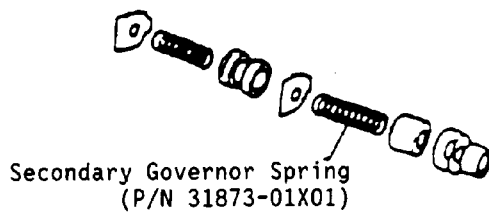
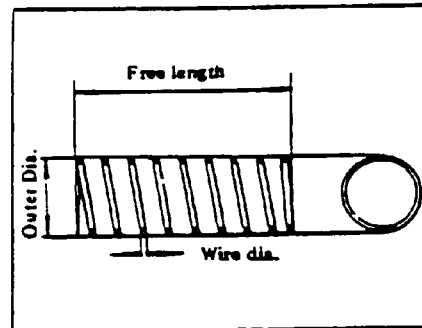
Figure 1

Governor valve spring chart

SPRING P/N	FREE LENGTH MM (IN)	WIRE DIA. MM (IN)	OUTER COIL DIA. MM (IN)
Former-31873-01X00	38.2 (1.504)	0.8 (0.031)	10.8 (0.425)
New -31873-01X01	41.0 (1.614)	0.8 (0.031)	10.8 (0.425)

**CORRECTION:** Install new Secondary Governor Spring, part # 31873-01X01
