# Technical Service Information

## CHRYSLER TRANSMISSIONS TESTING CONSISTENCY FROM 1989

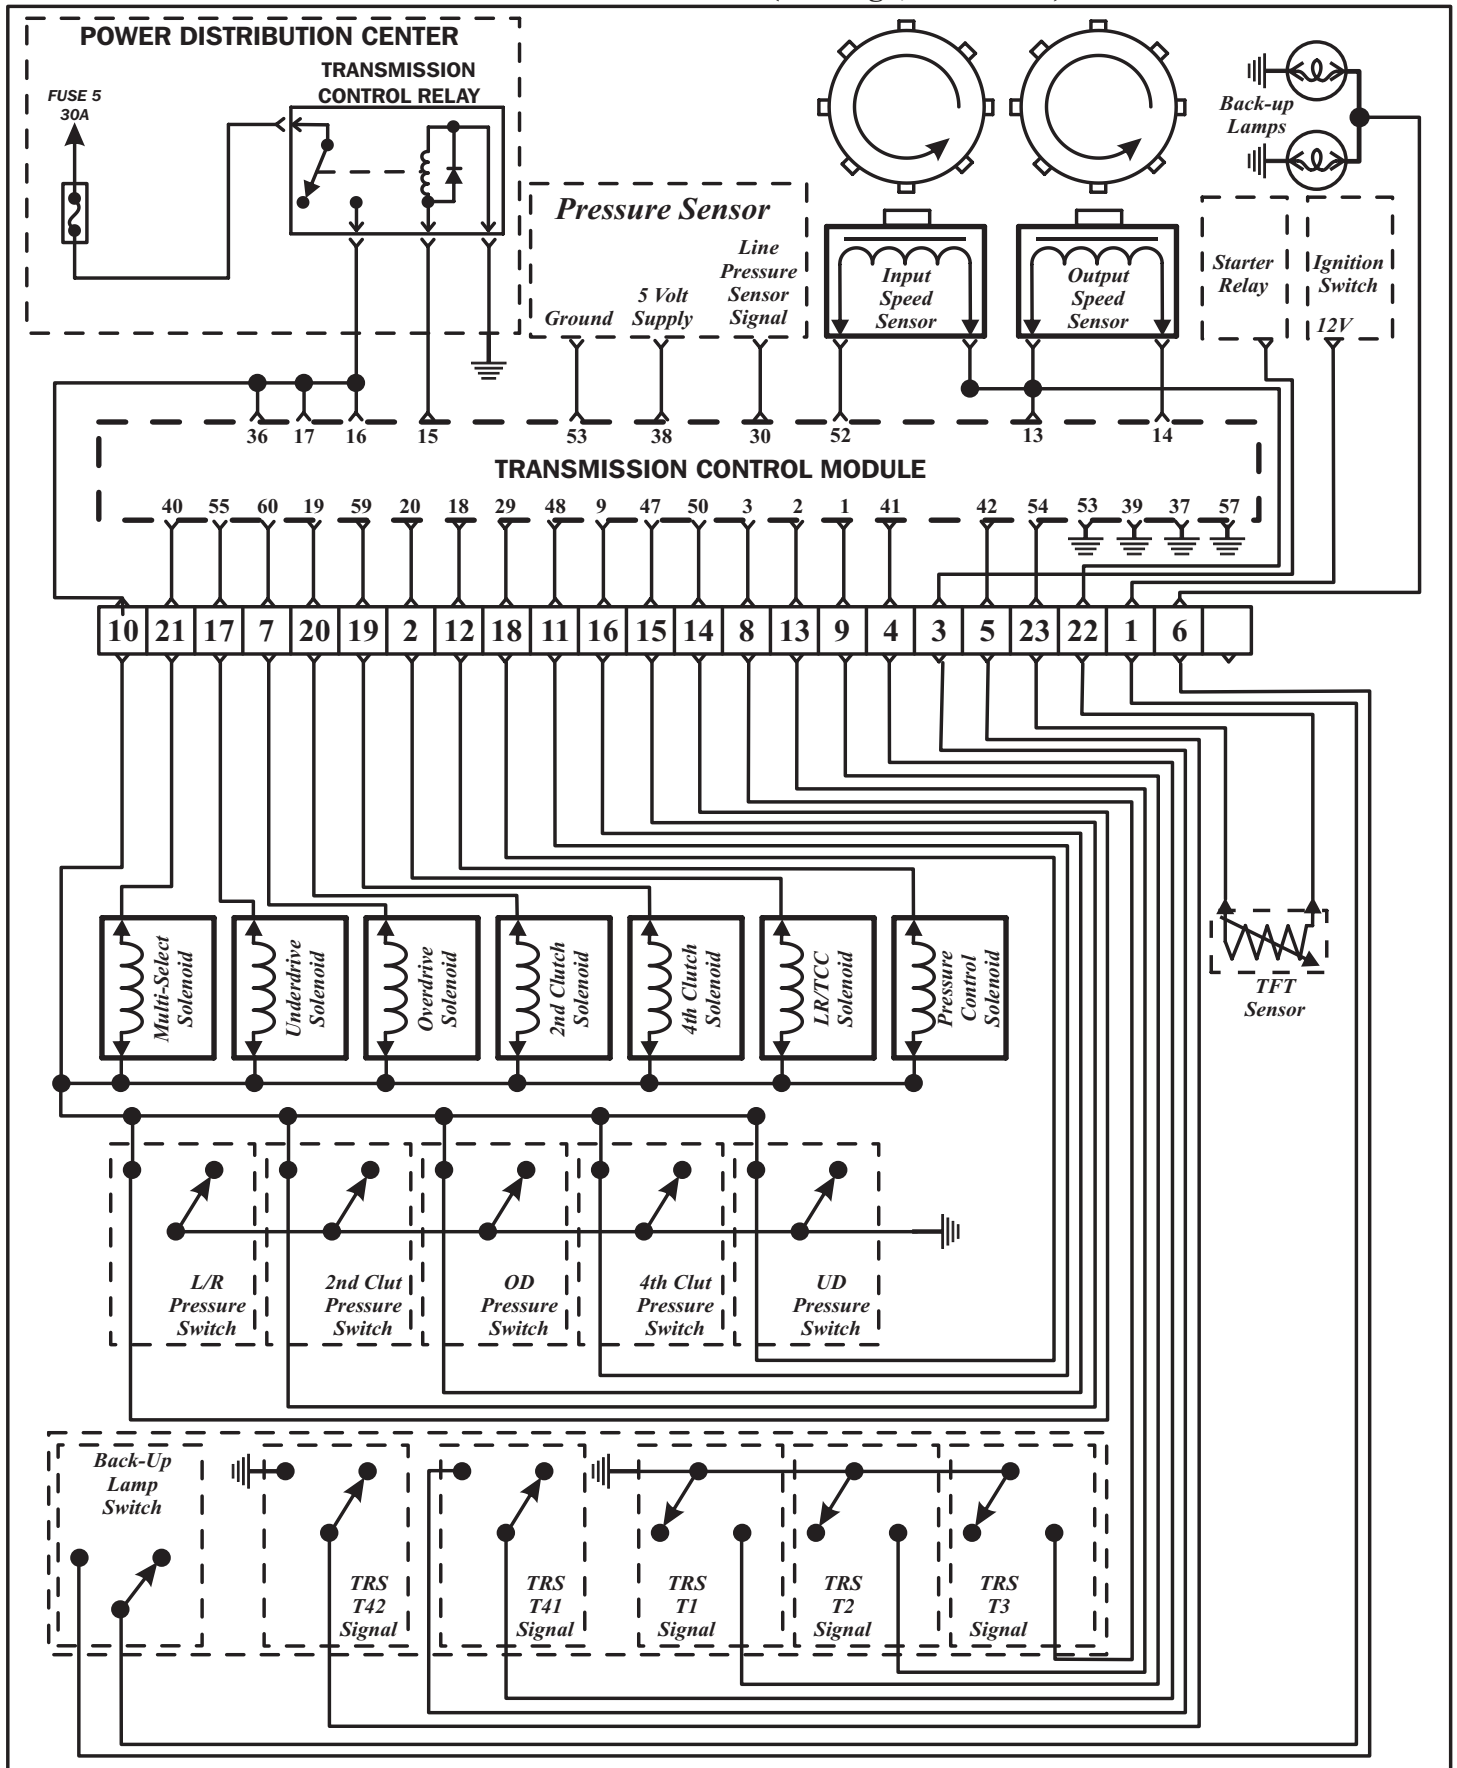
## TYPICAL 45RFE WIRING (Durango, Ram 3500)

By becoming familiar with the typical wiring diagrams provided in figures 2 through 6 and memorizing the terminals listed above, quick testing at the 60 way connector can be performed for a large number of vehicles spanning a period of 15 years without ever having to pull a wiring diagram such as the example given in Figure 1. The 45RFE has additional solenoids which caused a variation among the other three transmissions but as you can see two of the solenoids remained consistent. Quick testing can be done with all four of the transmissions with the Input and Output Speed sensors. Factory repair manuals provide a 300 to 1200 ohm value for these sensors but it has been ATSG's experience that they measure 500 to 600 ohms. Relay circuit testing is also the same with a slight exception for the 45RFE as there is one additional signal circuit at terminal 36.
