## FORD E4OD FORWARD CLUTCH RETURN SPRING

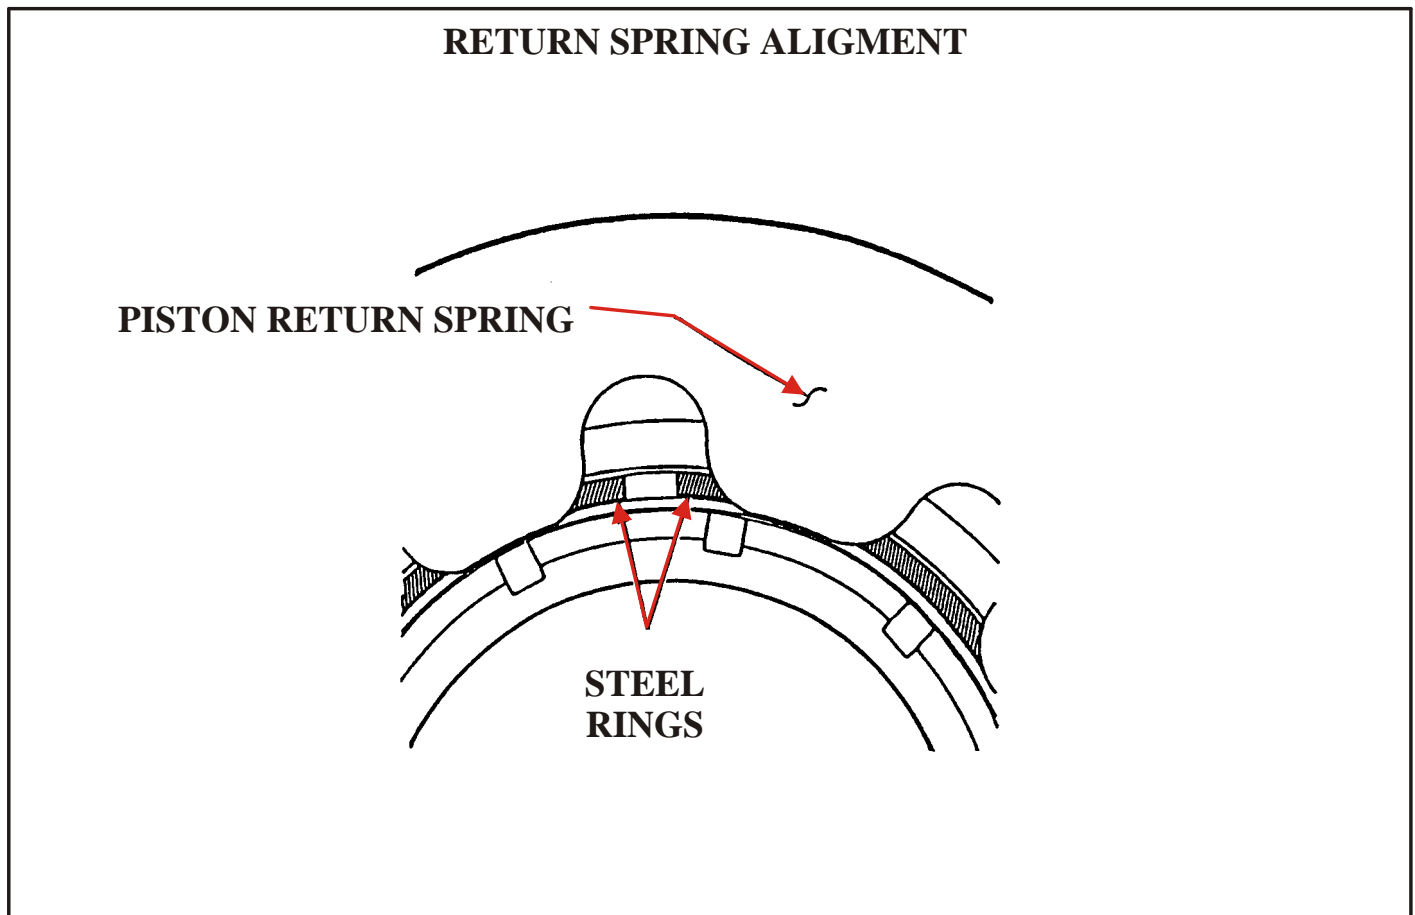
Figure 1

**COMPLAINT:** Forward clutch piston return spring fatigued, worn, and/or broken.

**CAUSE:** Improper orientation of steel ring on top of the forward clutch piston, and the forward clutch piston return spring.

**CORRECTION:** Position the forward clutch piston return spring so that both ends of the steel ring are visible within the space between the two adjacent fingers of the return spacing as shown in Figure 1.
