# Durchlasstest

VIP Mask

S015\_2

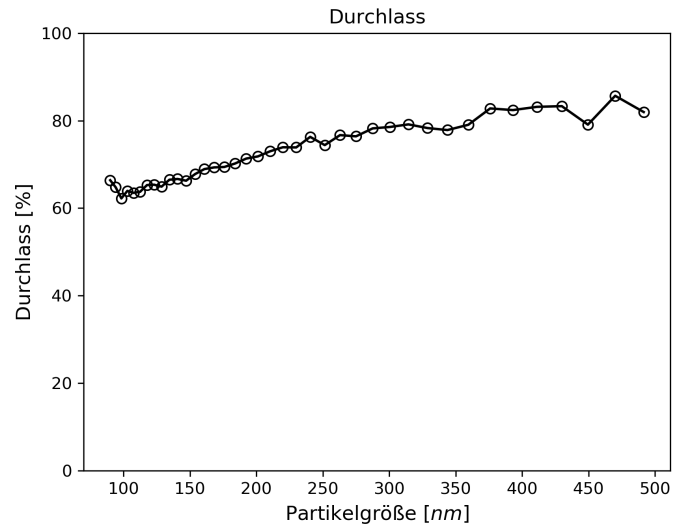
| Durchlass | 76.69 |
| Messzeit | 180 sec |

Holes around the mask edges are not completely closed, but it probably does not affect the measurement
