Unnamed tributary		ok-0526-r-001	Sedimentation Risk Index 48																																																																		
<u>Common:</u> 6.6mi W of Laurel Hill <u>Drainage:</u> Yellow River <u>GPS:</u> 30.960997, -86.571319 <u>Land owner:</u> Cennie Stokes		<u>County:</u> Okaloosa <u>State:</u> Florida <u>PLSS(T-R-S):</u> 5N-23-05 <u>Parcel No.:</u> 6 <u>Road Name:</u> Yellow Baptist Church Rd

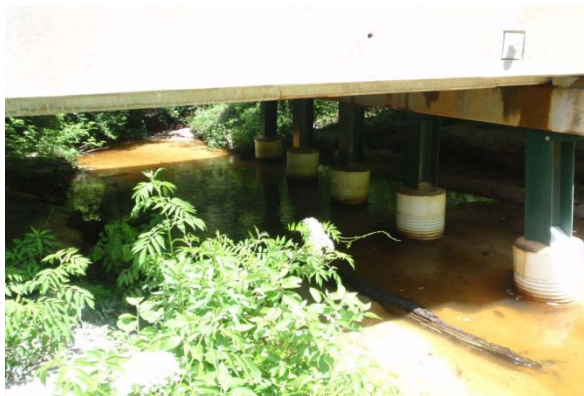
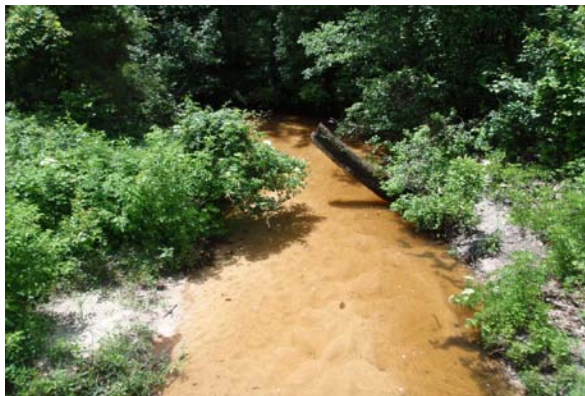
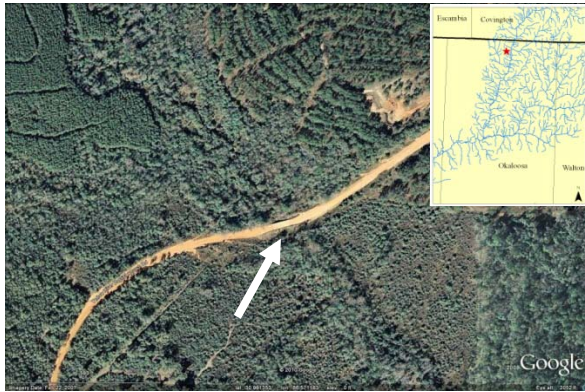
Crossing Structure: DS		DS																																																																			
<table border="1"> <thead> <tr> <th>Risk Factor</th> <th>Ranking</th> <th>Score</th> </tr> </thead> <tbody> <tr><td>US Channel Morph</td><td>C</td><td>5</td></tr> <tr><td>DS Channel Morph</td><td>C</td><td>5</td></tr> <tr><td>DS Bank Alteration</td><td>MINOR/PARTIAL</td><td>3</td></tr> <tr><td>Upstream Skew Angle</td><td><5°</td><td>5</td></tr> <tr><td>Crossing fill condition</td><td>Good/Vegetated</td><td>5</td></tr> <tr><td>Inlet/Outlet Condition</td><td>No Impairment</td><td>5</td></tr> <tr><td>Road Approach Material</td><td>All Sand/Clay</td><td>3</td></tr> <tr><td>Potential Eroded Volume Mean</td><td>>40 y³</td><td>1</td></tr> <tr><td>Approach Slope Mean</td><td>>4%</td><td>1</td></tr> <tr><td>Soil K Factor</td><td><0.20</td><td>5</td></tr> <tr><td>Upstream Rt Outlet</td><td>Vegetated</td><td>1</td></tr> <tr><td>Upstream Lt Outlet</td><td>Vegetated</td><td>1</td></tr> <tr><td>Upstream Rt Ditch</td><td>Vegetated</td><td>1</td></tr> <tr><td>Upstream Lt Ditch</td><td>Vegetated</td><td>1</td></tr> <tr><td>Downstream Rt Outlet</td><td>Vegetated</td><td>1</td></tr> <tr><td>Downstream Lt Outlet</td><td>Vegetated</td><td>1</td></tr> <tr><td>Downstream Rt Ditch</td><td>Vegetated</td><td>1</td></tr> <tr><td>Downstream Lt Ditch</td><td>Vegetated</td><td>1</td></tr> <tr><td>Outlet Total</td><td>Improved Outlet System</td><td>5</td></tr> <tr><td>Ditches Total</td><td>Improved Drainage System</td><td>5</td></tr> <tr><td>SRI Total</td><td>Low Risk</td><td>48</td></tr> </tbody> </table>		Risk Factor	Ranking	Score	US Channel Morph	C	5	DS Channel Morph	C	5	DS Bank Alteration	MINOR/PARTIAL	3	Upstream Skew Angle	<5°	5	Crossing fill condition	Good/Vegetated	5	Inlet/Outlet Condition	No Impairment	5	Road Approach Material	All Sand/Clay	3	Potential Eroded Volume Mean	>40 y ³	1	Approach Slope Mean	>4%	1	Soil K Factor	<0.20	5	Upstream Rt Outlet	Vegetated	1	Upstream Lt Outlet	Vegetated	1	Upstream Rt Ditch	Vegetated	1	Upstream Lt Ditch	Vegetated	1	Downstream Rt Outlet	Vegetated	1	Downstream Lt Outlet	Vegetated	1	Downstream Rt Ditch	Vegetated	1	Downstream Lt Ditch	Vegetated	1	Outlet Total	Improved Outlet System	5	Ditches Total	Improved Drainage System	5	SRI Total	Low Risk	48

Risk Factor	Ranking	Score																																																																			
US Channel Morph	C	5																																																																			
DS Channel Morph	C	5																																																																			
DS Bank Alteration	MINOR/PARTIAL	3																																																																			
Upstream Skew Angle	<5°	5																																																																			
Crossing fill condition	Good/Vegetated	5																																																																			
Inlet/Outlet Condition	No Impairment	5																																																																			
Road Approach Material	All Sand/Clay	3																																																																			
Potential Eroded Volume Mean	>40 y ³	1																																																																			
Approach Slope Mean	>4%	1

Soil K Factor	<0.20	5																																																																			
Upstream Rt Outlet	Vegetated	1																																																																			
Upstream Lt Outlet	Vegetated	1																																																																			
Upstream Rt Ditch	Vegetated	1																																																																			
Upstream Lt Ditch	Vegetated	1																																																																			
Downstream Rt Outlet	Vegetated	1																																																																			
Downstream Lt Outlet	Vegetated	1																																																																			
Downstream Rt Ditch	Vegetated	1																																																																			
Downstream Lt Ditch	Vegetated	1																																																																			
Outlet Total	Improved Outlet System	5

Ditches Total	Improved Drainage System	5																																																																			
SRI Total	Low Risk	48																																																																			
Additional Site Features <u>Crossing Type and Quantity:</u> Bridge, 1 <u>Crossing Materials:</u> Reinforced Concrete <u>Soil Types:</u> 12,16,23,24,37,43,46,49,50 <u>Rt Approach Prism Fill:</u> 1.0in <u>Lt Approach Prism Fill:</u> 1.0in		<table border="1"> <thead> <tr> <th>Feature</th> <th>Within Range</th> <th>Descriptive Field</th> </tr> </thead> <tbody> <tr> <td>303(d)</td> <td>No</td> <td>N/A</td> </tr> <tr> <td>Wetland Species</td> <td>Yes</td> <td>1-3 FOCAL SPECIES IN UPLAND AREAS</td> </tr> <tr> <td>Rare and Imperiled</td> <td>No</td> <td>N/A</td> </tr> <tr> <td>Land Use/Cover</td> <td>Yes</td> <td>ACREAGE NOT ZONED FOR AGRICULTURE / WETLAND FORESTED MIX</td> </tr> <tr> <td>Candidate Mussels</td> <td>No</td> <td>N/A</td> </tr> <tr> <td>Sturgeon C.H.</td> <td>No</td> <td>N/A</td> </tr> </tbody> </table>		Feature	Within Range	Descriptive Field	303(d)	No	N/A	Wetland Species	Yes	1-3 FOCAL SPECIES IN UPLAND AREAS	Rare and Imperiled	No	N/A	Land Use/Cover	Yes	ACREAGE NOT ZONED FOR AGRICULTURE / WETLAND FORESTED MIX	Candidate Mussels	No	N/A	Sturgeon C.H.	No	N/A
