Lightwood Knot Creek		co-1102-r-013	Sedimentation Risk Index <b>50</b>																																																																		
<u>Common:</u> 4.4mi E of Five Points <u>Drainage:</u> Yellow River <u>GPS:</u> 31.440008403,-86.229630273 <u>Land owner:</u> H&MM North, Willis Powell South		<u>County:</u> Covington <u>State:</u> Alabama <u>PLSS (T-R-S):</u> 5N-18E-3 <u>Parcel No.:</u> 1.01, 1 <u>Road Name:</u> Hudson Rd

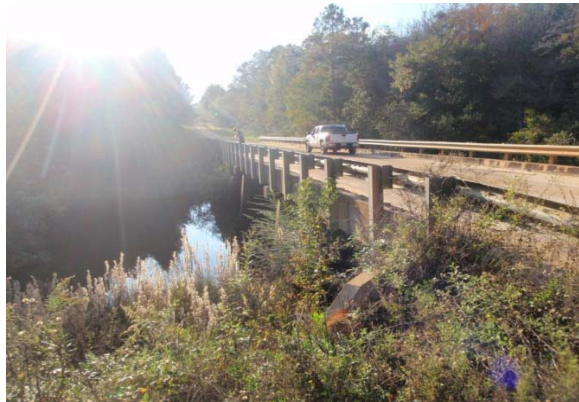
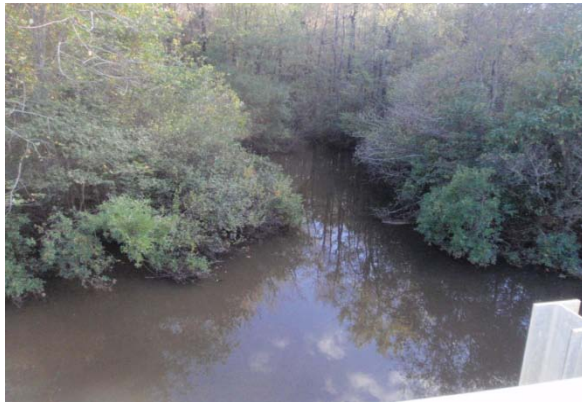
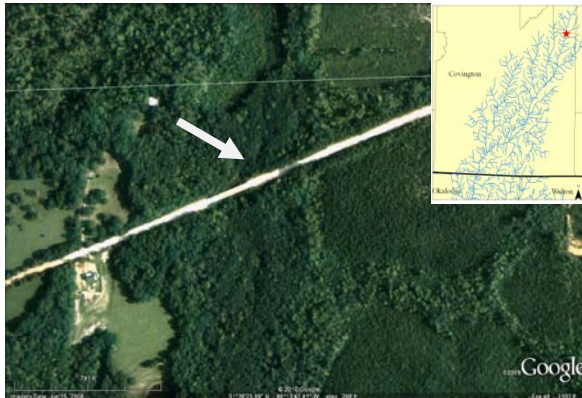
Crossing Structure: DS		DS																																																																			
<table border="1"> <thead> <tr> <th>Risk Factor</th> <th>Ranking</th> <th>Score</th> </tr> </thead> <tbody> <tr><td>US Channel Morph</td><td>WETLAND</td><td>5</td></tr> <tr><td>DS Channel Morph</td><td>WETLAND</td><td>5</td></tr> <tr><td>DS Bank Alteration</td><td>MINOR/PARTIAL</td><td>3</td></tr> <tr><td>Upstream Skew Angle</td><td>&lt;5°</td><td>5</td></tr> <tr><td>Crossing fill condition</td><td>Fair/Rip Rap</td><td>3</td></tr> <tr><td>Inlet/Outlet Condition</td><td>No Impairment</td><td>5</td></tr> <tr><td>Road Approach Material</td><td>All Aggregate</td><td>5</td></tr> <tr><td>Potential Eroded Volume Mean</td><td>&gt;40 y<sup>3</sup></td><td>1</td></tr> <tr><td>Approach Slope Mean</td><td>2.1-4%</td><td>3</td></tr> <tr><td>Soil K Factor</td><td>&lt;0.20</td><td>5</td></tr> <tr><td>Upstream Rt Outlet</td><td>Vegetated</td><td>1</td></tr> <tr><td>Upstream Lt Outlet</td><td>Vegetated</td><td>1</td></tr> <tr><td>Upstream Rt Ditch</td><td>Vegetated</td><td>1</td></tr> <tr><td>Upstream Lt Ditch</td><td>Vegetated</td><td>1</td></tr> <tr><td>Downstream Rt Outlet</td><td>Vegetated</td><td>1</td></tr> <tr><td>Downstream Lt Outlet</td><td>Vegetated</td><td>1</td></tr> <tr><td>Downstream Rt Ditch</td><td>Vegetated</td><td>1</td></tr> <tr><td>Downstream Lt Ditch</td><td>Vegetated</td><td>1</td></tr> <tr><td>Outlet Total</td><td>Improved Outlet System</td><td>5</td></tr> <tr><td>Ditches Total</td><td>Improved Drainage System</td><td>5</td></tr> <tr><td><b>SRI Total</b></td><td><b>Low Risk</b></td><td><b>50</b></td></tr> </tbody> </table>		Risk Factor	Ranking	Score	US Channel Morph	WETLAND	5	DS Channel Morph	WETLAND	5	DS Bank Alteration	MINOR/PARTIAL	3	Upstream Skew Angle	<5°	5	Crossing fill condition	Fair/Rip Rap	3	Inlet/Outlet Condition	No Impairment	5	Road Approach Material	All Aggregate	5	Potential Eroded Volume Mean	>40 y <sup>3</sup>	1	Approach Slope Mean	2.1-4%	3	Soil K Factor	<0.20	5	Upstream Rt Outlet	Vegetated	1	Upstream Lt Outlet	Vegetated	1	Upstream Rt Ditch	Vegetated	1	Upstream Lt Ditch	Vegetated	1	Downstream Rt Outlet	Vegetated	1	Downstream Lt Outlet	Vegetated	1	Downstream Rt Ditch	Vegetated	1	Downstream Lt Ditch	Vegetated	1	Outlet Total	Improved Outlet System	5	Ditches Total	Improved Drainage System	5	<b>SRI Total</b>	<b>Low Risk</b>	<b>50</b>

Risk Factor	Ranking	Score																																																																			
US Channel Morph	WETLAND	5																																																																			
DS Channel Morph	WETLAND	5																																																																			
DS Bank Alteration	MINOR/PARTIAL	3																																																																			
Upstream Skew Angle	<5°	5																																																																			
Crossing fill condition	Fair/Rip Rap	3																																																																			
Inlet/Outlet Condition	No Impairment	5																																																																			
Road Approach Material	All Aggregate	5																																																																			
Potential Eroded Volume Mean	>40 y <sup>3</sup>	1

Approach Slope Mean	2.1-4%	3																																																																			
Soil K Factor	<0.20	5																																																																			
Upstream Rt Outlet	Vegetated	1																																																																			
Upstream Lt Outlet	Vegetated	1																																																																			
Upstream Rt Ditch	Vegetated	1																																																																			
Upstream Lt Ditch	Vegetated	1																																																																			
Downstream Rt Outlet	Vegetated	1																																																																			
Downstream Lt Outlet	Vegetated	1																																																																			
Downstream Rt Ditch	Vegetated	1																																																																			
Downstream Lt Ditch	Vegetated	1

Outlet Total	Improved Outlet System	5																																																																			
Ditches Total	Improved Drainage System	5																																																																			
<b>SRI Total</b>	<b>Low Risk</b>	<b>50</b>																																																																			
<b>Additional Site Features</b> <u>Crossing Type and Quantity:</u> Bridge,1 <u>Crossing Materials:</u> Reinforced Concrete <u>Soil Types:</u> MBA,OrE,TrB,TrD <u>Rt Approach Prism Fill:</u> 0.25in <u>Lt Approach Prism Fill:</u> 0.25in		<table border="1"> <thead> <tr> <th>Feature</th> <th>Within Range</th> <th>Descriptive Field</th> </tr> </thead> <tbody> <tr><td>303(d)</td><td>No</td><td>N/A</td></tr> <tr><td>Wetland Species</td><td>No</td><td>N/A</td></tr> <tr><td>Rare and Imperiled</td><td>No</td><td>N/A</td></tr> <tr><td>Land Use/Cover</td><td>Yes</td><td>N/A/ DEVELOPED OPEN SPACE</td></tr> <tr><td>Candidate Mussels</td><td>No</td><td>N/A</td></tr> <tr><td>Sturgeon C.H.</td><td>No</td><td>N/A</td></tr> </tbody> </table>		Feature	Within Range	Descriptive Field	303(d)	No	N/A	Wetland Species	No	N/A	Rare and Imperiled	No	N/A	Land Use/Cover	Yes	N/A/ DEVELOPED OPEN SPACE	Candidate Mussels	No	N/A	Sturgeon C.H.	No	N/A
