Unnamed tributary		co-1104-r-002	Sedimentation Risk Index 46																																																																		
<u>Common:</u> 2.8mi NW of Friendship <u>Drainage:</u> Lightwood Knot <i>GPS:</i> 31.407215305,-86.253754894 <u>Land owner:</u> Hillary Brannen & Nancy Chalker		<u>County:</u> Covington <u>PLSS (T-R-S):</u> 5N-18E-16 <u>Parcel No.:</u> 1 <u>Road Name:</u> HDC Rd

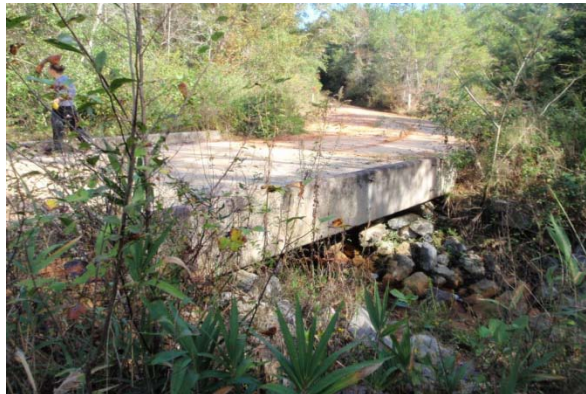
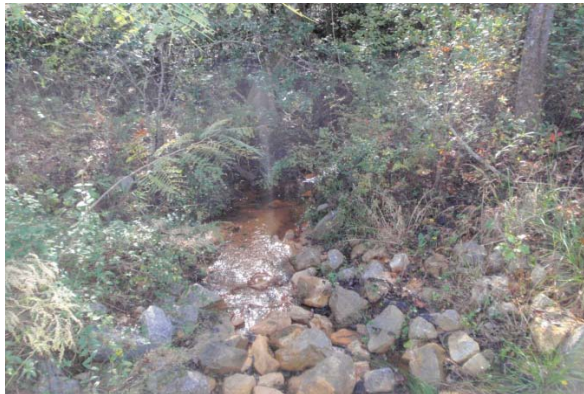
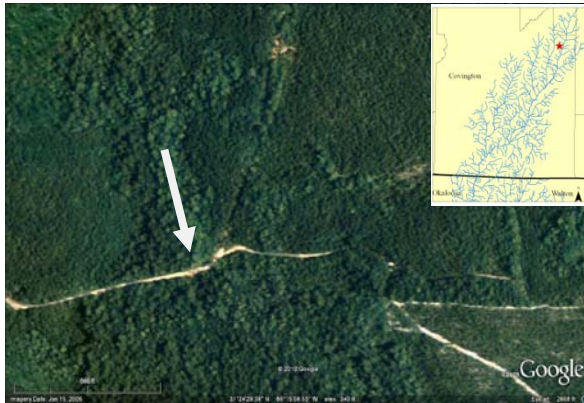
Crossing Structure: DS		DS																																																																			
<table border="1"> <thead> <tr> <th>Risk Factor</th> <th>Ranking</th> <th>Score</th> </tr> </thead> <tbody> <tr><td>US Channel Morph</td><td>E</td><td>5</td></tr> <tr><td>DS Channel Morph</td><td>E</td><td>5</td></tr> <tr><td>DS Bank Alteration</td><td>MINOR/PARTIAL</td><td>3</td></tr> <tr><td>Upstream Skew Angle</td><td><5°</td><td>5</td></tr> <tr><td>Crossing fill condition</td><td>Fair/Rip Rap</td><td>3</td></tr> <tr><td>Inlet/Outlet Condition</td><td>No Impairment</td><td>5</td></tr> <tr><td>Road Approach Material</td><td>All Sand/Clay</td><td>3</td></tr> <tr><td>Potential Eroded Volume Mean</td><td><21 y³</td><td>5</td></tr> <tr><td>Approach Slope Mean</td><td>2.1-4%</td><td>3</td></tr> <tr><td>Soil K Factor</td><td><0.20</td><td>5</td></tr> <tr><td>Upstream Rt Outlet</td><td>Vegetated</td><td>1</td></tr> <tr><td>Upstream Lt Outlet</td><td>Vegetated</td><td>1</td></tr> <tr><td>Upstream Rt Ditch</td><td>Bare soil</td><td>0</td></tr> <tr><td>Upstream Lt Ditch</td><td>Bare soil</td><td>0</td></tr> <tr><td>Downstream Rt Outlet</td><td>Bare soil</td><td>0</td></tr> <tr><td>Downstream Lt Outlet</td><td>Bare soil</td><td>0</td></tr> <tr><td>Downstream Rt Ditch</td><td>Bare soil</td><td>0</td></tr> <tr><td>Downstream Lt Ditch</td><td>Bare soil</td><td>0</td></tr> <tr><td>Outlet Total</td><td>Partially Improved Outlet System</td><td>3</td></tr> <tr><td>Ditches Total</td><td>Unimproved Drainage System</td><td>1</td></tr> <tr><td>SRI Total</td><td>Low Risk</td><td>46</td></tr> </tbody> </table>		Risk Factor	Ranking	Score	US Channel Morph	E	5	DS Channel Morph	E	5	DS Bank Alteration	MINOR/PARTIAL	3	Upstream Skew Angle	<5°	5	Crossing fill condition	Fair/Rip Rap	3	Inlet/Outlet Condition	No Impairment	5	Road Approach Material	All Sand/Clay	3	Potential Eroded Volume Mean	<21 y ³	5	Approach Slope Mean	2.1-4%	3	Soil K Factor	<0.20	5	Upstream Rt Outlet	Vegetated	1	Upstream Lt Outlet	Vegetated	1	Upstream Rt Ditch	Bare soil	0	Upstream Lt Ditch	Bare soil	0	Downstream Rt Outlet	Bare soil	0	Downstream Lt Outlet	Bare soil	0	Downstream Rt Ditch	Bare soil	0	Downstream Lt Ditch	Bare soil	0	Outlet Total	Partially Improved Outlet System	3	Ditches Total	Unimproved Drainage System	1	SRI Total	Low Risk	46

Notes: Rip rap in downstream creating partial fish passage barrier.
