Unnamed tributary		co-0904-r-011	Sedimentation Risk Index 46																																																																		
<u>Common:</u> 8.0mi SE of Andalusia <u>Drainage:</u> Yellow River <i>GPS:</i> 31.223841314, -86.390269522 <u>Land owner:</u> Louise & Tip Grider -US, John E. Vick -DS		<u>County:</u> Covington <u>State:</u> Alabama <u>PLSS (T-R-S):</u> 3N-17E-18 <u>Parcel No.:</u> 5;7 <u>Road Name:</u> Lost Forty Rd

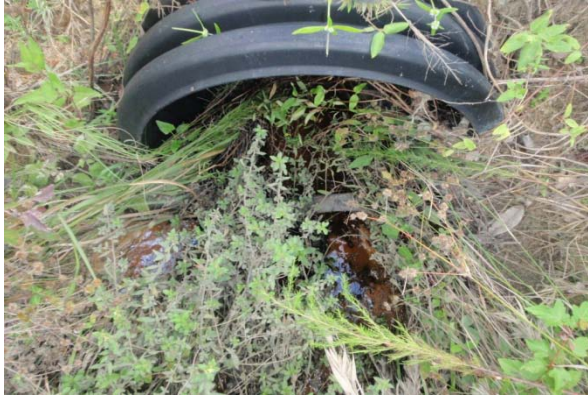
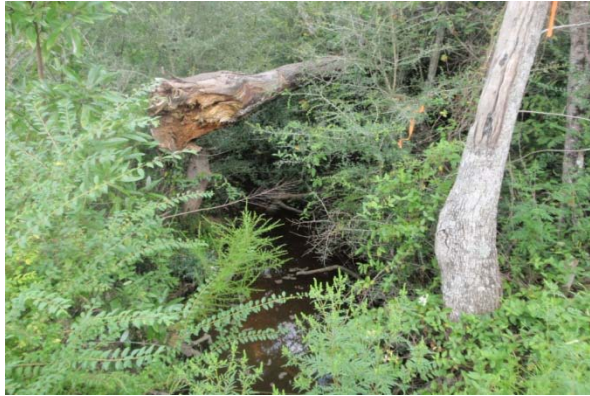
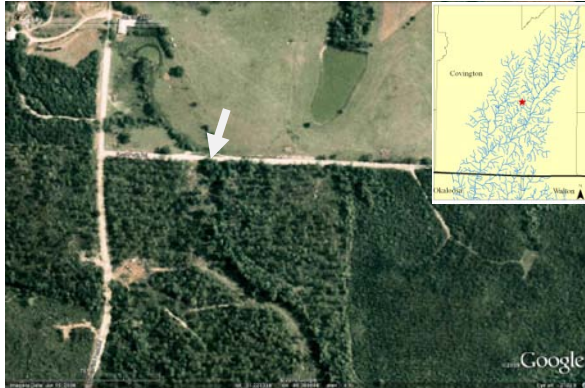
Risk Factor	Ranking	Score																																																																			
US Channel Morph	E	5																																																																			
DS Channel Morph	E	5																																																																			
DS Bank Alteration	NATURAL	5																																																																			
Upstream Skew Angle	5-30°	3																																																																			
Crossing fill condition	Poor/Bare soil	1																																																																			
Inlet/Outlet Condition	No Impairment	5																																																																			
Road Approach Material	All Sand/Clay	3																																																																			
Potential Eroded Volume Mean	<21 y ³	5																																																																			
Approach Slope Mean	2.1-4%	3

Soil K Factor	<0.20	5																																																																			
Upstream Rt Outlet	Vegetated	1																																																																			
Upstream Lt Outlet	Vegetated	1																																																																			
Upstream Rt Ditch	Bare soil	0																																																																			
Upstream Lt Ditch	Vegetated	1																																																																			
Downstream Rt Outlet	Bare soil	0																																																																			
Downstream Lt Outlet	Bare soil	0																																																																			
Downstream Rt Ditch	Bare soil	0																																																																			
Downstream Lt Ditch	Bare soil	0																																																																			
Outlet Total	Partially Improved Outlet System	3

Ditches Total	Partially Improved Drainage System	3																																																																			
SRI Total	Low Risk	46																																																																			
Additional Site Features <u>Crossing Type and Quantity:</u> Culvert, 1 <u>Crossing Materials:</u> PVC <u>Soil Types:</u> BnB,BnC,CdB,FuB <u>Rt Approach Prism Fill:</u> 0.1in <u>Lt Approach Prism Fill:</u> 0.25in		<table border="1"> <thead> <tr> <th>Feature</th> <th>Within Range</th> <th>Descriptive Field</th> </tr> </thead> <tbody> <tr><td>303(d)</td><td>No</td><td>N/A</td></tr> <tr><td>Wetland Species</td><td>No</td><td>N/A</td></tr> <tr><td>Rare and Imperiled</td><td>No</td><td>N/A</td></tr> <tr><td>Land Use/Cover</td><td>Yes</td><td>N/A/ EAST GULF COASTAL PLAIN INTERIOR UPLAND LONGLEAF PINE WOODLAND- OFFSITE HARDWOOD MODIFIER</td></tr> <tr><td>Candidate Mussels</td><td>No</td><td>N/A</td></tr> <tr><td>Sturgeon C.H.</td><td>No</td><td>N/A</td></tr> </tbody> </table>		Feature	Within Range	Descriptive Field	303(d)	No	N/A	Wetland Species	No	N/A	Rare and Imperiled	No	N/A	Land Use/Cover	Yes	N/A/ EAST GULF COASTAL PLAIN INTERIOR UPLAND LONGLEAF PINE WOODLAND- OFFSITE HARDWOOD MODIFIER	Candidate Mussels	No	N/A	Sturgeon C.H.	No	N/A
