Unnamed tributary		co-1029-r-005	Sedimentation Risk Index 50																																																																		
<u>Common:</u> 7.8mi NE of Andalusia <u>Drainage:</u> Yellow River <u>GPS:</u> 31.349427806, -86.359341040 <u>Land owner:</u> Smith Family, Tr. -US, W.H. Lola Owens-DS		<u>County:</u> Covington <u>State:</u> Alabama <u>PLSS (T-R-S):</u> 4N-17E-4 <u>Parcel No.:</u> 2; 3.41 <u>Road Name:</u> E.J. Ready Rd

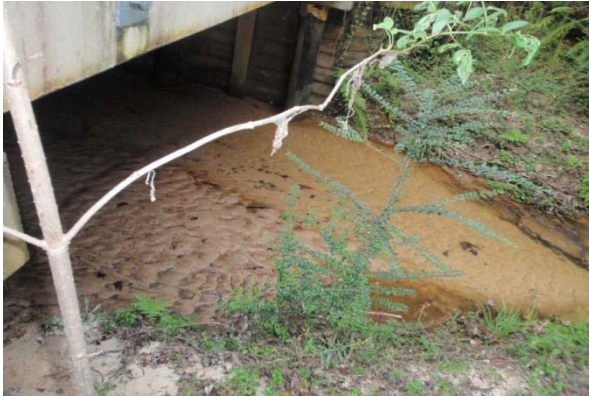
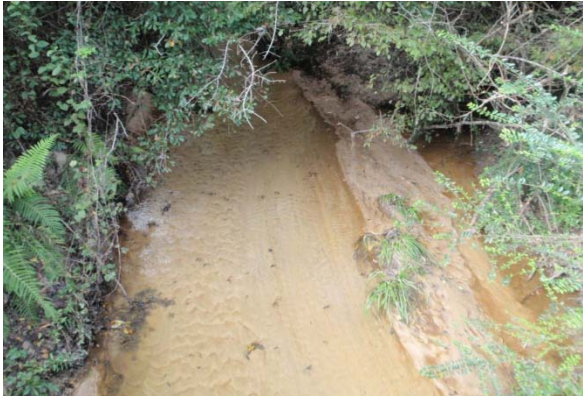
Crossing Structure: DS		US																																																																			
<table border="1"> <thead> <tr> <th>Risk Factor</th> <th>Ranking</th> <th>Score</th> </tr> </thead> <tbody> <tr><td>US Channel Morph</td><td>E</td><td>5</td></tr> <tr><td>DS Channel Morph</td><td>E</td><td>5</td></tr> <tr><td>DS Bank Alteration</td><td>MINOR/PARTIAL</td><td>3</td></tr> <tr><td>Upstream Skew Angle</td><td><5°</td><td>5</td></tr> <tr><td>Crossing fill condition</td><td>Good/Vegetated</td><td>5</td></tr> <tr><td>Inlet/Outlet Condition</td><td>No Impairment</td><td>5</td></tr> <tr><td>Road Approach Material</td><td>All Aggregate</td><td>5</td></tr> <tr><td>Potential Eroded Volume Mean</td><td><21 y³</td><td>5</td></tr> <tr><td>Approach Slope Mean</td><td>>4%</td><td>1</td></tr> <tr><td>Soil K Factor</td><td><0.20</td><td>5</td></tr> <tr><td>Upstream Rt Outlet</td><td>Vegetated</td><td>1</td></tr> <tr><td>Upstream Lt Outlet</td><td>Vegetated</td><td>1</td></tr> <tr><td>Upstream Rt Ditch</td><td>Bare soil</td><td>0</td></tr> <tr><td>Upstream Lt Ditch</td><td>Bare soil</td><td>0</td></tr> <tr><td>Downstream Rt Outlet</td><td>Vegetated</td><td>1</td></tr> <tr><td>Downstream Lt Outlet</td><td>Vegetated</td><td>1</td></tr> <tr><td>Downstream Rt Ditch</td><td>Bare soil</td><td>0</td></tr> <tr><td>Downstream Lt Ditch</td><td>Bare soil</td><td>0</td></tr> <tr><td>Outlet Total</td><td>Improved Outlet System</td><td>5</td></tr> <tr><td>Ditches Total</td><td>Unimproved Drainage System</td><td>1</td></tr> <tr><td>SRI Total</td><td>Low Risk</td><td>50</td></tr> </tbody> </table>		Risk Factor	Ranking	Score	US Channel Morph	E	5	DS Channel Morph	E	5	DS Bank Alteration	MINOR/PARTIAL	3	Upstream Skew Angle	<5°	5	Crossing fill condition	Good/Vegetated	5	Inlet/Outlet Condition	No Impairment	5	Road Approach Material	All Aggregate	5	Potential Eroded Volume Mean	<21 y ³	5	Approach Slope Mean	>4%	1	Soil K Factor	<0.20	5	Upstream Rt Outlet	Vegetated	1	Upstream Lt Outlet	Vegetated	1	Upstream Rt Ditch	Bare soil	0	Upstream Lt Ditch	Bare soil	0	Downstream Rt Outlet	Vegetated	1	Downstream Lt Outlet	Vegetated	1	Downstream Rt Ditch	Bare soil	0	Downstream Lt Ditch	Bare soil	0	Outlet Total	Improved Outlet System	5	Ditches Total	Unimproved Drainage System	1	SRI Total	Low Risk	50
