Unnamed tributary		wa-0714-r-005	Sedimentation Risk Index 44																																																																		
<u>Common:</u> 9.8mi NW of DeFuniak Springs <u>Drainage:</u> Big Swamp Creek <u>GPS:</u> 30.843701, -86.197376 <u>Land owner:</u> Vivian Worley-US, Juanita Courtney-DS		<u>County:</u> Walton <u>State:</u> Florida <u>PLSS(T-R-S):</u> 4N-20-13 <u>Parcel No.:</u> 3; 5 <u>Road Name:</u> Price Rd

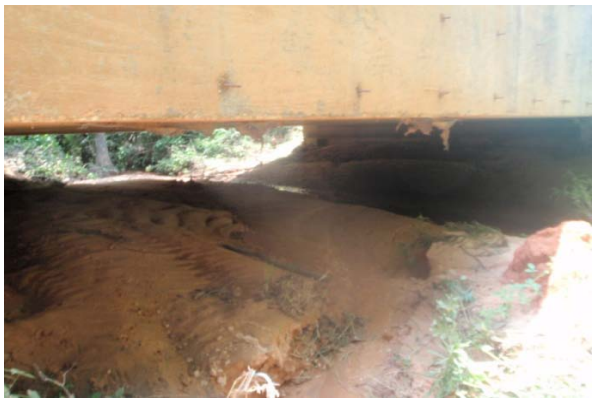
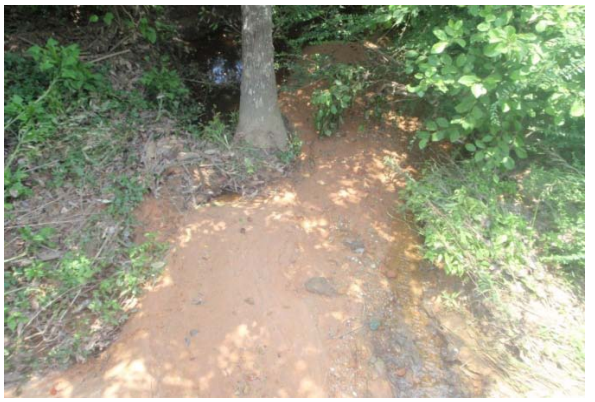
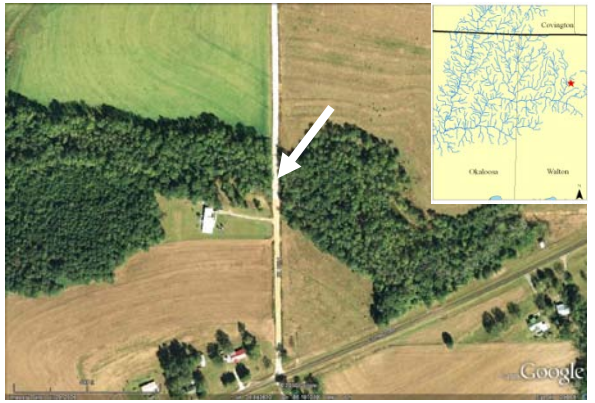
Crossing Structure: DS		DS																																																																			
<table border="1"> <thead> <tr> <th>Risk Factor</th> <th>Ranking</th> <th>Score</th> </tr> </thead> <tbody> <tr><td>US Channel Morph</td><td>DA</td><td>3</td></tr> <tr><td>DS Channel Morph</td><td>DA</td><td>3</td></tr> <tr><td>DS Bank Alteration</td><td>MINOR/PARTIAL</td><td>3</td></tr> <tr><td>Upstream Skew Angle</td><td><5°</td><td>5</td></tr> <tr><td>Crossing fill condition</td><td>Good/Vegetated</td><td>5</td></tr> <tr><td>Inlet/Outlet Condition</td><td>Sed Islands/Scouring</td><td>3</td></tr> <tr><td>Road Approach Material</td><td>All Aggregate</td><td>5</td></tr> <tr><td>Potential Eroded Volume Mean</td><td><21 y³</td><td>5</td></tr> <tr><td>Approach Slope Mean</td><td>2.1-4%</td><td>3</td></tr> <tr><td>Soil K Factor</td><td><0.20</td><td>5</td></tr> <tr><td>Upstream Rt Outlet</td><td>Vegetated</td><td>1</td></tr> <tr><td>Upstream Lt Outlet</td><td>Vegetated</td><td>1</td></tr> <tr><td>Upstream Rt Ditch</td><td>Bare soil</td><td>0</td></tr> <tr><td>Upstream Lt Ditch</td><td>Bare soil</td><td>0</td></tr> <tr><td>Downstream Rt Outlet</td><td>Bare soil</td><td>0</td></tr> <tr><td>Downstream Lt Outlet</td><td>Vegetated</td><td>1</td></tr> <tr><td>Downstream Rt Ditch</td><td>Bare soil</td><td>0</td></tr> <tr><td>Downstream Lt Ditch</td><td>Bare soil</td><td>0</td></tr> <tr><td>Outlet Total</td><td>Partially Improved Outlet System</td><td>3</td></tr> <tr><td>Ditches Total</td><td>Unimproved Drainage System</td><td>1</td></tr> <tr><td>SRI Total</td><td>Medium Risk</td><td>44</td></tr> </tbody> </table>				Risk Factor	Ranking	Score	US Channel Morph	DA	3	DS Channel Morph	DA	3	DS Bank Alteration	MINOR/PARTIAL	3	Upstream Skew Angle	<5°	5	Crossing fill condition	Good/Vegetated	5	Inlet/Outlet Condition	Sed Islands/Scouring	3	Road Approach Material	All Aggregate	5	Potential Eroded Volume Mean	<21 y ³	5	Approach Slope Mean	2.1-4%	3	Soil K Factor	<0.20	5	Upstream Rt Outlet	Vegetated	1	Upstream Lt Outlet	Vegetated	1	Upstream Rt Ditch	Bare soil	0	Upstream Lt Ditch	Bare soil	0	Downstream Rt Outlet	Bare soil	0	Downstream Lt Outlet	Vegetated	1	Downstream Rt Ditch	Bare soil	0	Downstream Lt Ditch	Bare soil	0	Outlet Total	Partially Improved Outlet System	3	Ditches Total	Unimproved Drainage System	1	SRI Total	Medium Risk	44

Notes: Aggregate getting into stream channel.
