Unnamed tributary		co-0904-r-002	Sedimentation Risk Index <b>44</b>																																																																		
<u>Common:</u> 4.8mi SE of Andalusia <u>Drainage:</u> Five Runs Creek <i>GPS:</i> 31.255353548, -86.430402047 <u>Land owner:</u> Dixon Family Partnership LP		<u>County:</u> Covington <i>State:</i> Alabama <u>PLSS (T-R-S):</u> 3N-16E-3 <u>Parcel No.:</u> 1 <u>Road Name:</u> Head Farm Rd

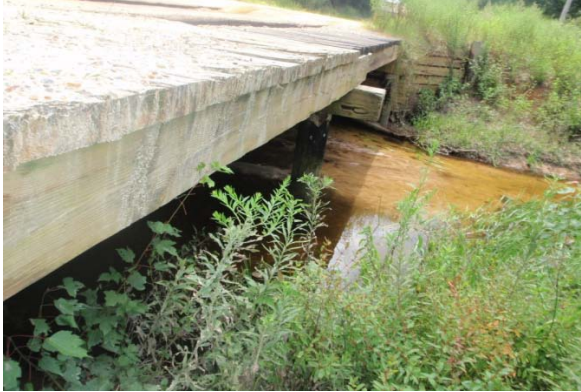
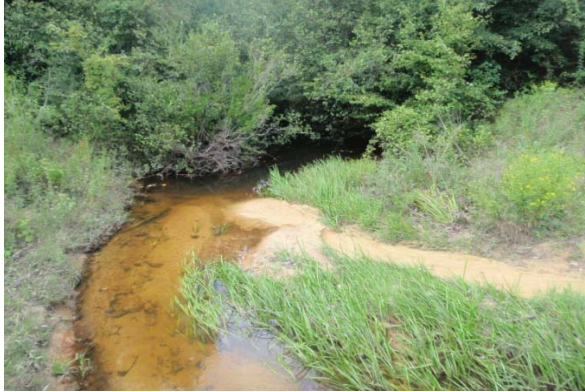
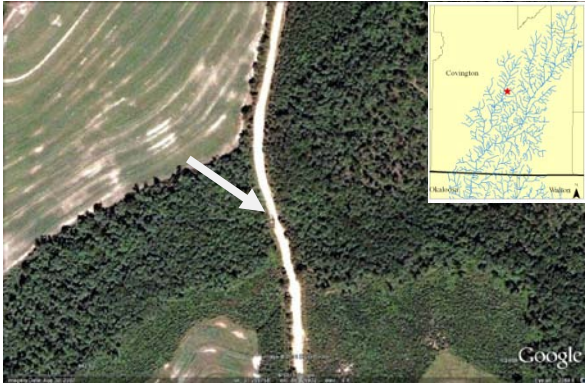
Crossing Structure: DS		DS																																																																			
<table border="1"> <thead> <tr> <th>Risk Factor</th> <th>Ranking</th> <th>Score</th> </tr> </thead> <tbody> <tr><td>US Channel Morph</td><td>C</td><td>5</td></tr> <tr><td>DS Channel Morph</td><td>C</td><td>5</td></tr> <tr><td>DS Bank Alteration</td><td>HIGH</td><td>1</td></tr> <tr><td>Upstream Skew Angle</td><td>&gt;30°</td><td>1</td></tr> <tr><td>Crossing fill condition</td><td>Fair/Rip Rap</td><td>3</td></tr> <tr><td>Inlet/Outlet Condition</td><td>Sed Islands/Scouring</td><td>3</td></tr> <tr><td>Road Approach Material</td><td>All Sand/Clay</td><td>3</td></tr> <tr><td>Potential Eroded Volume Mean</td><td>&lt;21 y<sup>3</sup></td><td>5</td></tr> <tr><td>Approach Slope Mean</td><td>&lt;2%</td><td>5</td></tr> <tr><td>Soil K Factor</td><td>&lt;0.20</td><td>5</td></tr> <tr><td>Upstream Rt Outlet</td><td>Vegetated</td><td>1</td></tr> <tr><td>Upstream Lt Outlet</td><td>Rip Rap</td><td>1</td></tr> <tr><td>Upstream Rt Ditch</td><td>Bare soil</td><td>0</td></tr> <tr><td>Upstream Lt Ditch</td><td>Vegetated</td><td>1</td></tr> <tr><td>Downstream Rt Outlet</td><td>Vegetated</td><td>1</td></tr> <tr><td>Downstream Lt Outlet</td><td>Vegetated</td><td>1</td></tr> <tr><td>Downstream Rt Ditch</td><td>Bare soil</td><td>0</td></tr> <tr><td>Downstream Lt Ditch</td><td>Bare soil</td><td>0</td></tr> <tr><td>Outlet Total</td><td>Improved Outlet System</td><td>5</td></tr> <tr><td>Ditches Total</td><td>Partially Improved Drainage System</td><td>3</td></tr> <tr><td><b>SRI Total</b></td><td><b>Medium Risk</b></td><td><b>44</b></td></tr> </tbody> </table>		Risk Factor	Ranking	Score	US Channel Morph	C	5	DS Channel Morph	C	5	DS Bank Alteration	HIGH	1	Upstream Skew Angle	>30°	1	Crossing fill condition	Fair/Rip Rap	3	Inlet/Outlet Condition	Sed Islands/Scouring	3	Road Approach Material	All Sand/Clay	3	Potential Eroded Volume Mean	<21 y <sup>3</sup>	5	Approach Slope Mean	<2%	5	Soil K Factor	<0.20	5	Upstream Rt Outlet	Vegetated	1	Upstream Lt Outlet	Rip Rap	1	Upstream Rt Ditch	Bare soil	0	Upstream Lt Ditch	Vegetated	1	Downstream Rt Outlet	Vegetated	1	Downstream Lt Outlet	Vegetated	1	Downstream Rt Ditch	Bare soil	0	Downstream Lt Ditch	Bare soil	0	Outlet Total	Improved Outlet System	5	Ditches Total	Partially Improved Drainage System	3	<b>SRI Total</b>	<b>Medium Risk</b>	<b>44</b>

Notes: Significant difference between US and DS channel. Note sediment loading from DS Rt outlet pictured.
